LIMITED OCCURRENCE INVESTIGATION REPORT – FINAL

Reference Number		CA18/3/2/1486					
Classification	Serious Incident	Date	19 June 2025			Time	0930Z
Type of Operation	Training (Part 141)						
Location							
Place of Departure	Lanseria International Airport (FALA), Gauteng Province		Place of Intended Landing	Lanseria International Airport (FALA), Gauteng Province			
Place of Occurrence	Northern Farm Nature Reserve						
GPS Co-ordinates	Latitude	25° 55' 37.09" S	Longitude	27° 58' 03.06" E	Elevation	5 420 ft	
Aircraft Information							
Registration	ZS-SJZ						
Make; Model; S/N	Diamond Aircraft Industries; DA-20-C1 (Serial Number: C0524)						
Damage to Aircraft	Substantial		Total Aircraft Hours	6957.78			
Pilot-in-command							
Licence Type	Commercial Pilot Licence (CPL)		Gender	Male		Age	23
Licence Valid	Yes	Total Hours	422.2		Total Hours on Type	309.0	
Total Hours 30 Days	84.3		Total Flying on Type Past 90 Days	150.2			
People On-board	1+1	Injuries	0	Fatalities	0	Other (on ground)	0

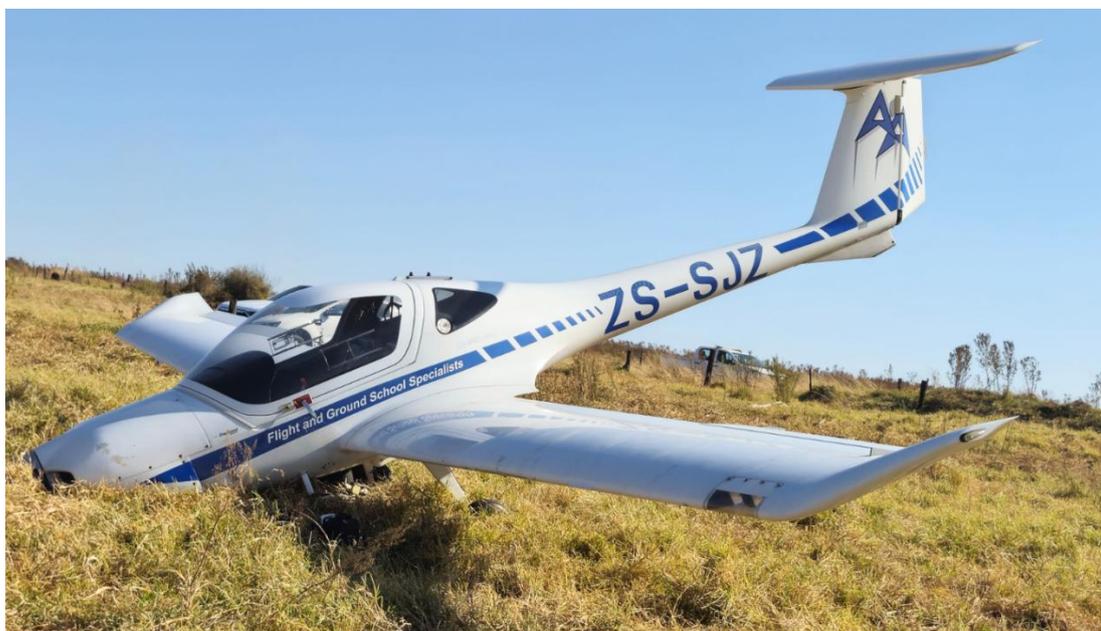
The aircraft landed on the field covered with tall thick grass. During the landing roll, the aircraft impacted a fence, bounced and leaped over a dirt road. It then impacted a second fence with its nose landing gear about 14 metres (m) from the dirt road. The aircraft continued to roll forward for 24m with the nose section scrapping the grass before it came to a full stop. The aircraft sustained substantial damage to the nose landing gear, and minor damage to the leading edges of both wings due to impact with the fence poles. Both crew members disembarked from the aircraft unassisted and with no injuries. The serious incident occurred approximately 2 nautical miles (nm) east of FALA.

Figure 2: The aircraft as it came to a full stop.

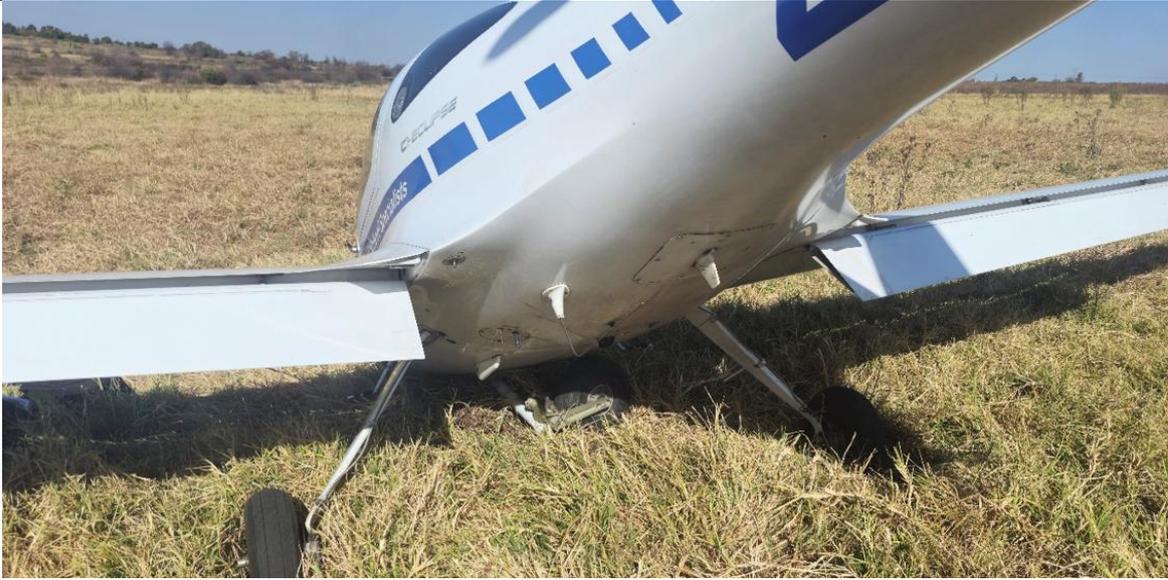
Figure 3: The damaged nose landing gear.

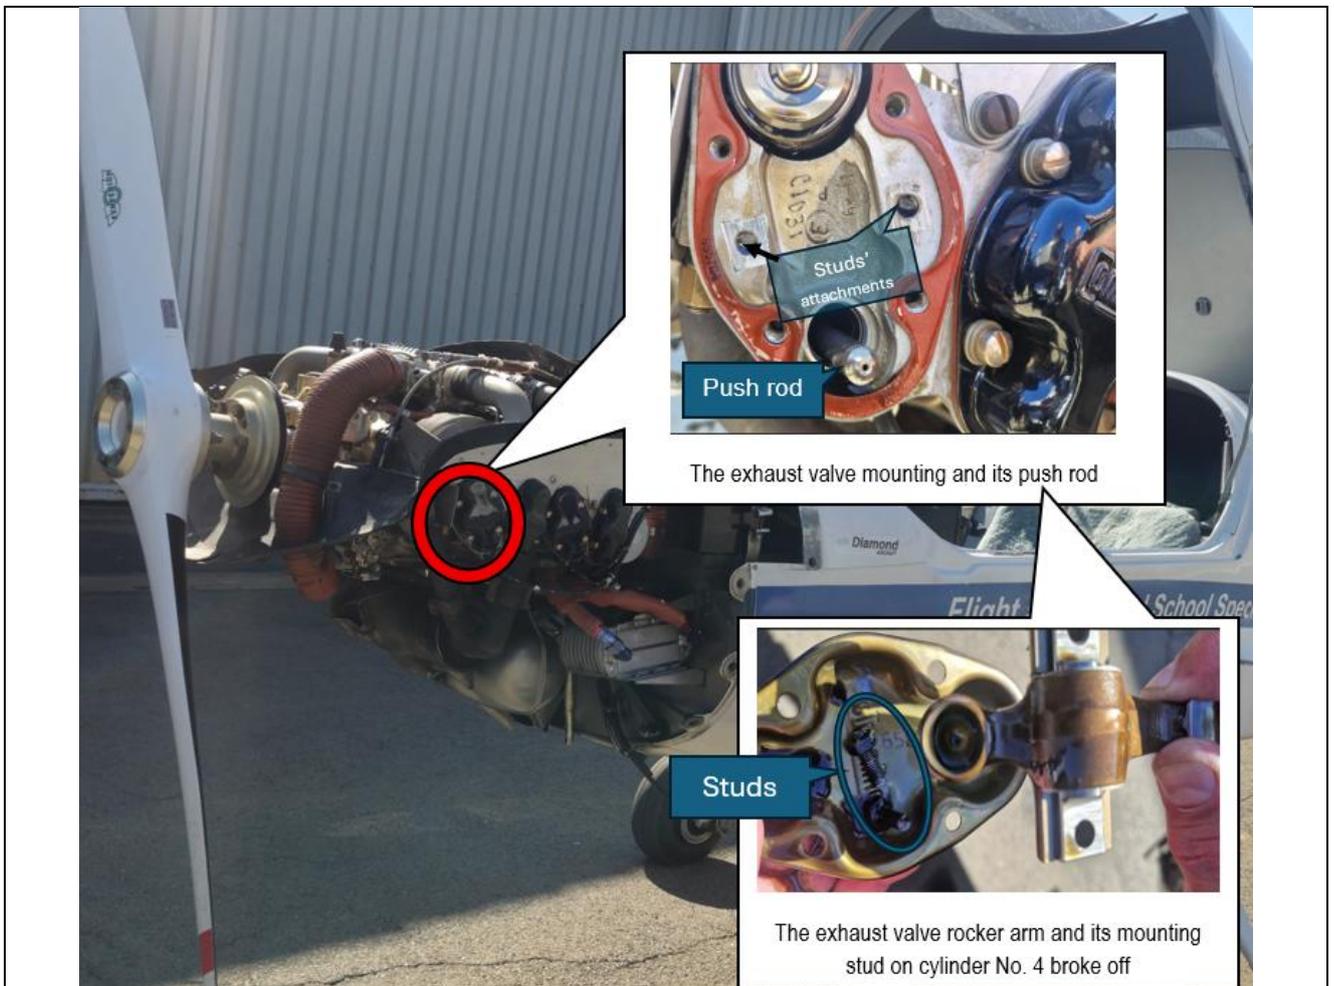
On 25 June 2025, the investigating team visited the operator's maintenance facility at FALA to conduct an engine-run test. During the test, it was observed that the No.4 exhaust valve was stuck in a partially open position, preventing the proper release of exhaust gases. This restriction caused significant back pressure in the cylinder which resulted in combustion gas backfiring and abnormal engine vibration. Further inspection revealed that the rocker arm cover for the affected valve had become loose. When removed, it was found that the rocker arm attachment studs had sheared off, which led to loss of valve actuation. As a result, the valve could not fully open or close during the engine cycle. The malfunction led to loss of compression in engine cylinder No.4 and contributed directly to engine power loss and the subsequent stoppage.

The root cause was traced to possible improper torque application on the rocker arm studs which compromised valve operation under load.

Figure 4: The damaged No.4 cylinder.

The aircraft experienced an engine power loss during a training exercise following an EFATO simulation. The loss of power was traced to the failure of the No.4 cylinder exhaust valve system. The exhaust valve rocker arm became inoperative due to the failure of its mounting studs. As a result, the exhaust valve failed to open which caused the combustion gases to back up, building excessive pressure within the combustion chamber. This led to a disruption in normal combustion and propulsion of the engine No.4 cylinder, ultimately resulting in a noticeable engine power loss that led the pilot to conduct a forced landing.

<p>4. <u>Mission</u></p> <p>4.1. During an EFATO simulating exercise, the aircraft lost engine power which was caused by the failure of the No.4 cylinder exhaust valve rocker arm. The rocker arm became inoperative due to the broken mounting studs which led to the exhaust valve remaining closed and causing a build-up of combustion gas pressure in the cylinder, thus, disrupting engine power.</p>
<p>Probable Cause(s)</p> <p>Unsuccessful forced landing following an engine power loss due to the failure of the No.4 engine cylinder exhaust valve rocker arm.</p>
<p>Contributing Factor(s)</p> <ol style="list-style-type: none"> 1. The rocker arm became inoperative due to the broken mounting studs which led to the exhaust valve remaining closed and causing a build-up of combustion gas pressure in the cylinder, thus disrupting engine power. 2. Possible improper torque application on the rocker arm studs which compromised valve operation under load.
