LIMITED OCCURRENCE INVESTIGATION REPORT – DRAFT

Reference Number	CA18/3/2/1487						
Classification	Serious Incident	Date	19 June 2025		Time	1451Z	
Type of Operation	Training (Part 141)						
Location							
Place of Departure	Wonderboom Aerodrome (FAWB), Gauteng Province		Place of Intended Landing		Freeway Park Aerodrome (FAFW), Gauteng Province		
Place of Occurrence	Approximately 3 metres to the right of Runway 02 at FAFW, Gauteng Province						
GPS Co-ordinates	Latitude	25°29' 03" S	Longitude	28° 17' 20" E	Elevation	3 838ft	
Aircraft Information							
Registration	ZU-WMM						
Make; Model; S/N	Sling 2 (Serial Number:144)						
Damage to Aircraft	Minor			Total Aircraft Hours	2 742		
Pilot-in-command							
Licence Type	Commercial Pilot Licence (CPL)		Gender	Male		Age	30
Licence Valid	Yes	Total Hours	724.8		Total Hours on Type	35.2	
Total Hours 30 Days	9.9		Total Flying on Type Past 90 Days	35.2			
People On-board	1+1	Injuries	0	Fatalities	0	Other (on ground)	0

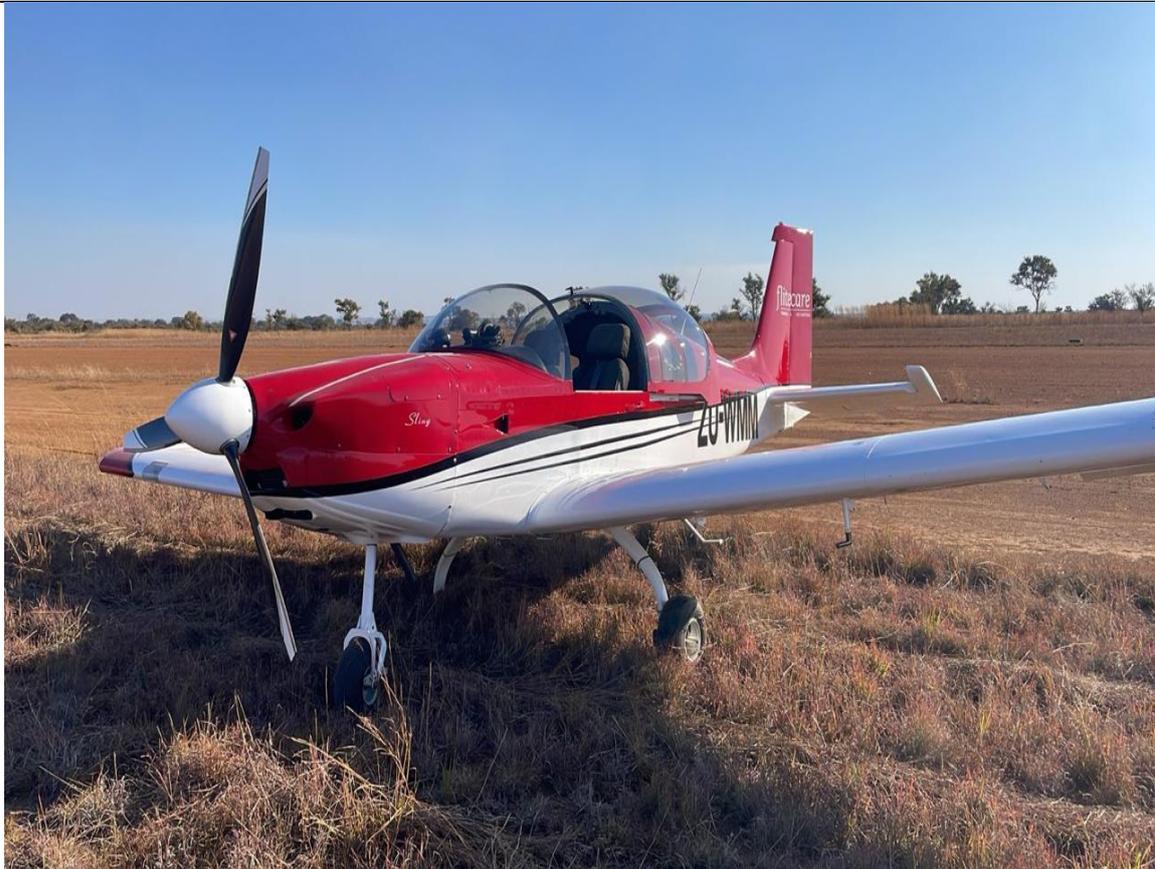
in preparation for landing on RWY 02 before performing another touch-and-go landing. After receiving confirmation from the FI, the pilot applied back pressure on the control column; however, the aircraft had a high rate of descent and, subsequently, landed hard. After touching down, the aircraft's right main wheel separated from the strut and struck the leading edge of the horizontal stabiliser. Despite the damage, the pilot maintained directional control of the aircraft for most of the landing roll. During this time, the engine was shut down and isolated as a precautionary measure as the aircraft was out of balance due to the broken strut. However, towards the end of the landing roll, the pilot lost directional control of the aircraft which veered off to the right of RWY 02. The aircraft came to a stop approximately 3 metres (m) from RWY 02. There was no additional damage to the aircraft during the runway excursion. Both occupants were not injured; they deplaned the aircraft without assistance.

Figure 2: The aircraft as it came to rest. (Source: Flight Instructor)

- 4.1 The high rate of descent during the landing roll resulted in a hard landing; subsequently, the FI lost directional control and the aircraft veered off RWY 02.

Probable Cause(s)
Hard landing due to the high rate of descent which resulted in a runway excursion.
Contributing Factor(s)
None.
Safety Action(s)
None.
Safety Message and/or Safety Recommendation/s
None.
About this Report
<i>The decision to conduct a limited investigation is based on factors including whether the cause is known and the evidence supporting the cause is clear, the level of safety benefit likely to be obtained from an investigation and that will determine the scope of an investigation. For this occurrence, a limited investigation has been conducted, and the Accident and Incident Investigations Division (AIID) has relied on the information submitted by the affected person/s and organisation/s to compile this limited report. The report has been compiled using</i>
