LIMITED OCCURRENCE INVESTIGATION REPORT – FINAL

Reference Number		CA18/3/2/1488					
Classification	Serious Incident	Date	09 July 2025			Time	1040Z
Type of Operation	Private (Part 94)						
Location							
Place of Departure	Brakpan Airfield (FABB), Gauteng Province		Place of Intended Landing		Brakpan Airfield (FABB), Gauteng Province		
Place of Occurrence	Brakpan Airfield (FABB), Gauteng Province						
GPS Co-ordinates	Latitude	26° 14' 34" S	Longitude	028° 18' 02" E	Elevation	5 356 ft	
Aircraft Information							
Registration	ZU-DLH						
Make; Model; S/N	Cubby; PI X285 (Serial Number: AK 0404)						
Damage to Aircraft	Substantial			Total Aircraft Hours	373.9		
Pilot-in-command							
Licence Type	Airline Transport Pilot Licence (ATPL) (Aeroplane)		Gender	Male		Age	68
Licence Valid	Yes	Total Hours	21000		Total Hours on Type	371.5	
Total Hours 30 Days	2.0		Total Flying on Type Past 90 Days		2.0		
People On-board	1 + 1	Injuries	0	Fatalities	0	Other (on ground)	0

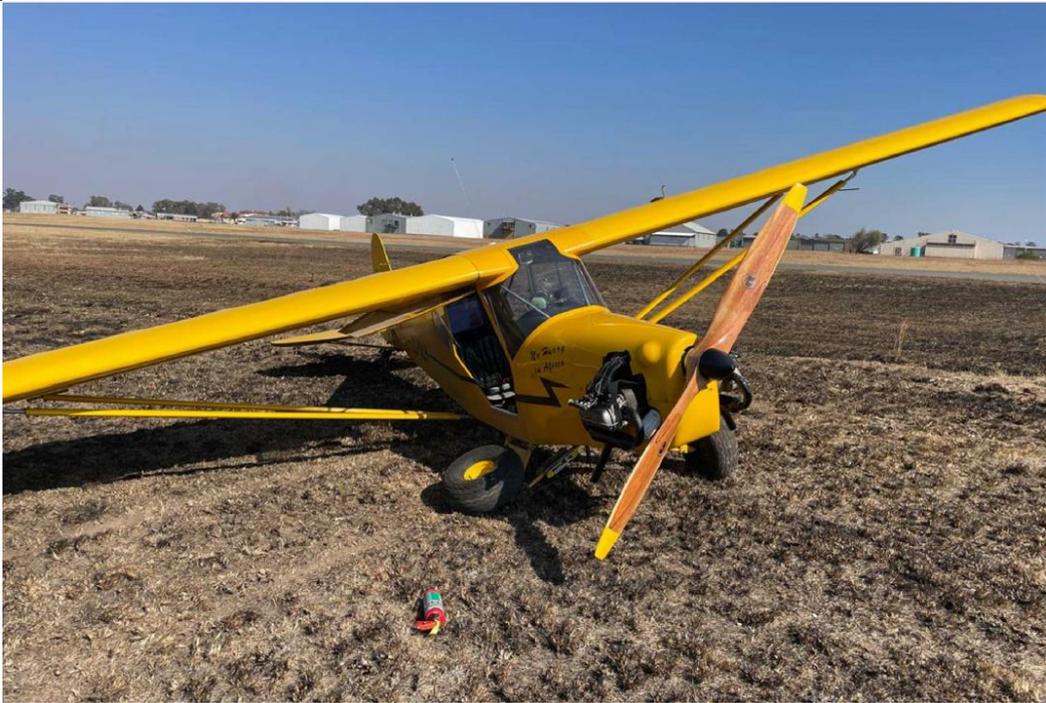
Figure 2: The aircraft after the serious incident with an outward bent right main landing gear strut. (Source: Pilot)

The right main landing gear was deformed (with signatures of being bent). The wheel collapsed outward which caused the strut to impact the ground pivoting; thus, the aircraft ground-looped to the right. The damage on the right-side landing gear may be associated with hard landings that could have occurred over a period during operation (Figure 3).

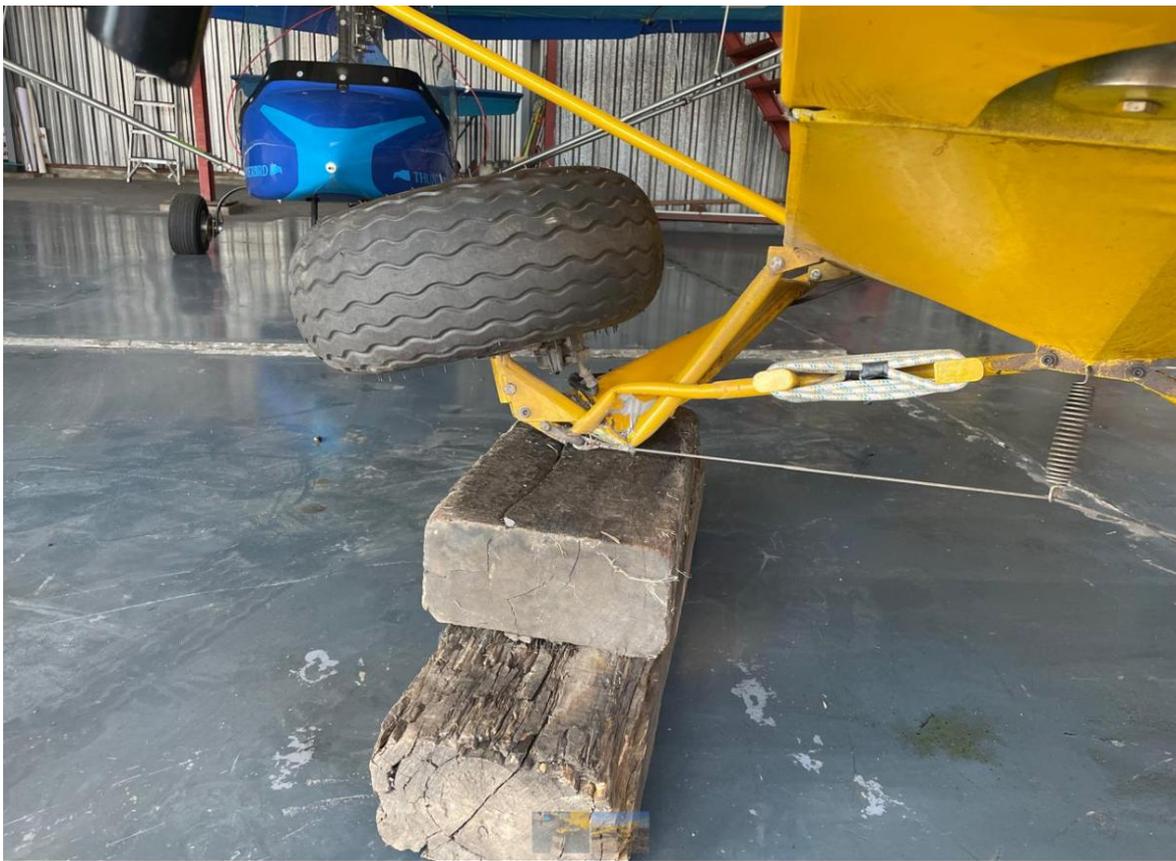
Figure 3: The damage on the landing gear was found to be consistent with the effects of hard landings. (Source: Pilot)

<p>Probable Cause(s)</p> <p>The right main landing gear collapsed outwardly during the landing roll, causing the pilot to lose directional control of the aircraft.</p>
<p>Contributing Factor(s)</p> <p>Uneven or soft grass surface.</p> <p>Pre-existing damage on the right main landing gear.</p>
<p>Safety Action(s)</p> <p>None.</p>
<p>Safety Message and/or Safety Recommendation/s</p> <p>None.</p>
<p>About this Report</p> <p><i>The decision to conduct a limited investigation is based on factors including whether the cause is known and the evidence supporting the cause is clear, the level of safety benefit likely to be obtained from an investigation and that will determine the scope of an investigation. For this occurrence, a limited investigation has been conducted, and the Accident and Incident Investigations Division (AIID) has relied on the information submitted by the affected person/s and organisation/s to compile this limited report. The report has been compiled using information supplied in the initial notification, as well as from follow-up desktop enquiries to bring awareness of potential safety issues to the industry in respect of this occurrence, as well as possible safety action/s that the industry might want to consider in preventing a recurrence of a similar occurrence.</i></p> <p><i>All times given in this report are Co-ordinated Universal Time (UTC) and will be denoted by (Z). South African Standard Time is UTC plus 2 hours.</i></p>
