LIMITED OCCURRENCE INVESTIGATION REPORT – FINAL

Reference Number	CA18/3/2/1489						
Classification	Serious Incident	Date	31 July 2025		Time	0720Z	
Type of Operation	Private (Part 94)						
Location							
Place of Departure	Potchefstroom Aerodrome (FAPS), North West Province		Place of Intended Landing	Potchefstroom Aerodrome (FAPS), North West Province			
Place of Occurrence	Right side of Runway (RWY) 03 at Potchefstroom Aerodrome (FAPS)						
GPS Co-ordinates	Latitude	26°40'24.73" S	Longitude	27°04'53.39" E	Elevation	4 484.9 ft	
Aircraft Information							
Registration	ZU-UEH						
Make; Model; S/N	Fournier; RF-4D (Serial Number: 4112)						
Damage to Aircraft	Substantial		Total Aircraft Hours	2 656.6			
Pilot-in-command							
Licence Type	National Pilot Licence (NPL)		Gender	Male		Age	76
Licence Valid	Yes	Total Hours	2 931.3		Total Hours on Type	65	
Total Hours 30 Days	0.6		Total Flying on Type Past 90 Days	0.6			
People On-board	1+0	Injuries	0	Fatalities	0	Other (on ground)	0

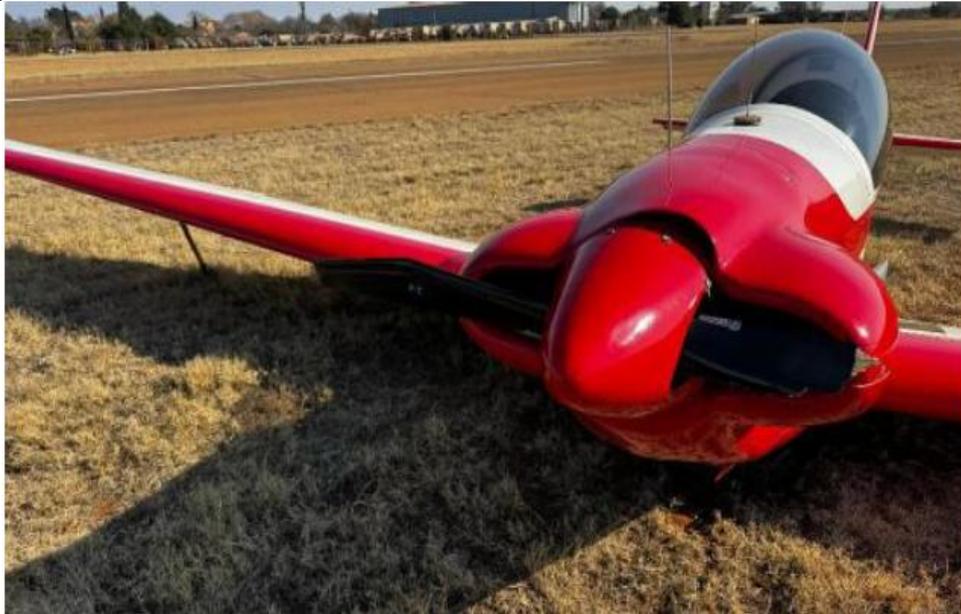
grass area to complete the turn (rolling resistance was higher and the surface was uneven). Due to the aircraft's tailwheel configuration which positioned the aircraft in a nose-up attitude on the ground, the pilot was unable to spot the depression on the terrain whilst manoeuvring on the grass. As a result, the main landing gear rolled over the unmarked depression and the nose abruptly pitched forward. Consequently, the propeller blades struck the ground which, subsequently, led to the propeller fracture.

Figure 2: The aircraft at its resting position on the grass terrain after the serious incident. (Source: Pilot)

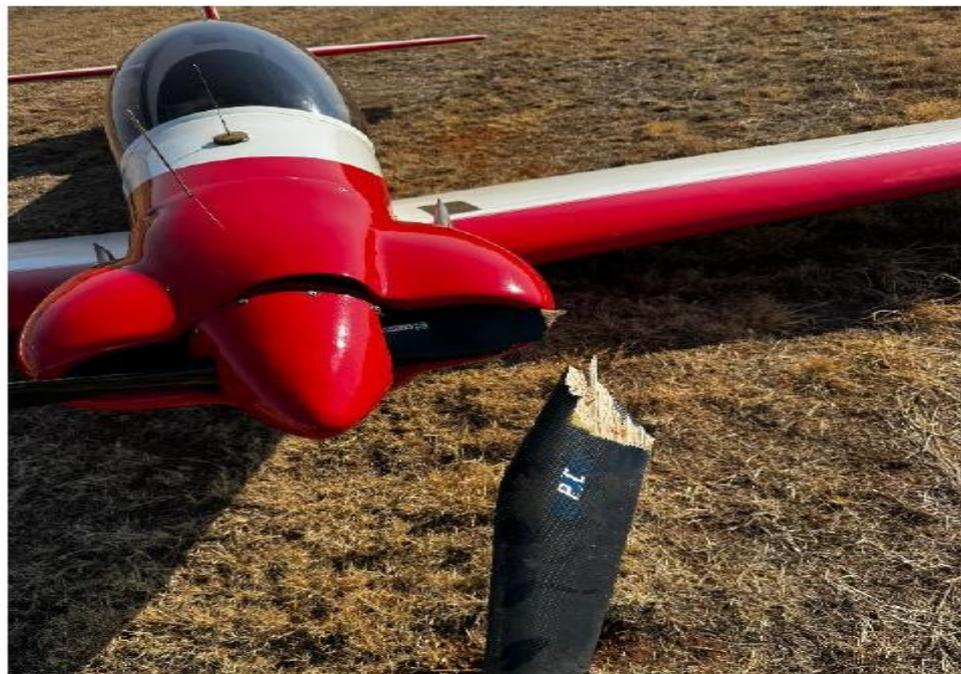
Figure 3: The fractured propeller blade. (Source: Pilot)

Probable Cause(s)
Crosswind-induced loss of directional control during ground manoeuvring caused the aircraft to roll over the uneven terrain which led to the propeller fracture.
Contributing Factor(s)
None.
Safety Action(s)
None.
Safety Message and/or Safety Recommendation/s
None.
About this Report
<p><i>The decision to conduct a limited investigation is based on factors including whether the cause is known and the evidence supporting the cause is clear, the level of safety benefit likely to be obtained from an investigation and that will determine the scope of an investigation. For this occurrence, a limited investigation has been conducted, and the Accident and Incident Investigations Division (AIID) has relied on the information submitted by the affected person/s and organisation/s to compile this limited report. The report has been compiled using information supplied in the initial notification, as well as from follow-up desk top enquiries to bring awareness of potential safety issues to the industry in respect of this occurrence, as well as possible safety action/s that the industry might want to consider in preventing a recurrence of a similar occurrence.</i></p> <p><i>All times given in this report are Co-ordinated Universal Time (UTC) and will be denoted by (Z). South African Standard Time is UTC plus 2 hours.</i></p>

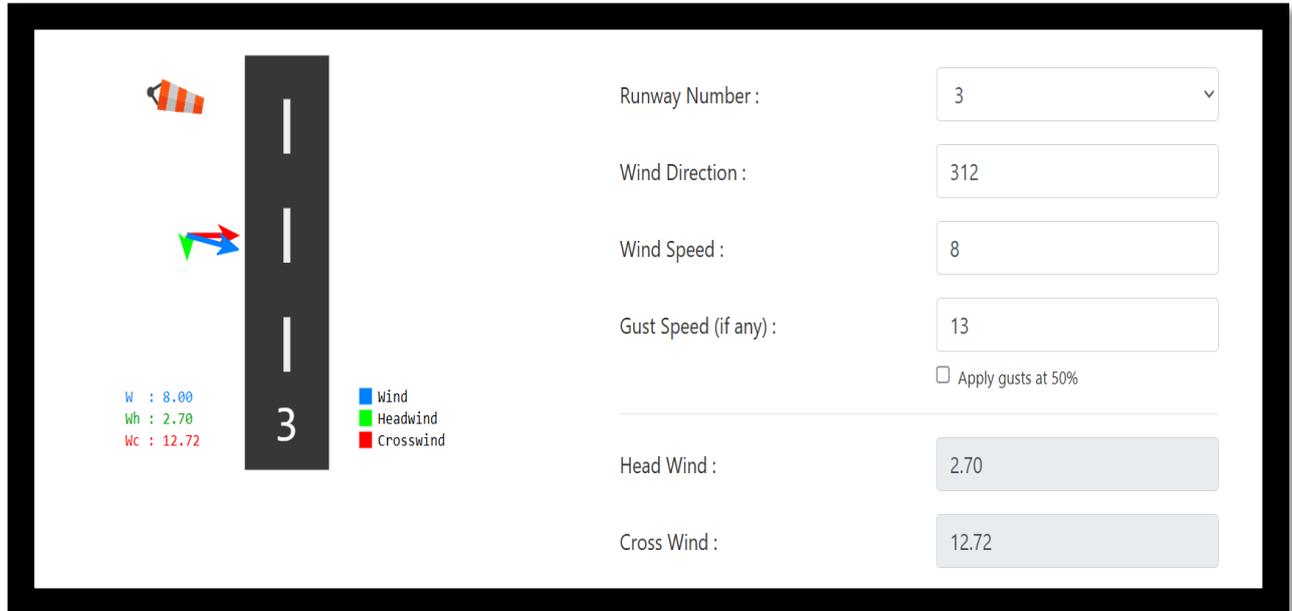
Crosswind Calculation

Based on the calculation above, the aircraft experienced a 2.70 headwind and 12.72 crosswind during the manoeuvre on RWY 03.

Whilst the crosswind of 12.72 kts is within the Fournier RF-4D demonstrated maximum of 15 kts, it would still present a significant challenge during low-speed ground handling, particularly due to the aircraft’s tailwheel configuration and non-castor tailwheel.
