## AIRCRAFT SERIOUS INCIDENT REPORT AND EXECUTIVE SUMMARY

<b>Reference:</b>		CA18/3/2/1490	
<b>Aircraft Registration</b>	ZS-ZWO	<b>Date of Incident</b>	2 August 2025		<b>Time of Incident</b>	0922Z
<b>Type of Aircraft</b>	Boeing 737-800		<b>Type of Operation</b>	Air Transport (Part 121)		
<b>Pilot-in-command Licence Type</b>	Airline Transport Pilot Licence (ATPL)		<b>Age</b>	38	<b>Licence Valid</b>	Yes
<b>Flying Experience</b>		<b>Total Flying Hours</b>	8 965.0	<b>Hours on Type</b>	4 486.0	
<b>Last Point of Departure</b>	O.R. Tambo International Aerodrome (FAOR), Gauteng Province, South Africa					
<b>Next Point of Intended Landing</b>	Abeid Amani Karume International Aerodrome (HTZA), Zanzibar, Tanzania					
<b>Damage to Aircraft</b>	No damage					
<b>Location of the incident site with reference to easily defined geographical points (GPS readings if possible)</b>						
Approximately 30 675 feet (ft) at Global Positioning System (GPS) co-ordinates: 24°54'06.4" S 029°52'47.3" E

**Reference Number** : CA18/3/2/1490  
**Occurrence Category** : Serious Incident (Category 3)  
**Type of Operation** : Air Transport Operations (Part 121)  
**Name of Operator** : FlySafair  
**Aircraft Re

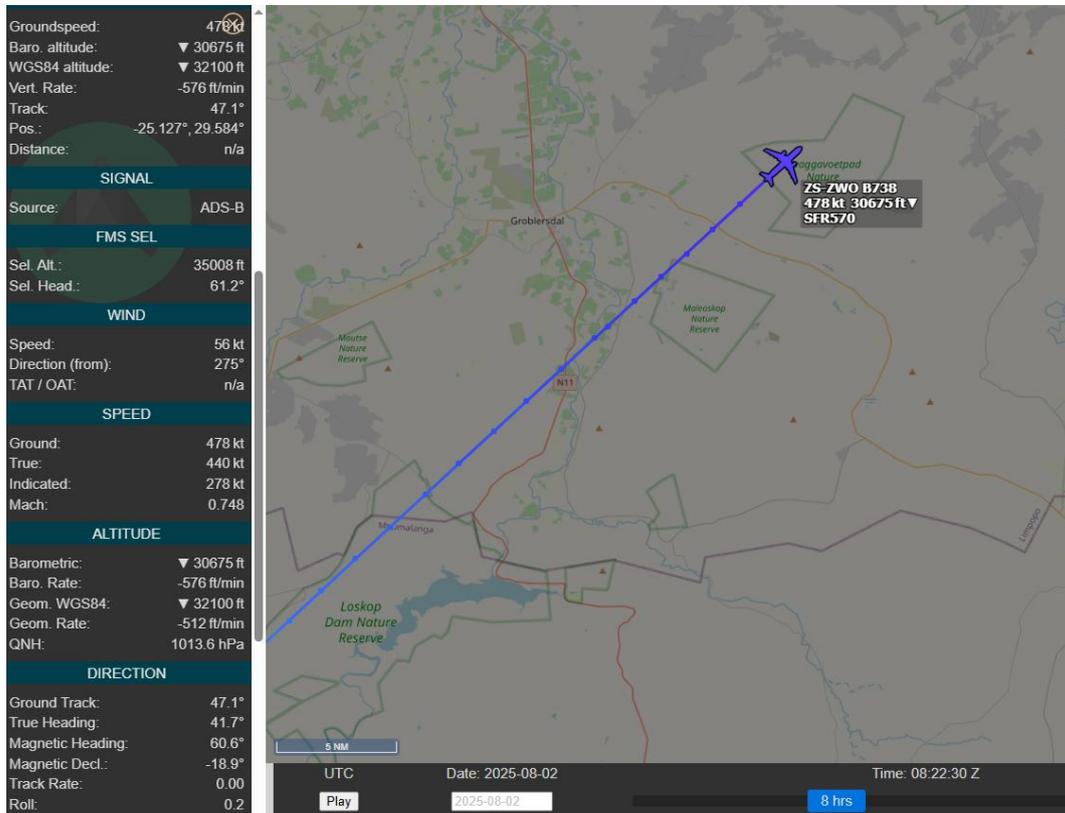
- 1.1.4 However, as the aircraft was passing through 30 675 ft for the cruise altitude at 35 000 ft (FL350), a Bleed Trip Off light illuminated on the right pack. The PM noticed that both duct pressures had dropped to zero. The crew could feel in their ears that the cabin rate was climbing, which was confirmed by the cabin rate indicator. The PF confirmed the outflow valve indicator was in the fully closed position. The PM took over as PF; he commenced the emergency descent to the cleared altitude of 14 000 ft, followed by a further descent to 10 000 ft. The cabin altitude warning light on each pilot's forward panel illuminated, and the aural warning sounded. *(The warning light illuminates simultaneously with the aural warning when the cabin altitude is greater than 10 000 ft and remains illuminated until the cabin altitude pressure switch deactivates. The cabin altitude pressure switch can deactivate between 500 and 1 500 ft below the activation altitude.)* The cockpit crew donned their oxygen masks and completed memory items for cabin altitude warning or rapid decompression.

Figure 1: Radar information showing altitude captured at 30 675ft.

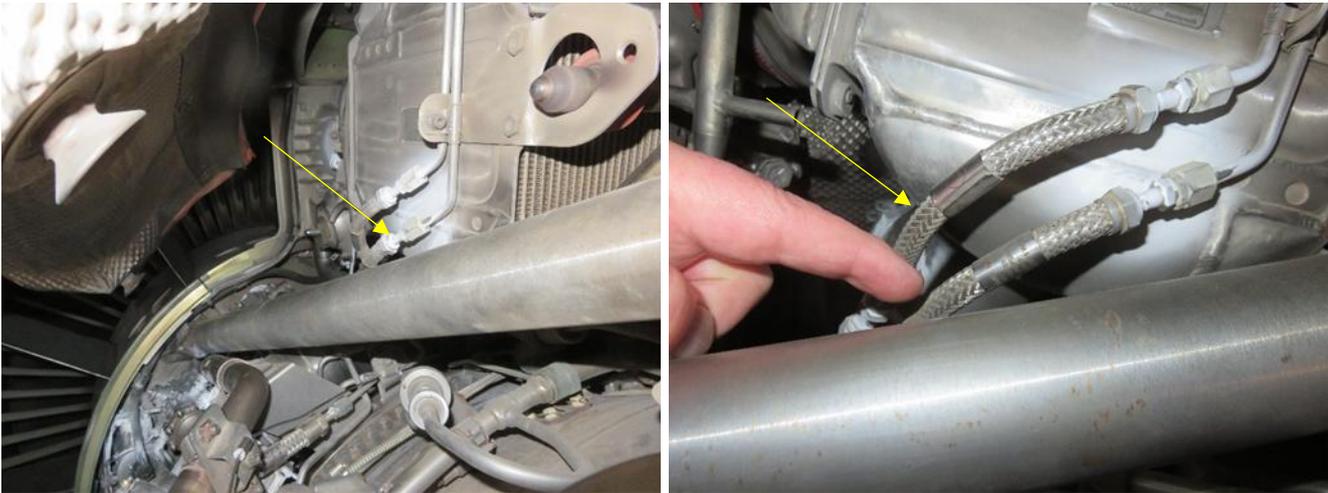
1.16.10 The sense lines are installed on the side of the engine. However, the heatshield surrounding these lines significantly impedes visual inspection, making it difficult to assess their condition effectively.

**Figure 4:** Example of the two sense lines on the side of the engine.

Another contributing factor that made it impossible to notice the ruptured sense lines was due to limited visibility with the heat shield that covered the sense lines. This design impeded effective visual inspection and contributed to the failure going unnoticed.

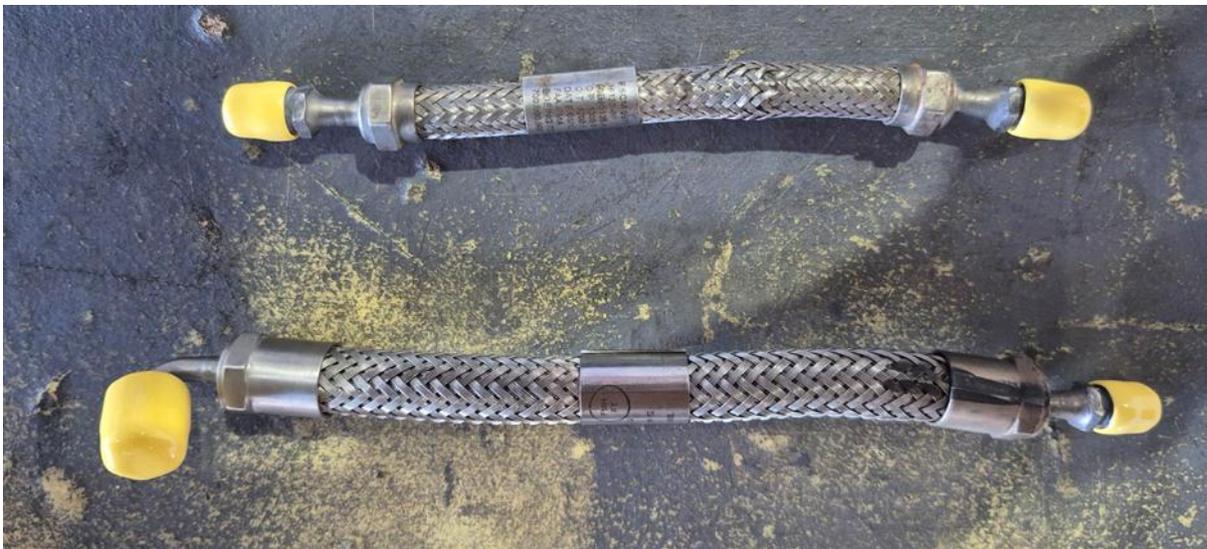
1.16.9 Once the aircraft was on the ground, the AMO troubleshot the bleed air system; it was found that the system was leaking. The leak was determined to have originated from the two sense lines on engine Number 1 which had ruptured.

**Figure 5:** The leaking sense lines after they were removed from the engine.

- 3.2.14 Post-flight diagnostics confirmed a leak in the bleed air system in engine Number 1 which was traced to the ruptured sense lines on the engine.

Following this serious incident, a bleed system health check was conducted on engine Number 1, which revealed leaks in the PRSOV and associated sense lines; both components were subsequently replaced. Post-replacement testing confirmed the system was free of further leaks; engine Number 2 underwent the same inspection with no defects found.

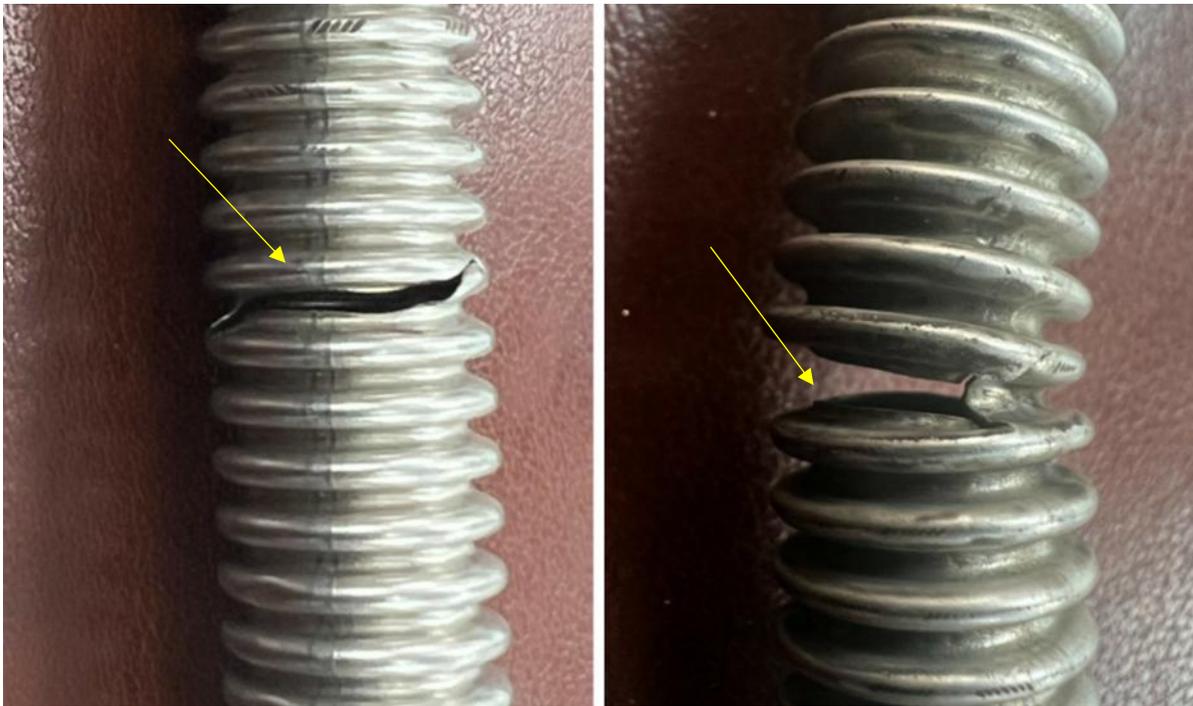
**Figure 6:** The ruptured sense lines after they were disassembled.

- 3.3.1 An abrupt loss of cabin pressure occurred during flight due to a simultaneous failure in the aircraft’s bleed air system. The serious incident was triggered by a rupture in the sense lines of engine Number 1, which compromised its bleed air output and compounded by a Bleed Trip Off condition on engine Number 2, which further disrupted the pressurisation system.
