LIMITED OCCURRENCE INVESTIGATION REPORT – FINAL

Reference Number	CA18/3/2/1491						
Classification	Serious Incident		Date	07 August 2025		Time	1020Z
Type of Operation	Private (Part 94)						
Location							
Place of Departure	Morningstar Airfield, Western Cape Province		Place of Intended Landing		Altona Airstrip near Klipheuwel, Western Cape Province		
Place of Occurrence	Altona Airstrip near Klipheuwel, Western Cape Province						
GPS Co-ordinates	Latitude	33°42'27.9" S	Longitude	18°38'46.1" E	Elevation	1 899.61 ft	
Aircraft Information							
Registration	ZU-FEH						
Make; Model; S/N	Sonex; A-Model (Serial Number: 956)						
Damage to Aircraft	Minor		Total Aircraft Hours	90.1			
Pilot-in-command							
Licence Type	Private Pilot Licence (PPL)		Gender	Male		Age	45
Licence Valid	Yes	Total Hours	553.6		Total Hours on Type	48	
Total Hours 30 Days	4.4		Total Flying on Type Past 90 Days	9.2			
People On-board	1+0	Injuries	0	Fatalities	0	Other (on ground)	0

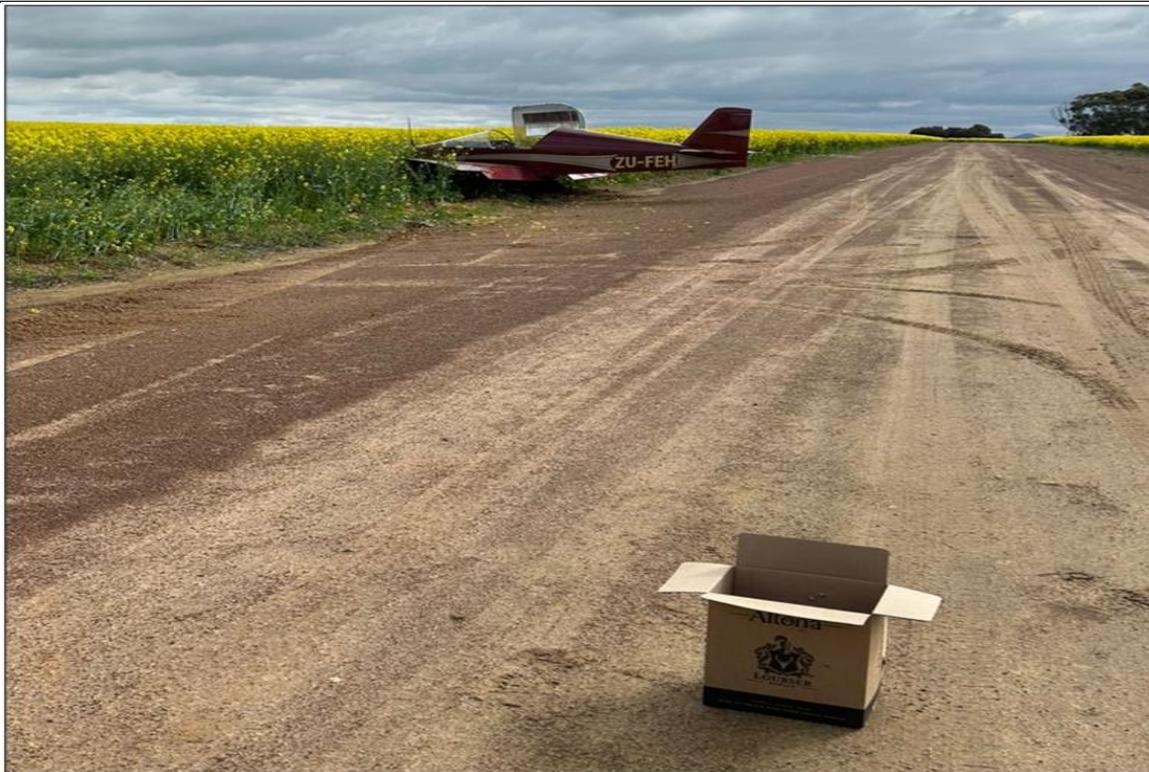
After the serious incident, the pilot shut down the engine and safely exited the aircraft; he was uninjured. A post-serious incident inspection identified minor damage to several components of the aircraft, including the right-wing tip and leading edge, nose landing gear strut, right main landing gear and propeller. The cardboard box was later examined and found to be empty. The pilot was unable to find out the person who placed it on the runway.

Figure 2: The aircraft at its resting position and the cardboard box in the foreground on the runway.
(Source: Pilot)

- 2.5. The aircraft's Certificate of Registration (C of R) was issued to the present owner on 13 November 2024.
- 2.6. The presence of a cardboard box on the runway prompted the pilot to take an evasive action during the landing roll which led to loss of directional control and a runway excursion.

Loss of directional control during the landing roll following a manoeuvre to avoid impacting a cardboard box on the runway.
