LIMITED OCCURRENCE INVESTIGATION REPORT – FINAL

Reference Number	CA18/3/2/1492						
Classification	Serious Incident	Date	05 August 2025	Time	0910Z		
Type of Operation	ZS-RMU: Commercial (Part 127); ZS-STF: Private (Part 94)						
Location							
Place of Departure	Virginia Airport (FAVG), KwaZulu-Natal Province	Place of Intended Landing	Virginia Airport (FAVG), KwaZulu-Natal Province				
Place of Occurrence	Final approach Runway 05 at Virginia Airport (FAVG), KwaZulu-Natal Province						
GPS Co-ordinates	Latitude	S29°46'.31"	Longitude	E31°03'.20"	Elevation	20 feet	
Aircraft Information							
Registration	ZS-RMU and ZU-STF						
Make; Model; S/N (ZS-RMU)	Robinson; R44 (Serial Number: 0992)						
Make; Model; S/N (ZU-STF)	The Airplane Factory; Sling 2 (Serial Number: 245)						
Damage to Aircraft (ZS-RMU)	None	Total Aircraft Hours	2658.6				
Damage to Aircraft (ZS-STF)	None	Total Aircraft Hours	3011.2				
Pilot-in-command							
Licence Type ZS-RMU	Commercial Pilot Licence (CPL) Helicopter		Gender	Male	Age	27

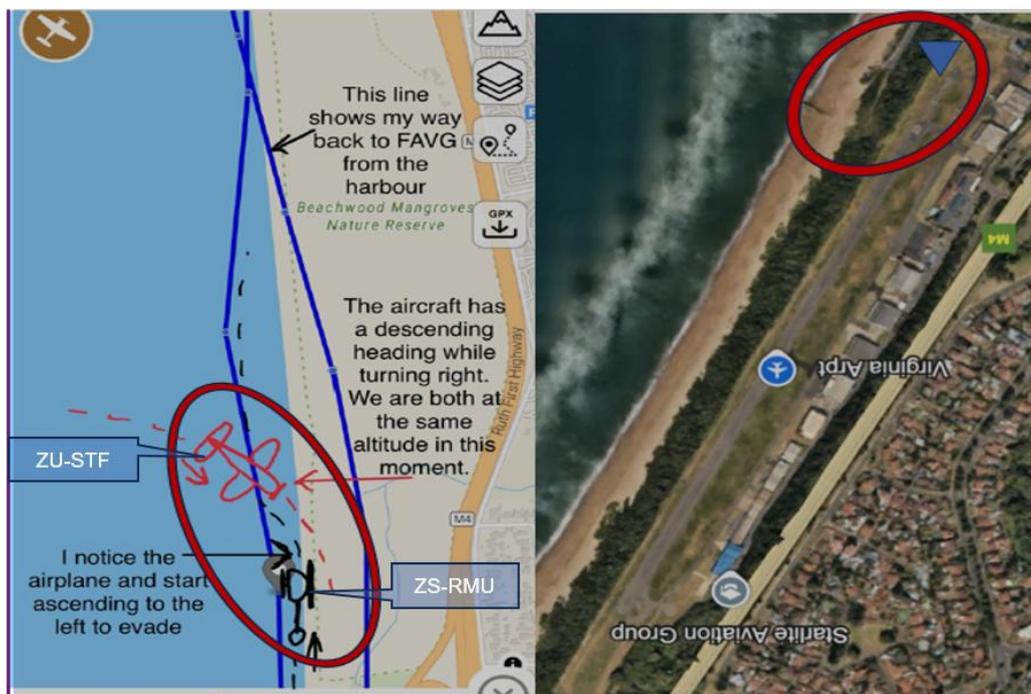
Figure 1: The position of the ZS-STF and ZS-RMU at the time the avoidance manoeuvre was executed; the ZS-RMU ascended on final approach for Runway 05. (Source: ZS-RMU pilot)

The figure above illustrates the reported airspace conflict at FAVG. The blue marking on the right-side shows the approximate area where the serious incident occurred.

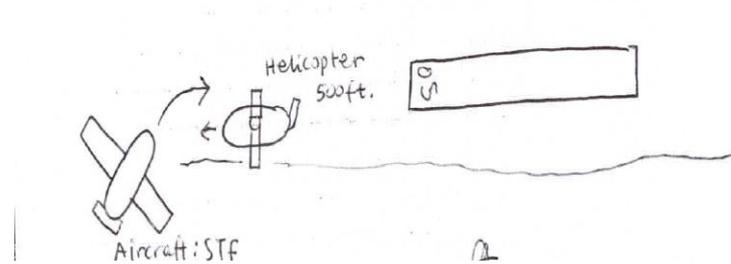
Illustration 1: A sketch of the positions when the serious incident occurred. (Source: ZU-STF pilot)
