LIMITED OCCURRENCE INVESTIGATION REPORT – FINAL

Reference Number	CA18/3/2/1493						
Classification	Serious Incident		Date	11 August 2025		Time	1210Z
Type of Operation	Private (Part 91)						
Location							
Place of Departure	Dortchester Private Farm, North West Province		Place of Intended Landing	New Tempe Aerodrome (FATP), Free State Province			
Place of Occurrence	Runway 01 at New Tempe Aerodrome (FATP), Free State Province						
GPS Co-ordinates	Latitude	29° 01' 49.26" S	Longitude	26° 09' 47.41" E	Elevation	4504ft	
Aircraft Information							
Registration	ZS-FLR						
Make; Model; S/N	Beechcraft V35A (Serial Number: D-8923)						
Damage to Aircraft	Substantial			Total Aircraft Hours	3 608.0		
Pilot-in-command							
Licence Type	Private Pilot Licence (PPL)		Gender	Male		Age	51
Licence Valid	Yes	Total Hours	633.5		Total Hours on Type	199.5	
Total Hours 30 Days	3		Total Flying on Type Past 90 Days	5			
People On-board	1+1	Injuries	0	Fatalities	0	Other (on ground)	0

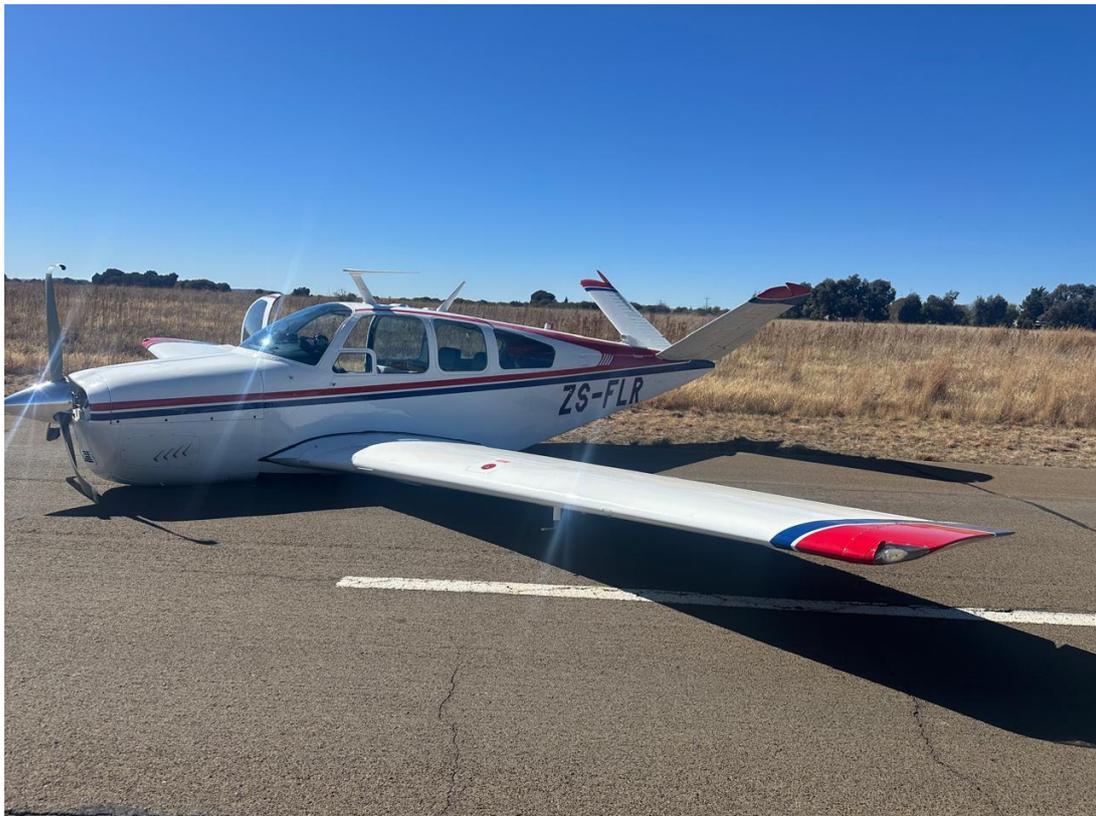
disembarked from the aircraft; they were not injured. The aircraft sustained damage to the propeller, wing flaps and airframe belly skin.

Figure 2: The aircraft at the serious incident site. (Source: Pilot)

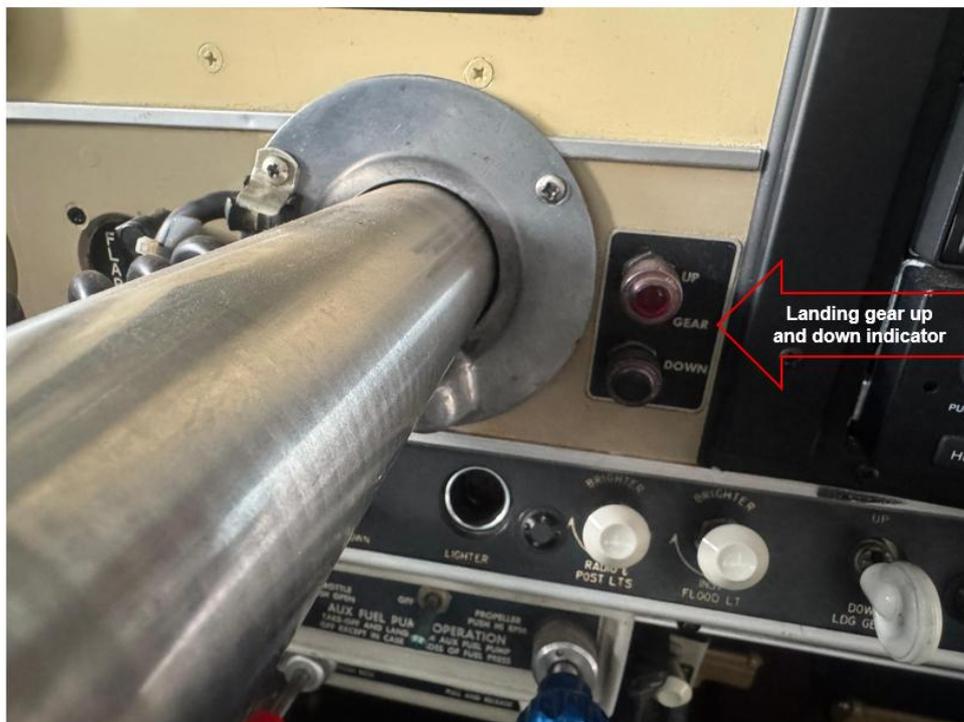
The pilot reported that the aircraft was airworthy at the time of the flight. It was recovered to the hangar at FATP on 11 August 2025. According to the technical report from the aircraft maintenance engineer (AME), the aircraft was placed on jacks, and the undercarriage retraction system was tested. It was found that the emergency extension handle had inadvertently become engaged in-flight. The pilot stated that during the flight, the passenger had moved the luggage that was located behind the front seat and inadvertently activated (engaged) the emergency extension handle. This jammed the emergency extension handle during undercarriage operation. The AME further stated that this also tripped the undercarriage motor circuit breaker. The handle was returned to its stowed position, and the undercarriage subsequently operated normally. The AME reported that the only abnormality he noticed during the inspection was the undercarriage/throttle warning light that was unserviceable at the time of testing. The pilot stated that the landing gear down seemed illuminated, but it was confirmed to be unserviceable by the AME during the post-accident inspection.

Figure 3: The landing gear up and down indicator lights. (Source: Aircraft maintenance engineer)

7. The undercarriage/throttle warning light was found unserviceable during the post-accident inspection.
8. The emergency landing gear extension handle was inadvertently engaged in-flight which caused the handle to jam during undercarriage operation whilst the aircraft was in the landing phase. This, therefore, tripped the undercarriage motor circuit breaker.

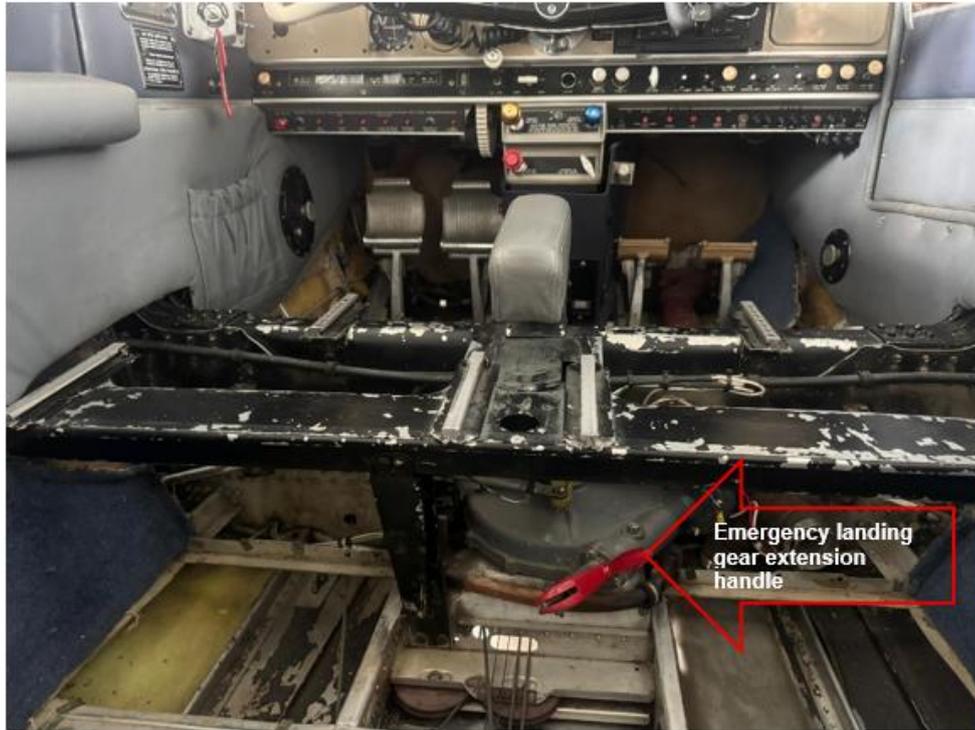
Figure 4: The emergency landing gear extension handle. (Source: Aircraft maintenance engineer)

According to the Pilot's Operating Handbook, the hand crank handle should have a cover; the AME reported that the aircraft did not have one. The pilot stated that the emergency extension handle was inadvertently engaged by the passenger whilst moving the luggage in-flight. The AME confirmed that it was possible to inadvertently engage the emergency landing gear extension handle.

Contributing Factor(s)
The emergency landing gear extension handle was inadvertently engaged during flight.
Safety Action(s)
None.
Safety Message and/or Safety Recommendation/s
None.
About this Report
<p><i>The decision to conduct a limited investigation is based on factors including whether the cause is known and the evidence supporting the cause is clear, the level of safety benefit likely to be obtained from an investigation and that will determine the scope of an investigation. For this occurrence, a limited investigation has been conducted, and the Accident and Incident Investigations Division (AIID) has relied on the information submitted by the affected person/s and organisation/s to compile this limited report. The report has been compiled using information supplied in the initial notification, as well as from follow-up desk top enquiries to bring awareness of potential safety issues to the industry in respect of this occurrence, as well as possible safety action/s that the industry might want to consider in preventing a recurrence of a similar occurrence.</i></p> <p><i>All times given in this report are Co-ordinated Universal Time (UTC) and will be denoted by (Z). South African Standard Time is UTC plus 2 hours.</i></p>
