LIMITED OCCURRENCE INVESTIGATION REPORT – FINAL

Reference Number	CA18/3/2/1495					
Classification	Serious Incident	Date	12 August 2025		Time	0915Z
Type of Operation	Commercial (ZS-ZWX Part 121 and ZS-ALL Part 121)					
Location						
Place of Departure	ZS-ZWX: Cape Town International Airport (FACT), Western Cape Province		Place of Intended Landing		ZS-ZWX: Kruger Mpumalanga International Airport (FAKN), Mpumalanga Province	
	ZS-ALL: Kruger Mpumalanga International Airport (FAKN), Mpumalanga Province				ZS-ALL: O.R. Tambo International Airport (FAOR), Gauteng Province	
Place of Occurrence	Runway 05 at Kruger Mpumalanga International Airport (FAKN), Mpumalanga Province					
GPS Co-ordinates	Latitude	S25°23'.49"	Longitude	E31°5'.96"	Elevation	2 829 feet
Aircraft Information						
Registration	ZS-ZWX and ZS-ALL					
Make; Model; S/N	ZS-ZWX: Boeing; 737-800 (Serial Number: 39877)					
Make; Model; S/N	ZS-ALL: Embraer; ERJ-135 (Serial Number: 538)

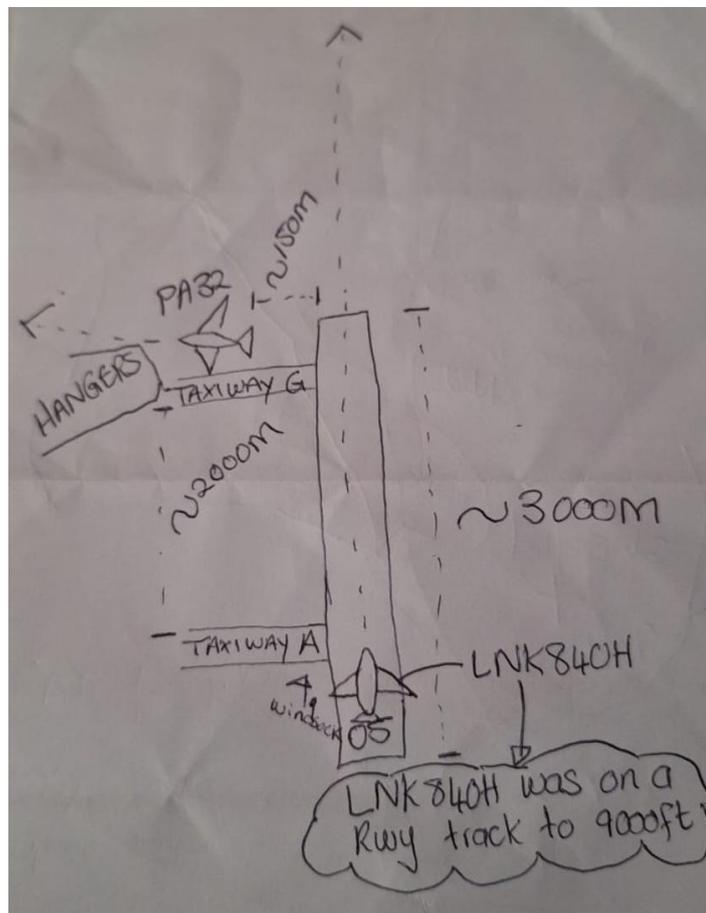
After a few minutes, the ZS-ALL crew stated that they were directed to continue with taxi and to line up behind the Piper Cherokee PA-32 at holding point A. Once lined up, the ZS-ZWX crew called the tower and advised that they were approaching MASHO (a dimensionless quantity representing the ratio of an aircraft speed to the speed of sound). The ATCO directed ZS-ZWX to continue with the approach. The ATCO then enquired from the Piper Cherokee PA-32 pilot if he was ready to depart, to which he replied "yes". The ZS-ALL crew asked the ATCO if he was aware they had lined up. The ATCO replied that VFR traffic would execute an early left turn after rotation.

Illustration 1: The position of the Piper Cherokee PA-32 that executed a left turn after rotation and ZS-ALL on the threshold of Runway 05. (Source: ATCO)

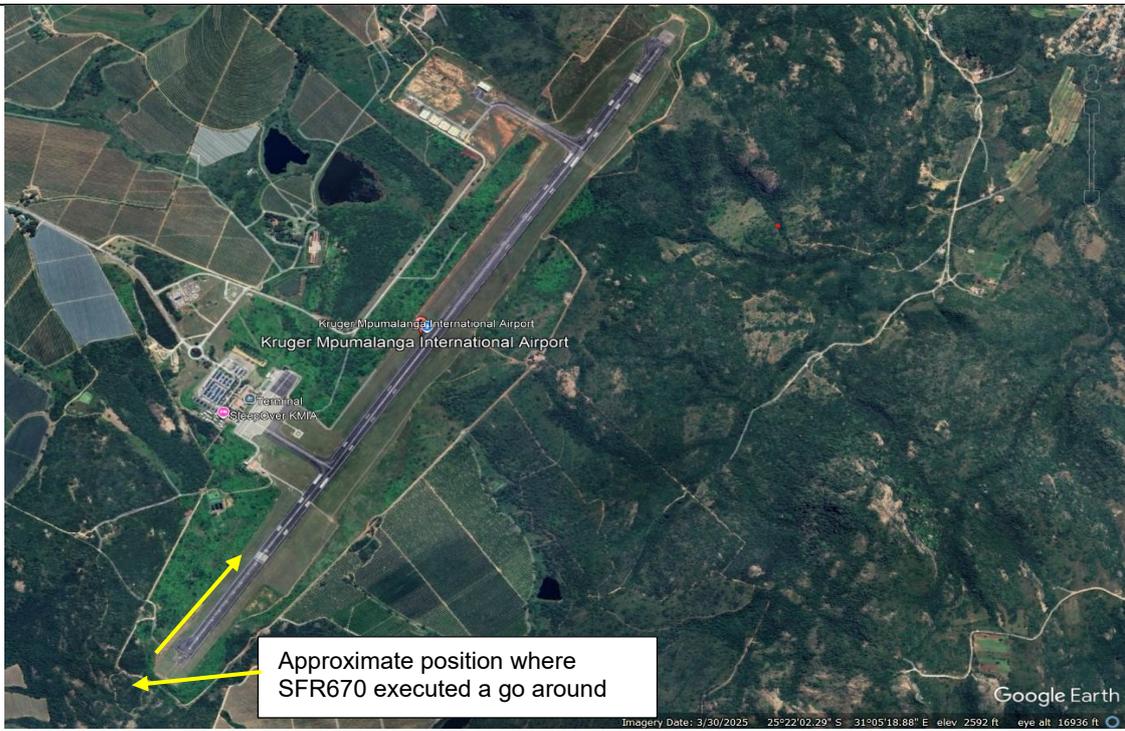
Figure 1: An aerial view of FAKN, the take-off and landing direction around the time of the serious incident.
(Source: Google Earth)
