AIRCRAFT SERIOUS INCIDENT REPORT AND EXECUTIVE SUMMARY

Reference:		CA18/3/2/1496	
Aircraft Registration	ZU-IHA	Date of Incident		16 August 2025		Time of Incident	0800Z
Type of Aircraft	Apollo T AL-60			Type of Operation		Parachute (Part 105)	
Pilot-in-command Licence Type		Private Pilot Licence (PPL)		Age	63	Licence Valid	Yes
Pilot-in-command Flying Experience		Total Flying Hours		8 118.3		Hours on Type	1387.7
Last Point of Departure		Parys Aerodrome (FAPY), Free State Province					
Next Point of Intended Landing		Parys Aerodrome (FAPY), Free State Province					
Damage to Aircraft		Substantial					
Location of the incident site with reference to easily defined geographical points (GPS readings if possible)							
Approximately 90 metres (m) short of Runway 07, Parys Aerodrome, at Global Positioning System co-ordinates determined to be South 26°53'44.8" East 027°29'24.1"							
Meteorological Information		Surface wind: 060°/15kts; Temperature: 08°C; Dew point: 03°C; Visibility: CAVOK

Probable Cause							
Engine power loss caused by the fractured first-stage turbine wheel on the axial turbine rotor blades prompted a forced landing which was unsuccessful approximately 90m short of

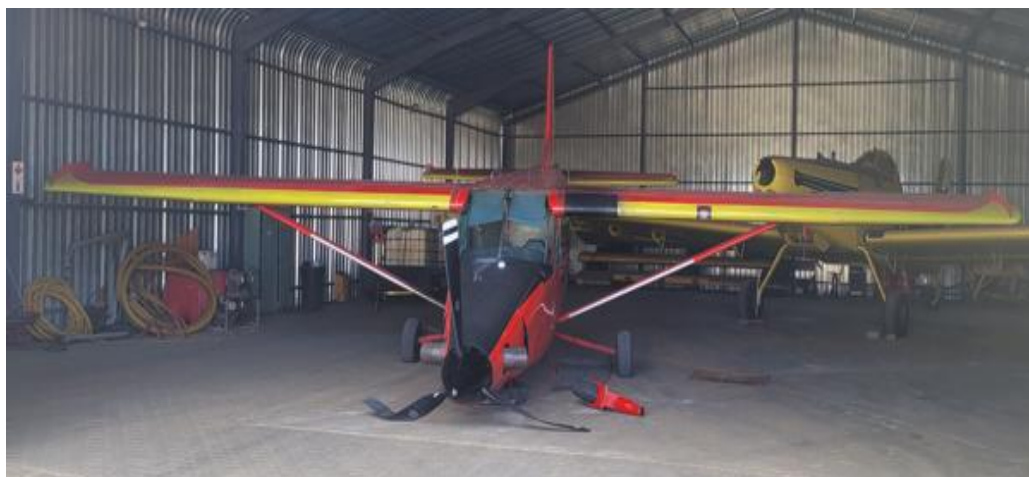
1.3.1. The aircraft sustained substantial damage.

Figure 2: The aircraft post-serious incident. (Source: Pilot)

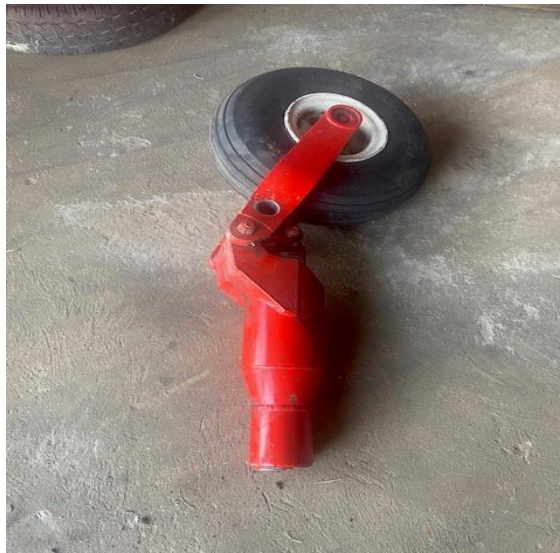
1.12.1 The nose gear was severed and the propeller was damaged. The fuselage and wings had remained intact.

Figure 4: The severed nose gear.

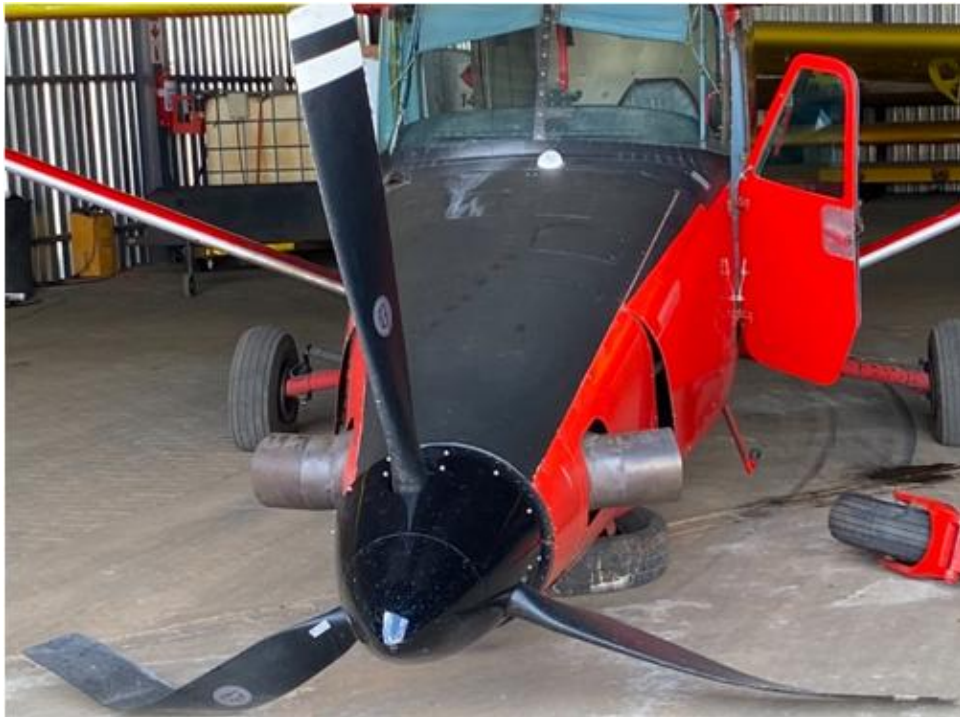
Figure 5: The damaged propeller blades.

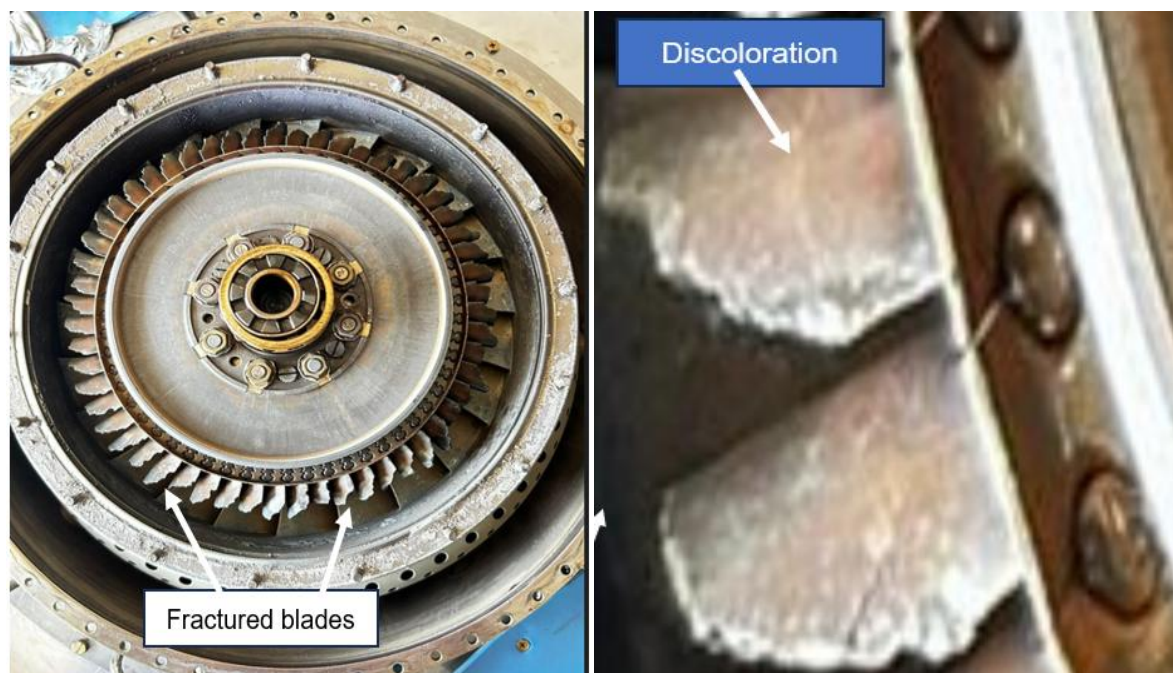
The examination of the engine revealed a fracture on the axial turbine rotor blades (the first-stage turbine wheel). The damage was observed across multiple blades, with fractures at a similar height. The blades surface exhibited signs of thermal distress, including discolouration, oxidation and a rough texture, which was consistent with exposure to elevated operating temperatures. There was no evidence of foreign object damage (FOD) as no localised impact or irregular damage patterns were observed.

Figures 6 and 7: Fractured axial turbine rotor blades (left picture). Discolouration on the turbine axial rotor blades (right picture).

- 2.2.4. Teardown examination of the engine revealed the fractured first-stage turbine wheel on the axial turbine rotor blades. The fracture was consistent with exposure to elevated operating temperatures. There was no evidence of foreign object damage (FOD) as no localised impact or irregular damage patterns were observed.

3.2.7. Teardown examination of the engine revealed the fractured first-stage turbine wheel on the axial turbine rotor blades. The fracture was consistent with exposure to elevated operating temperatures. There was no evidence of foreign object damage (FOD) as no localised impact or irregular damage patterns were observed.

3.3.1. Engine power loss caused by the fractured first-stage turbine wheel on the axial turbine rotor blades prompted a forced landing which was unsuccessful approximately 90 metres (m) short of FAPY Runway 07.

3.4.1. Progressive clearance loss due to sustained elevated temperatures.
