LIMITED OCCURRENCE INVESTIGATION REPORT – FINAL

Reference Number		CA18/3/2/1497									
Classification	Serious Incident		Date	19 August 2025		Time	1040Z				
Type of Operation	Training (Part 141)										
Location											
Place of Departure	Lanseria International Airport (FALA), Gauteng Province		Place of Intended Landing	Lanseria International Airport (FALA), Gauteng Province							
Place of Occurrence	Lanseria International Airport (FALA), Gauteng Province										
GPS Co-ordinates	Latitude	25° 56' 15" S		Longitude	27° 55' 45" E		Elevation	4500 ft			
Aircraft Information											
Registration	ZS-SVR										
Make; Model; S/N	Piper Cherokee; PA28-140 (Serial Number: 28-20118)										
Damage to Aircraft	Minor			Total Aircraft Hours	5501.06						
Pilot-in-command											
Licence Type	Student Pilot Licence (SPL)		Gender	Male		Age	23				
Licence Valid	Yes		Total Hours	32.7		Total Hours on Type	32.7				
Total Hours 30 Days	11.5		Total Flying on Type Past 90 Days	24.6

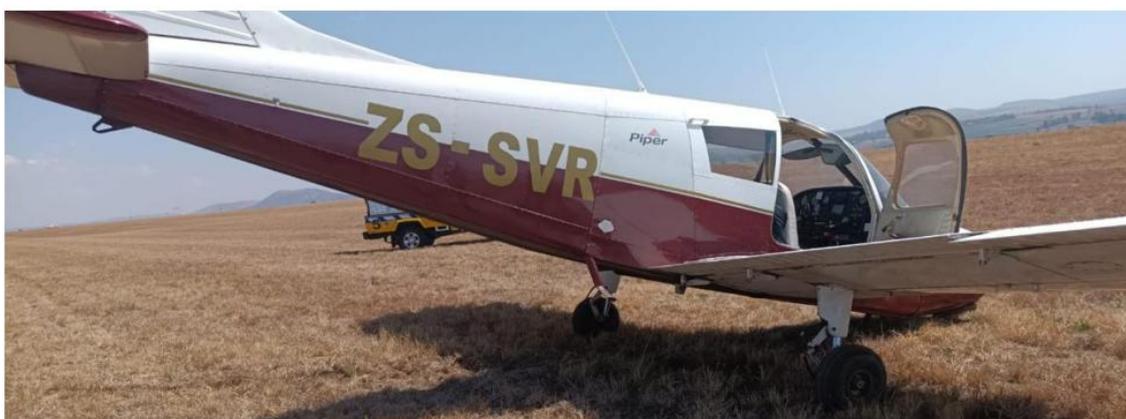
The aircraft came to a full stop a few metres from the left of the runway edge facing 090°. The SP evacuated the aircraft unassisted; he was also uninjured. The aircraft sustained damage to the nose landing gear and the propeller blades which were bent.

Figure 2: The aircraft at the serious incident site. (Source: Pilot)

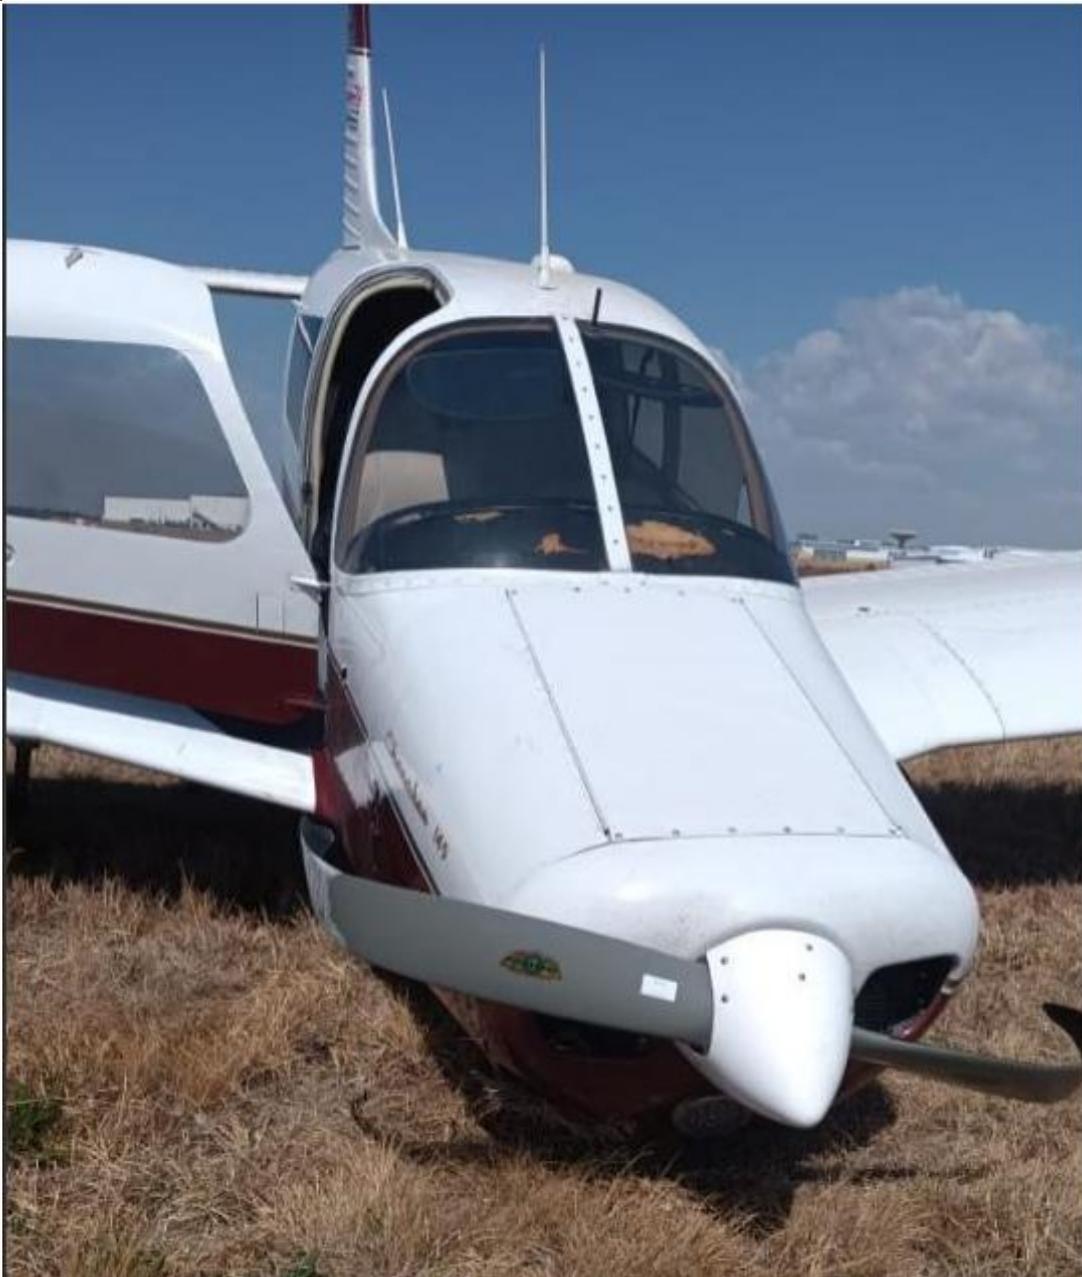
touched down hard again and began drifting to the left of the runway. As a result, he applied right rudder but the aircraft, due to the excessive speed, continued to veer towards the left and the right wing impacted the runway surface; moreover, the nose landing gear broke which caused the nose to drop and the propeller to impact the surface of the runway.

Figure 3: The front view of aircraft after the serious incident. (Source: Pilot)
