LIMITED OCCURRENCE INVESTIGATION REPORT – FINAL

Reference Number	CA18/3/2/1498						
Classification	Serious Incident		Date	19 August 2025		Time	0915Z
Type of Operation	Private (Part 94)						
Location							
Place of Departure	Jansenville Airstrip, Eastern Cape Province		Place of Intended Landing	Jansenville Airstrip, Eastern Cape Province			
Place of Occurrence	Jansenville Airstrip, Eastern Cape Province						
GPS Co-ordinates	Latitude	32° 58' 27" S	Longitude	24° 00' 00" E	Elevation	2 527 ft	
Aircraft Information							
Registration	ZU-FGD						
Make; Model; S/N	Bantam; B22J (Serial Number 09-336)						
Damage to Aircraft	Minor			Total Aircraft Hours	489.5		
Pilot-in-command							
Licence Type	National Pilot Licence (NPL)		Gender	Male		Age	50
Licence Valid	Yes	Total Hours	67.5		Total Hours on Type	15.6	
Total Hours 30 Days	0.8		Total Flying on Type Past 90 Days	0.8			
People On-board	1 + 1	Injuries	0	Fatalities	0	Other (on ground)	0
What Happened

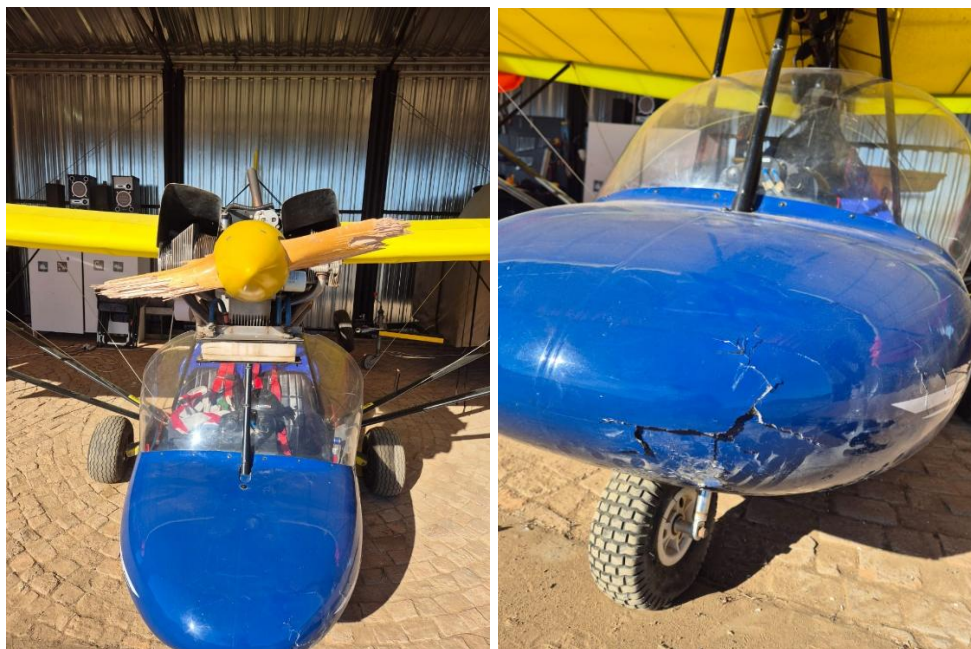
<p>On Tuesday, 19 August 2025, a pilot and a passenger on-board a Bantam B22J aircraft with registration ZU-FGD had planned to take-off on a private flight from Jansenville Airstrip, Eastern Cape province, with the intention to land at the same airstrip when the serious incident occurred. The flight was to be conducted under visual meteorological conditions (VMC) by day and under the provisions of Part 94 of the Civil Aviation Regulations (CAR) 2011, as amended.</p> <p>The pilot stated that he conducted a pre-flight inspection of the aircraft and no anomalies were noted. <i>The aircraft's technical documentation had no outstanding defects or deferred items.</i> The pilot started the engine and taxied the aircraft to Runway 11. During taxi, the pilot felt an anomaly in throttle authority (movement) and elected to return to his aircraft's hangar. To his surprise, the throttle opened to maximum power/high revolutions per minute (RPM) whilst he was taxiing back to the hangar. He reported that the throttle was stuck at maximum RPM; as a result, the aircraft accelerated after which he lost directional control. Consequently, the aircraft impacted the pilot's vehicle that was parked outside his hangar. The pilot switched off the master switch and fuel selector, and the engine stopped. The aircraft sustained minor damage to the composite nose cone, propeller and windshield. No person was injured.</p>

Figures 1 and 2: The damaged propeller (left) and the nose section's left lower composite structure (right).
(Source: Pilot)

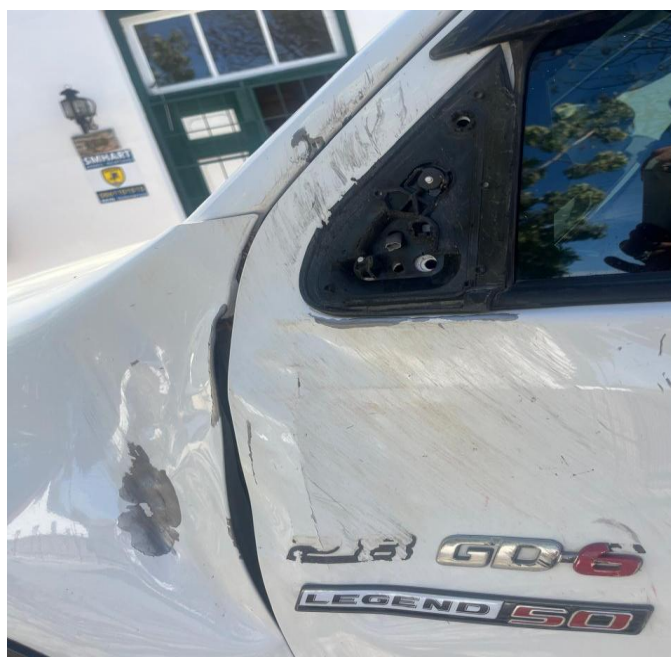
Figure 3: Third party damage caused to the motor vehicle. (Source: Pilot)

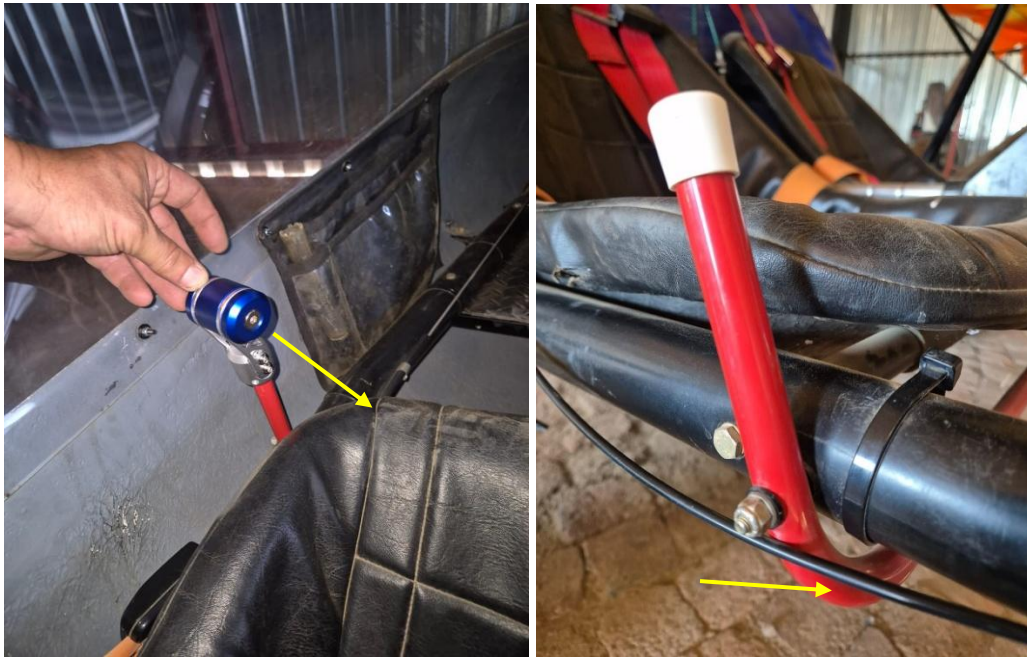
The approved person (AP) who inspected the aircraft found nothing abnormal. The general condition of the engine was also normal. The throttle cables that run inside the plastic sheath and associated linkages to the carburettors (dual) were tested, and they moved freely.

Figures 4 and 5: The throttle (left picture) on the left side of the pilot's seat. The throttle cables in the plastic sheath run from the left side of the pilot's seat to the engine (right picture). (Source: Pilot)
