**LIMITED OCCURRENCE INVESTIGATION REPORT – FINAL**

<b>Reference Number</b>	CA18/3/2/1499						
<b>Classification</b>	Serious Incident		<b>Date</b>	21 August 2025		<b>Time</b>	0824Z
<b>Type of Operation</b>	Training (Part 141)						
<b>Location</b>							
Place of Departure	Grand Central Airport (FAGC), Gauteng Province		Place of Intended Landing	Grand Central Airport (FAGC), Gauteng Province			
Place of Occurrence	Runway 17 at Grand Central Airport (FAGC)						
GPS Co-ordinates	Latitude	25° 58' 57.28" S	Longitude	028° 8' 16.86" E	Elevation	5 325 ft	
<b>Aircraft Information</b>							
Registration	ZS-EFI						
Make; Model; S/N	Piper Cherokee; PA28-140 (Serial Number: 28-20696)						
Damage to Aircraft	Minor			Total Aircraft Hours	5 579.5		
<b>Pilot-in-command</b>							
Licence Type	Student Pilot Licence (SPL)		Gender	Female		Age	25
Licence Valid	Yes	Total Hours	76.5		Total Hours on Type	64.4	
Total Hours 30 Days	14.4		Total Flying on Type Past 90 Days	39.7

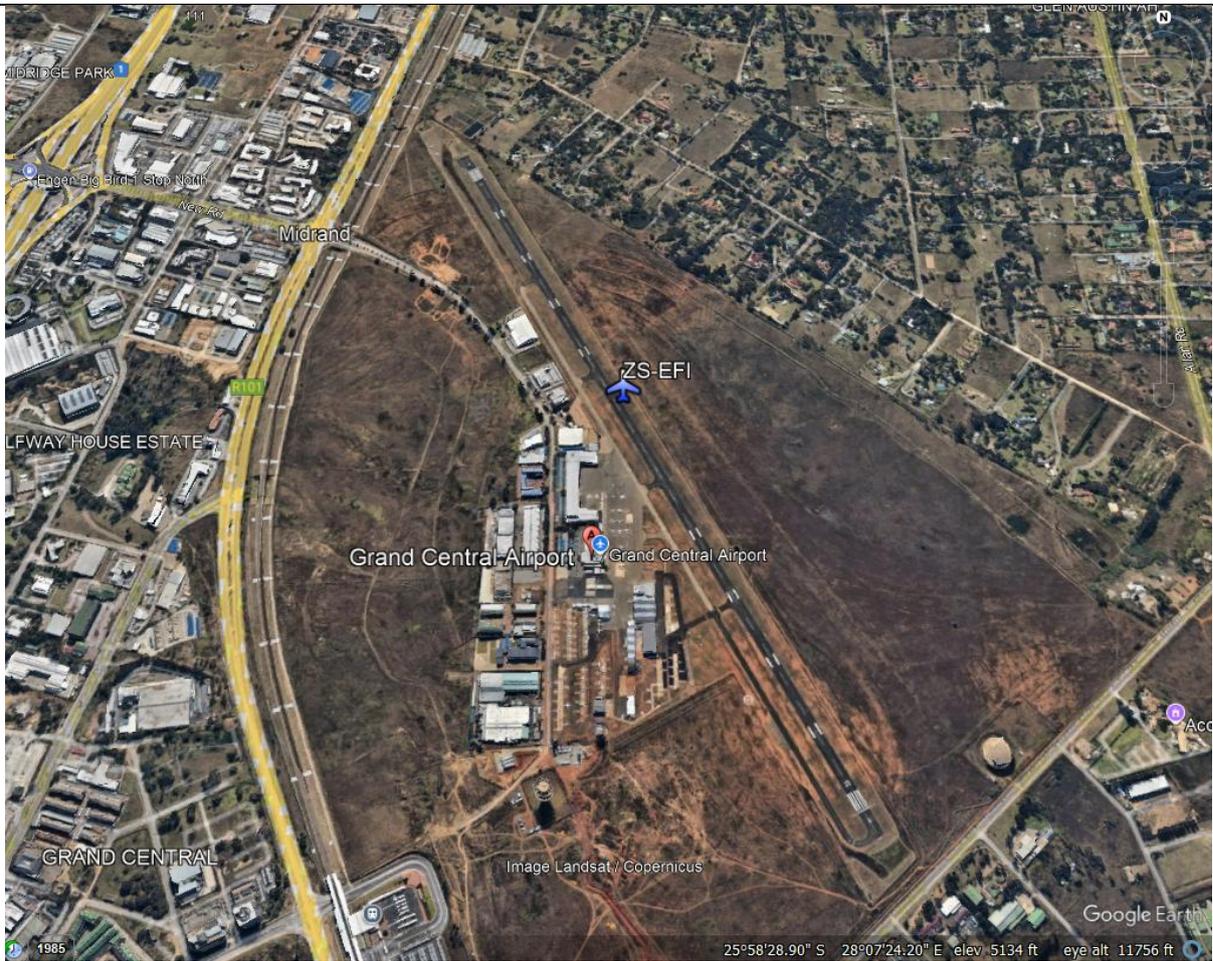
**Figure 1:** An overview of the serious incident site. (Source: Google Earth)

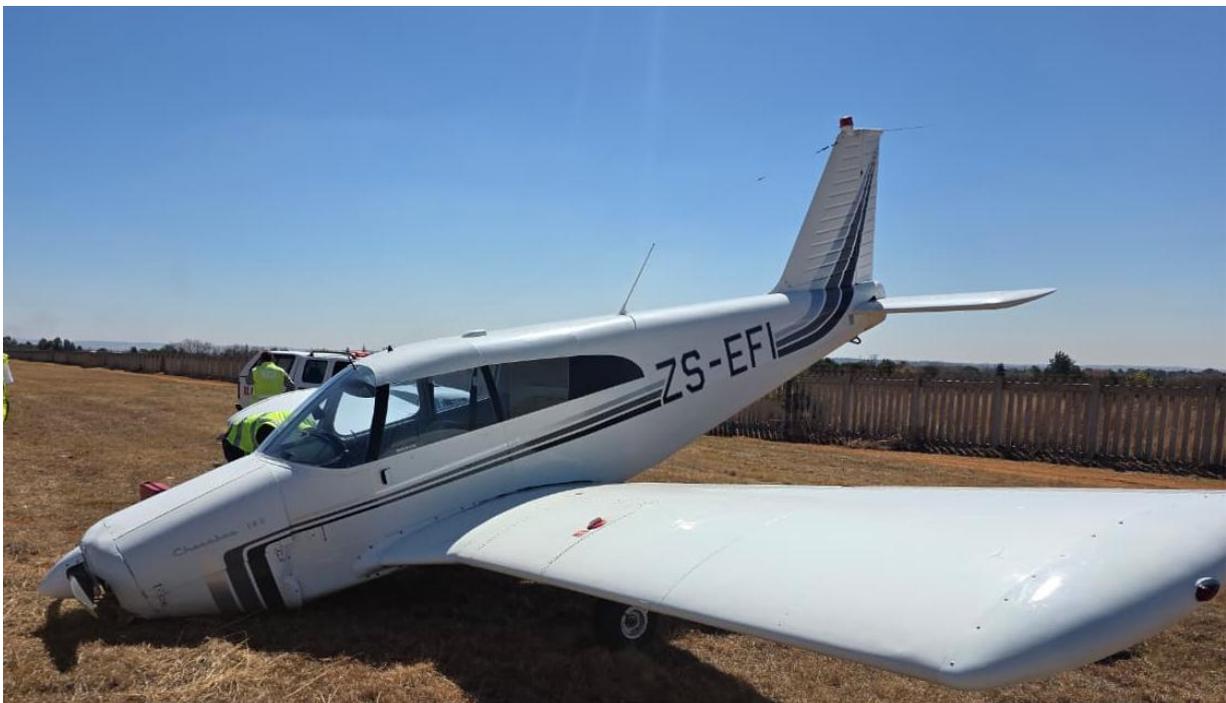
<b>People On-board</b>	1 + 0	<b>Injuries</b>	0	<b>Fatalities</b>	0	<b>Other (on ground)</b>	0
<b>What Happened</b>							
<p>On Thursday, 21 August 2025, a student pilot (SP) on-board a Piper Cherokee PA-28-140 aircraft with registration ZS-EFI departed on a solo navigational training flight from Grand Central Airport (FAGC), Gauteng province, with the intention to land back at the same airport. The flight was conducted under visual meteorological conditions (VMC) by day and under the provisions of Part 141 of the Civil Aviation Regulations (CAR) 2011 as amended.</p> <p>The SP stated that she completed the pre-flight checks with no anomalies noted; this was in preparation for her second solo navigational flight. The SP's route was from FAGC to Potchefstroom Airport (FAPS) via Grasmere (GAV) and to Rustenburg Airport (FARG) before returning to FAGC. The 3.2-hour flight was uneventful; however, the wind speed increased during approach for landing on Runway 17. The SP stated that she was not comfortable to land, which resulted in two go-arounds as the approaches were high and unstable. On the third attempt, the aircraft touched down hard and bounced; as a result, the nose wheel broke, and the propeller impacted the runway surface.</p> <p>The pilot evacuated the aircraft unassisted; she was uninjured. The aircraft sustained damage to the nose wheel and the propeller blades, which were bent.</p>

**Figure 2:** The aircraft near the serious incident site during recovery. (Source: Operator)

- 3.1 The student pilot made two high approaches and go-arounds on Runway 17. During the third attempt, the aircraft landed hard with the nose gear first. The nose wheel broke and the propeller blades impacted the runway surface; the aircraft came to rest on Runway 17.

The aircraft landed hard after the student pilot flared the aircraft too high; as a result, the nose wheel broke and the propeller blades impacted the runway surface.

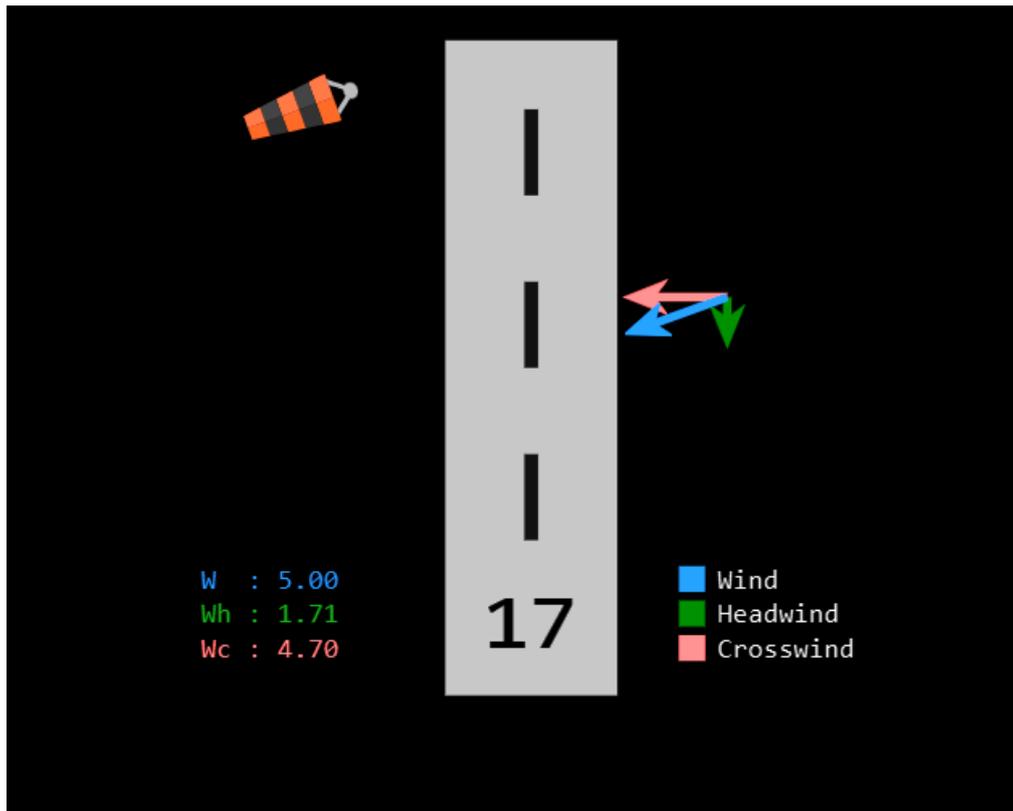
**Figure 3:** The wind component during landing. (Source: <https://e6bx.com/wind-components/>)

- 2.1 The weather conditions were not a contributory factor to this serious incident.
