## LIMITED OCCURRENCE INVESTIGATION REPORT – FINAL

| <b>Reference Number</b> | CA18/3/2/1500 | | | | | | |
| <b>Registration</b> | ZU-WIL | | | | | | |
| <b>Make; Model; S/N</b> | Jabiru J430 (Serial Number: 516) | | | | | | |

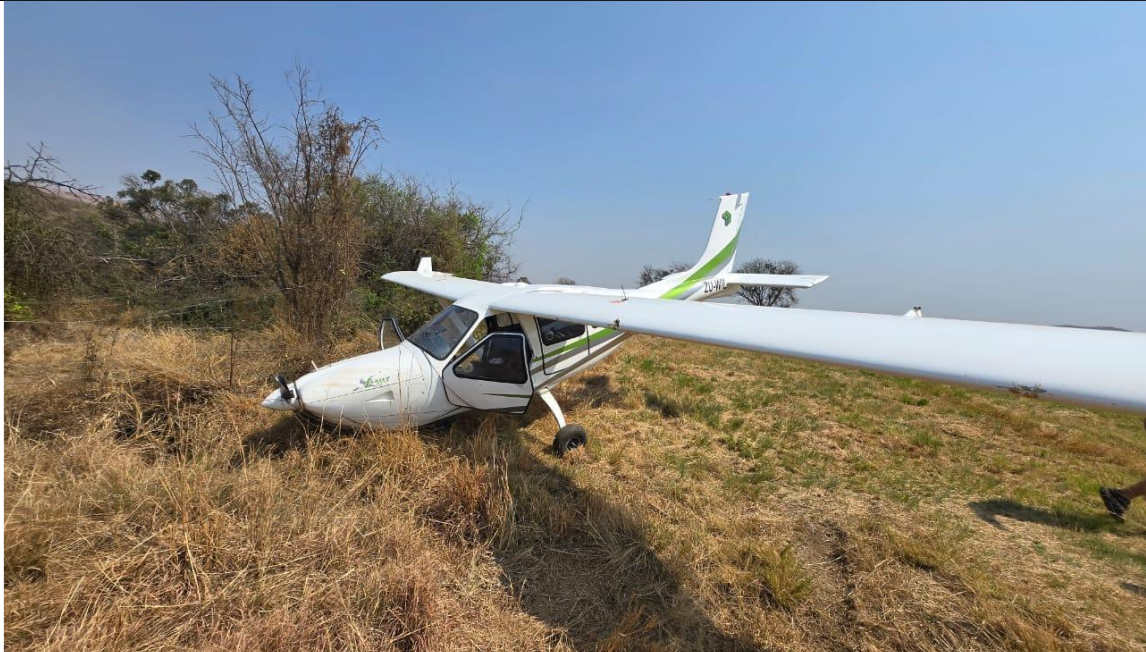
**Figure 2:** The aircraft after it had stopped. (Source: Pilot)

| 4.3 | After landing, the pilot opted to steer the aircraft to the left, through the airfield's perimeter fence due to insufficient runway surface available to bring the aircraft to a safe stop. |

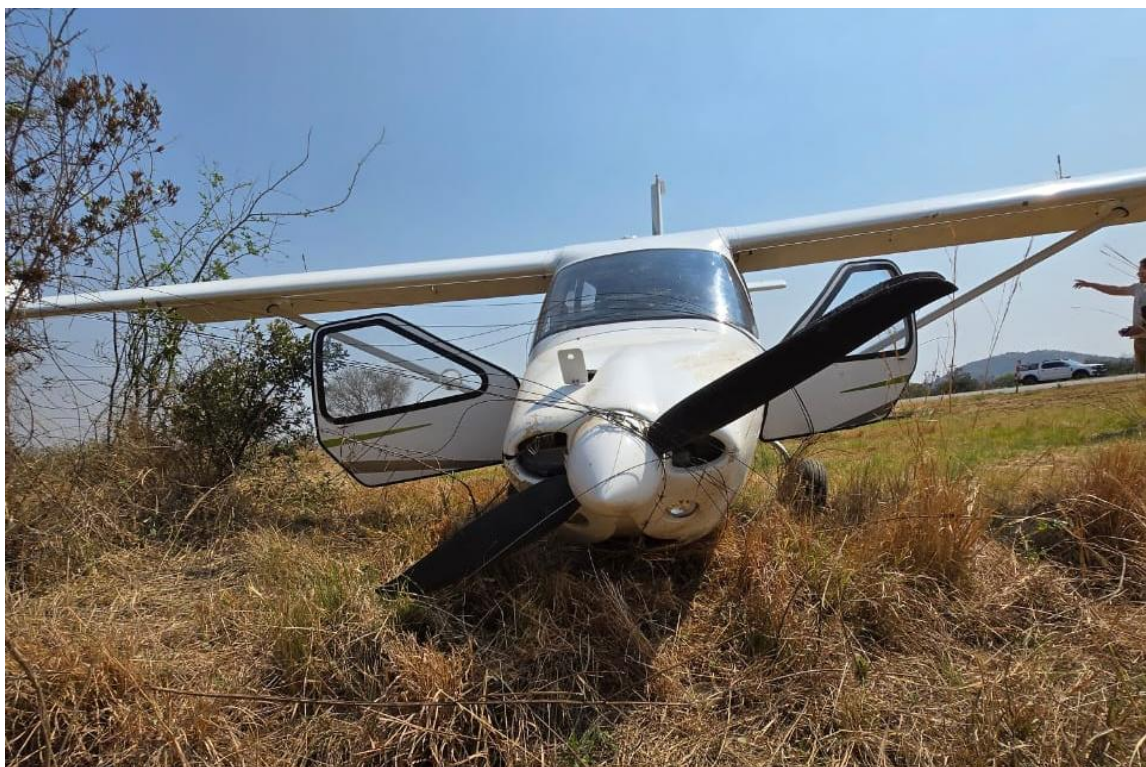
**Figure 3:** The barbed wire entangled around the propeller spinner and windshield. (Source: Pilot)

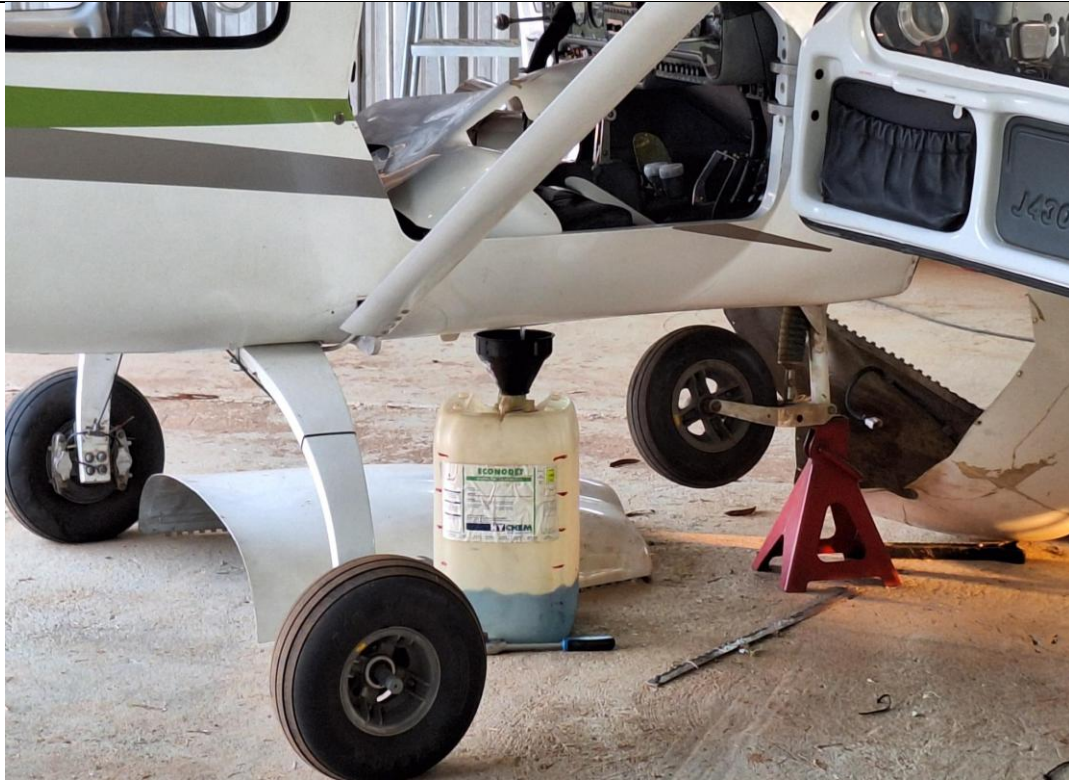
A team from the original equipment manufacturer (OEM) in George was sent to recover the aircraft to the factory for repairs. The team arrived on 8 September 2025, 10 days after the serious incident had occurred. Fifteen (15) litres of fuel was drained from the quick-drain valve at the bottom of the header tank (see Figures 4 and 5).

**Figure 4:** Fuel is drained through the quick-drain valve at the bottom of the header tank.

- 2.10 Fifteen (15) litres of fuel was drained from the aircraft on 8 September 2025 via the header tank drain valve. The header tank contained 6.5 litres of fuel; the fuel that remained in both wing tanks combined was approximately 8.5 litres. Approximately 48.5 litres of fuel from the wing tanks was unaccounted for if the tanks were filled to maximum on 21 August 2025.

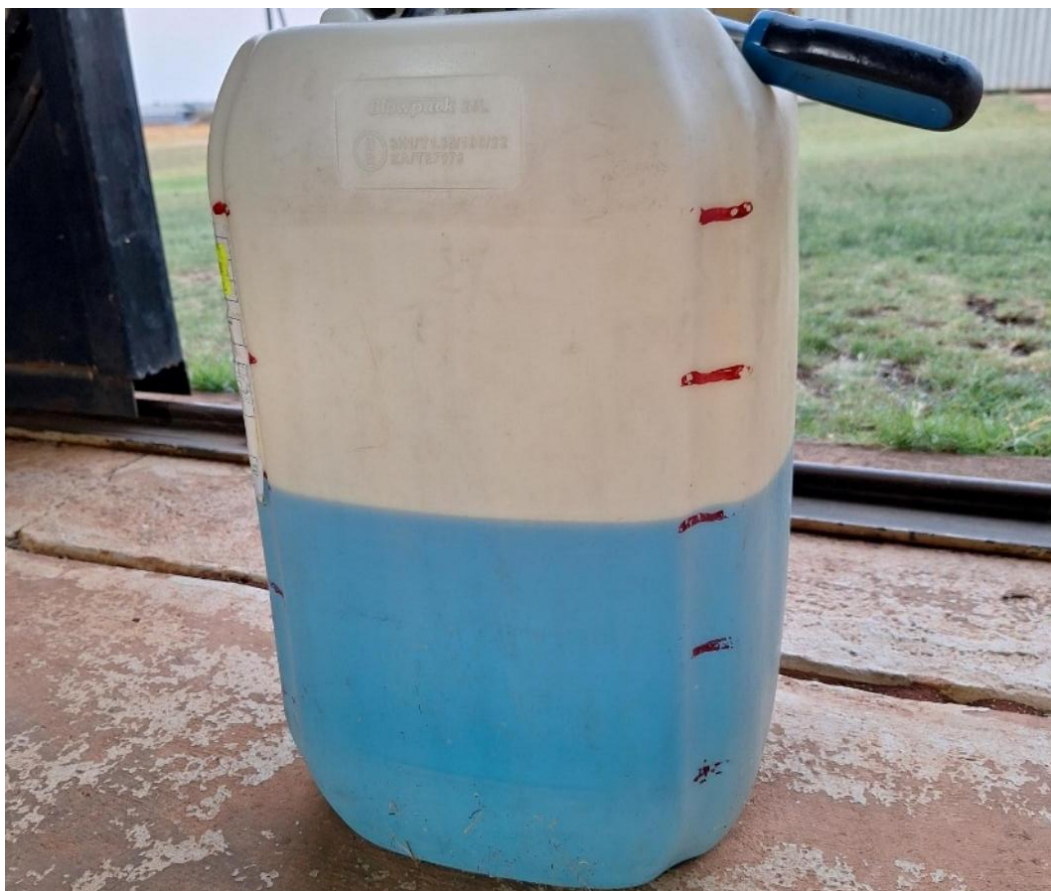
**Figure 5:** The drained 15 litres of fuel.

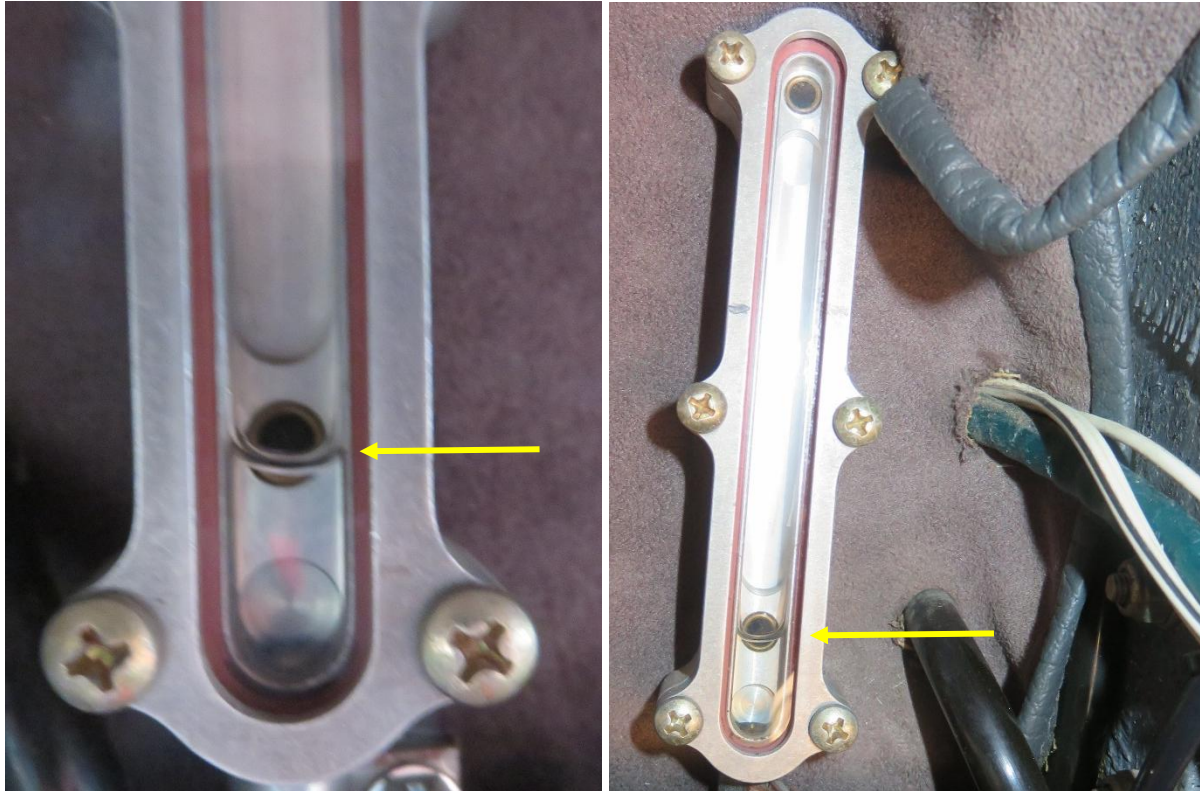
**Figure 6:** The fuel sight gauges on the left- and right-side wing tanks show depleted fuel.

- 2.8 During the inspection of the aircraft on 2 September 2025 at Kroon Airfield, both fuel sight gauges indicated empty wing tanks (see Figure 6). Fuel was drained from the purge valves of both wing tanks using a fuel tester; a small amount of fuel was drained from each wing tank (see Figure 14). No fuel was visible in either of the wing tanks when the fuel caps were removed (see Figures 14 and 15).

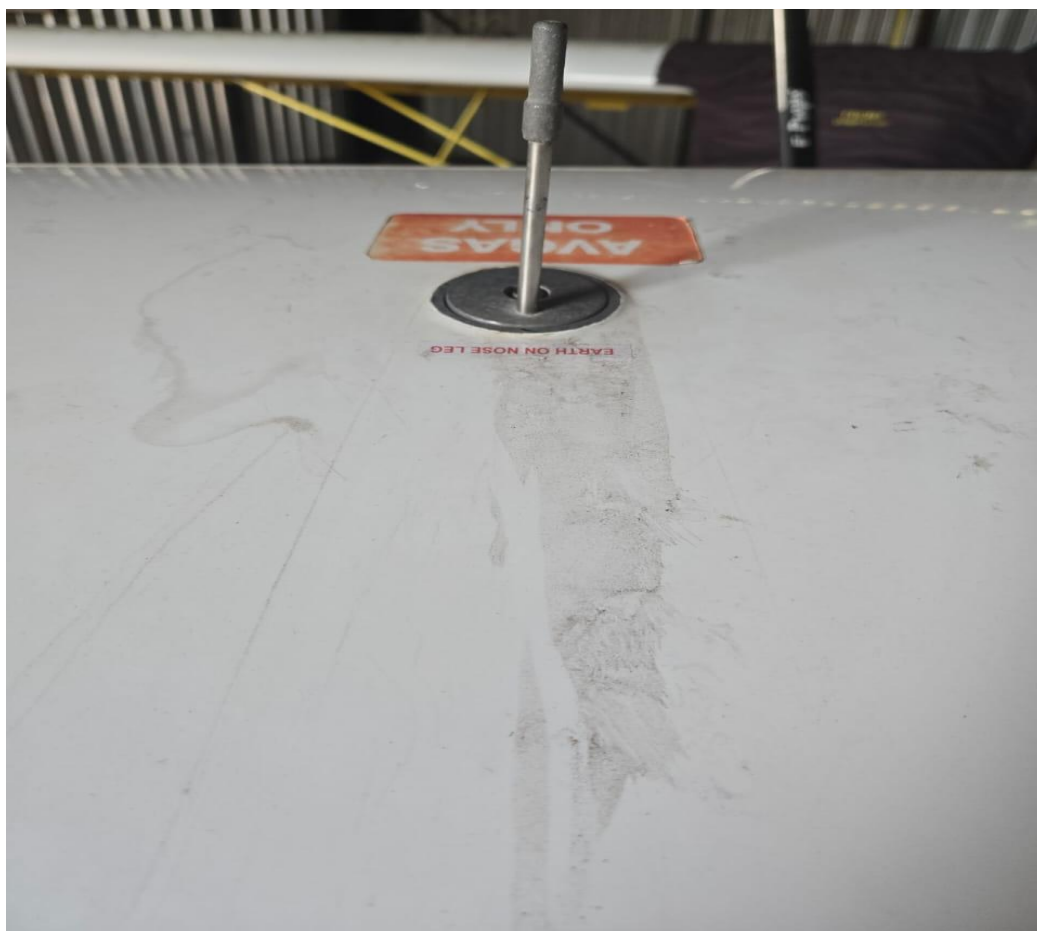
After the serious incident, the pilot stated that the turbulence they experienced might have contributed to fuel leaking from the filler caps of both wing tanks as the aircraft rolled along the longitudinal axis, but this could not be confirmed as they did not observe any fuel leaks during the flight.

**Figure 9:** Fuel streak on top of the right wing indicates fuel leak from the wing tank.  
(This photo was taken on 2 September 2025, four days after the serious incident flight).

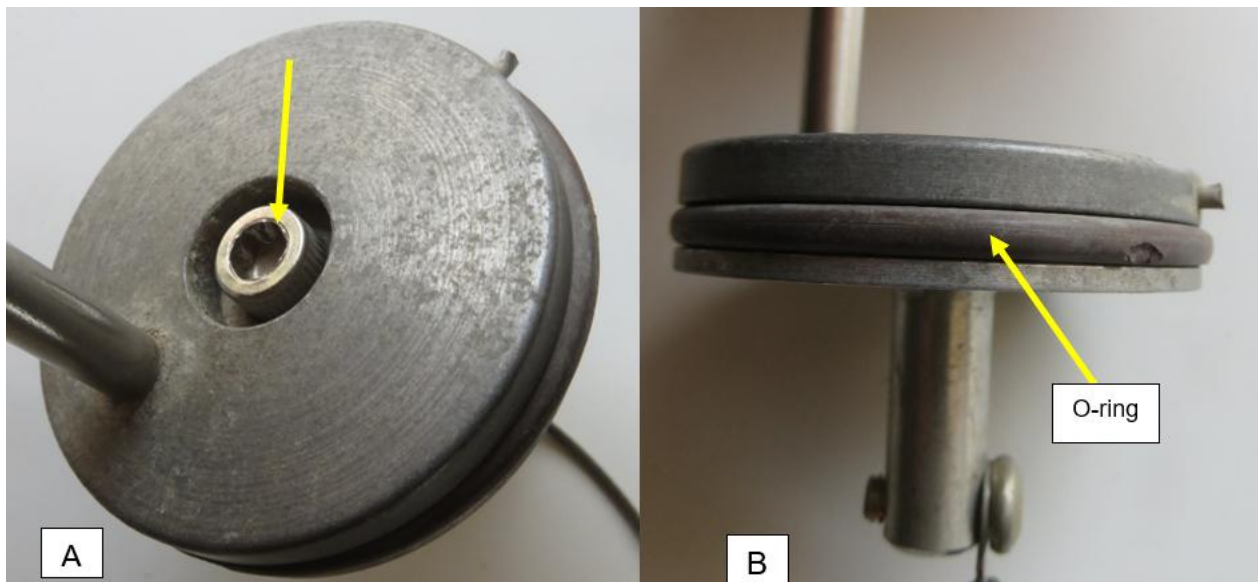
**Figure 10:** (a) The cap screw, which is used to tighten the fuel cap, was found to be elongated.  
(b) A side view of the fuel cap with the O-ring visible. The O-ring expands when the cap screw is tightened, securing the fuel cap to the fuel tank filler body.

Figure 10 displays the right-wing tank fuel cap. The cap screw on the left side also displays the same type of wear and tear.

- 2.9 Neither of the fuel tank cap screws could be loosened or tightened with a Hex T bar or an Allen key as required before and after refuelling because the cap screw sockets were widened. The fuel caps were, therefore, pressed into position but were not secured as required.

| The engine was likely starved of fuel after interruption of fuel supply due to an unknown amount of fuel being siphoned from the fuel tanks in-flight as the fuel caps were not properly secured. The pilot executed a forced landing at Kroon Airfield Runway 11 and touched down deep (more than halfway down the runway) due to the prevailing tailwind which led to a runway excursion. | |

| 1. | <p>It is recommended that all aircraft owners and pilots flying the Jabiru series fitted with wing tanks consider the necessary safety precautions with special emphasis on the correct opening and closing of the fuel caps, as well as ensuring that the vent holes are not blocked by fitting vent covers. Large O-rings are fitted to the fuel cap; these fuel caps are exposed to constant environmental conditions which could deteriorate the condition of the O-rings in a short period. These are on-condition items and need to be replaced as soon as they display evidence of wear and tear. The neglect of these units could also cause water to enter the fuel tanks.</p> <p>It is important to ensure that the fuel tanks are correctly closed with the use of a Hex T bar or an Allen key to tighten the cap screw. In this serious incident, this was not possible due to the widened cap screw sockets. The fuel caps, therefore, did not close as required, and fuel siphoned from the tanks in-flight. In high-wing aircraft, the pilot is not likely to see fuel leaking from the tanks. As the tanks empty, a vacuum or partial vacuum could form in the tanks, restricting fuel flow to the engine via the header tank.</p> |

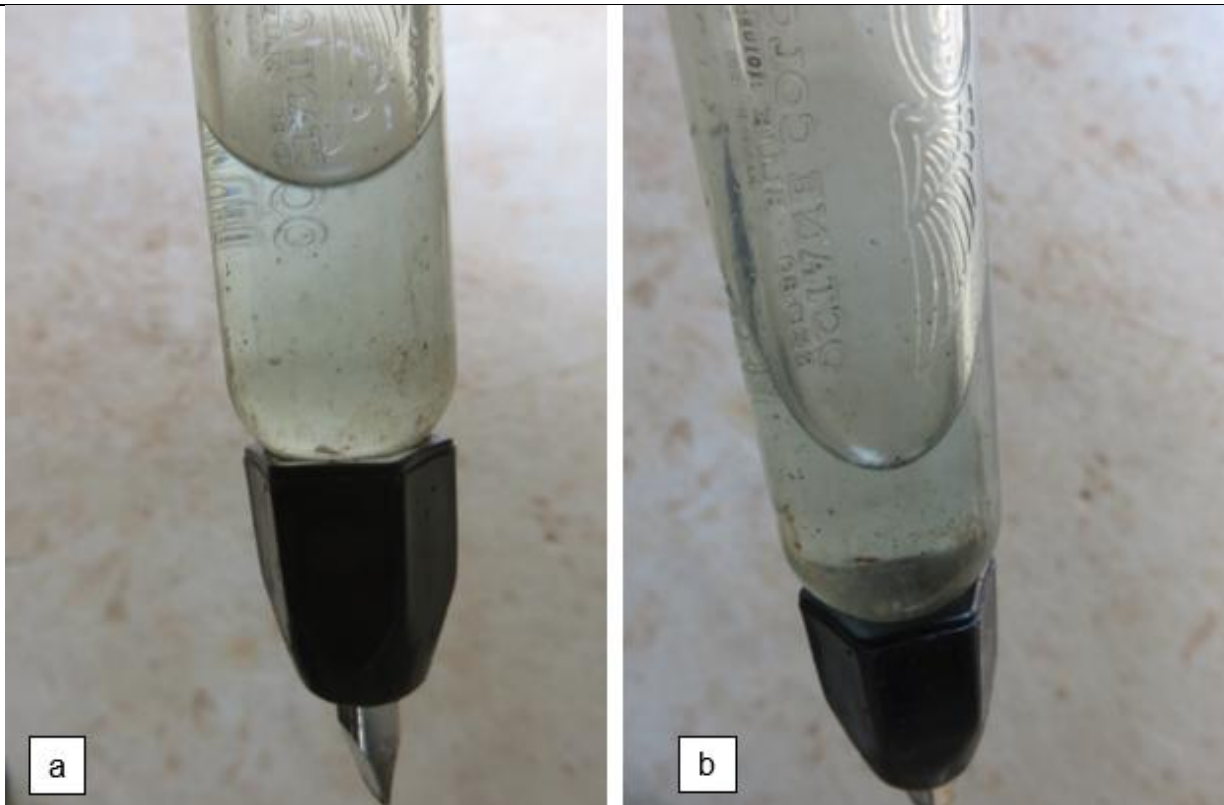
Figure 13a and b display the total amount of fuel that was drained from the left- and right-wing tanks purge valves on 2 September 2025.

**Figure 13:** The fuel drained from the left-wing (a) and right-wing (b) tanks.

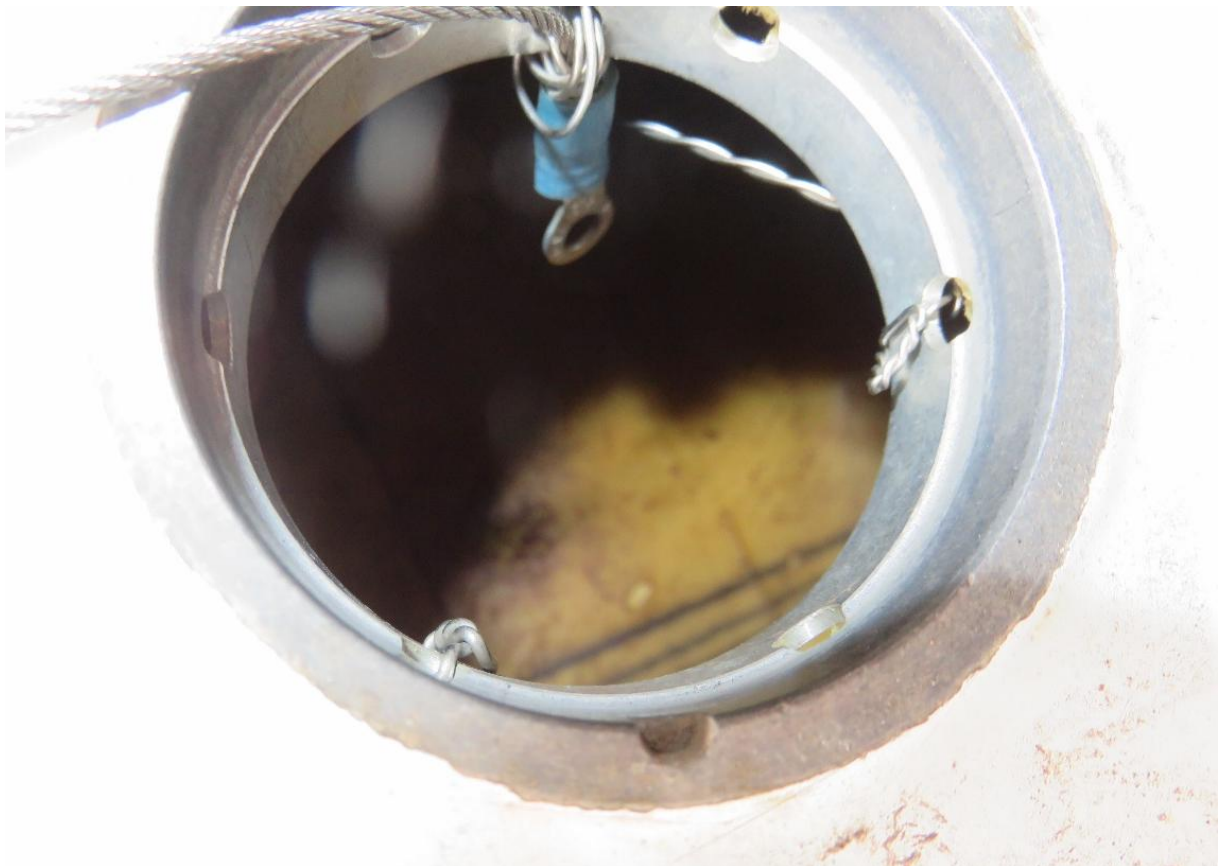
**Figure 14:** A photograph of the right-wing tank taken on 2 September 2025.  
The tank was empty after the fuel tank cap was removed.

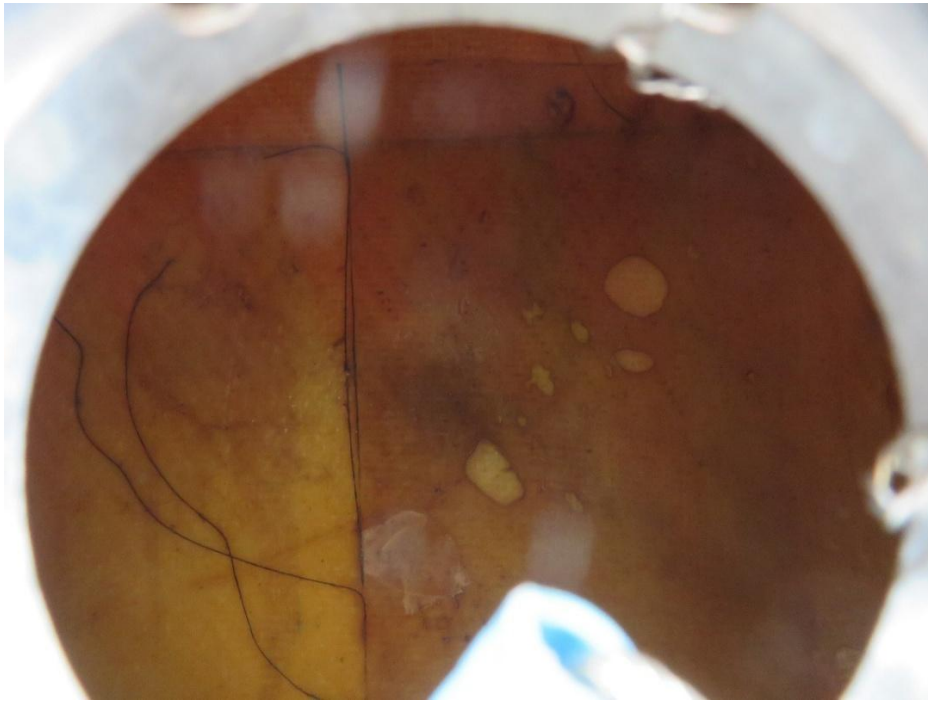
**Figure 15:** A photograph of the left-wing tank taken on 2 September 2025.  
The tank was empty after the fuel cap was removed.

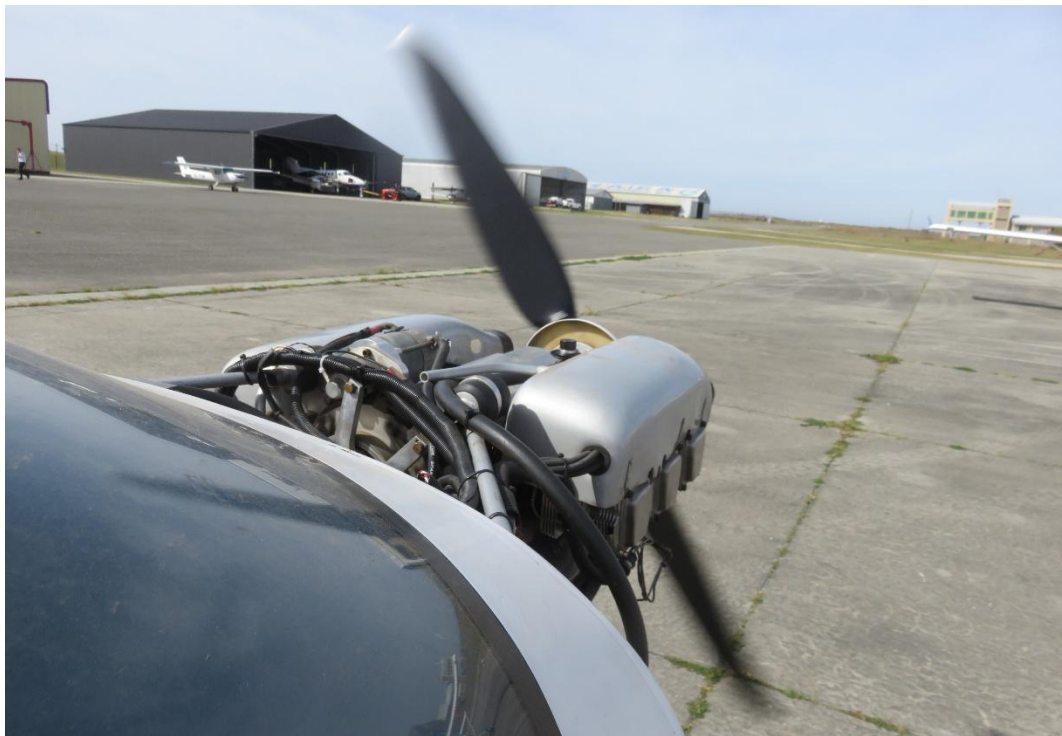
**Figure 16:** Image taken during the engine ground run test.

cowlings and wings were removed. The engine started without difficulty, and normal engine operating parameters were met during the ground run. The engine was switched off, and a restart was conducted without difficulty. The electrical fuel pump was tested and found to be functional. The electrical fuel pump was also switched on and off during the engine ground run with no indication of variation in engine revolutions per minute (RPM) which indicated that the mechanical fuel pump was also serviceable. No fuel leaks were identified during the ground run test.

- 2.11 The engine was not damaged during the serious incident. The engine test run (with the engine in the airframe) was conducted after the aircraft was returned to the OEM in George. The engine started without difficulty, and normal engine operating parameters were met during ground runs.
