LIMITED OCCURRENCE INVESTIGATION REPORT – FINAL

Reference Number	CA18/3/2/1501						
Classification	Serious Incident	Date	29 August 2025		Time	1520Z	
Type of Operation	Training (Part 141)						
Location							
Place of Departure	Springs Aerodrome (FASI), Gauteng Province		Place of Intended Landing	Springs Aerodrome (FASI), Gauteng Province			
Place of Occurrence	Springs Aerodrome (FASI)						
GPS Co-ordinates	Latitude	26°14'52.97" S	Longitude	028°23'57.32" E	Elevation	5 336 feet	
Aircraft Information							
Registration	ZS-MLD						
Make; Model; S/N	Piper; PA-34-200T (Serial Number 34-7670210)						
Damage to Aircraft	Substantial		Total Aircraft Hours	5 635.6			
Pilot-in-command							
Licence Type	Airline Transport Pilot Licence		Gender	Male		Age	43
Licence Valid	Yes	Total Hours	9 000.0		Total Hours on Type	1 000.0	
Total Hours 30 Days	30.0		Total Flying on Type Past 90 Days	100.0			
People On-board	2 + 0	Injuries	0	Fatalities	0	Other (on ground)	0
What Happened

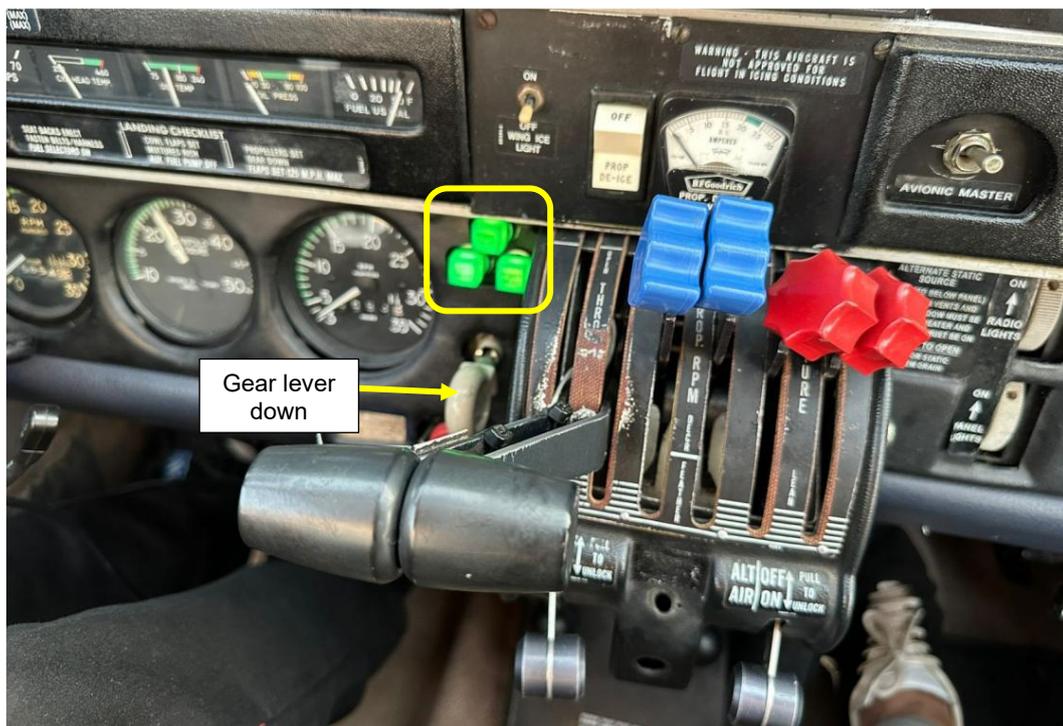
Figure 2: The cockpit instrument panel showing the gear lever down with three green indicators.
(Source: Pilot)

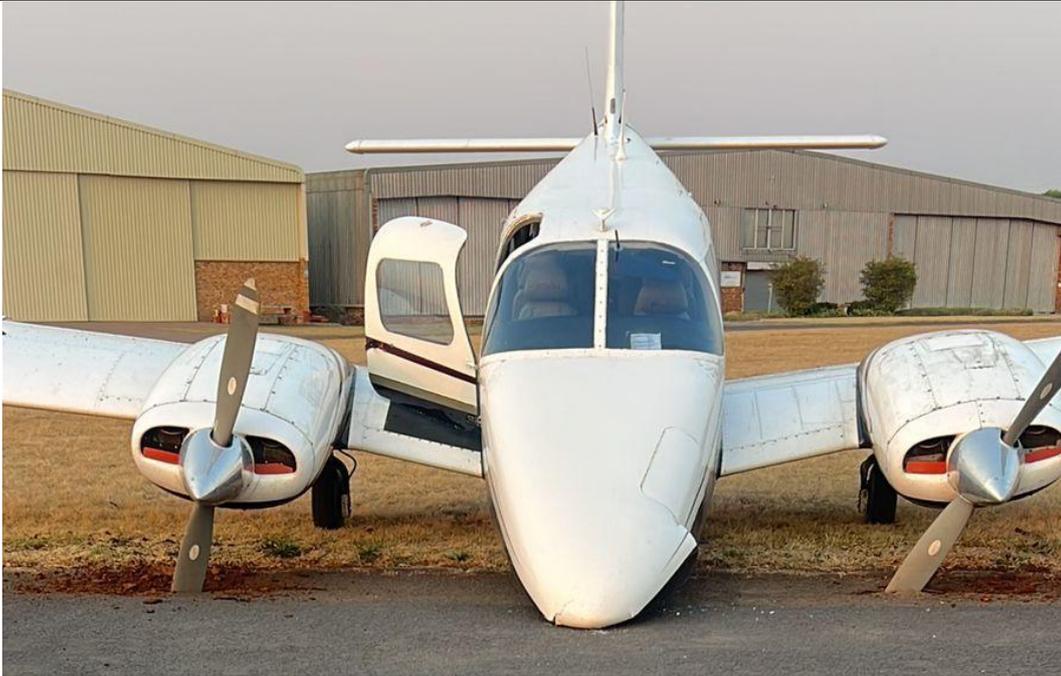
Figure 3: The aircraft as it came to rest after the nose gear had collapsed. (Source: Pilot)

The nose gear down lock spring link failed whilst the crew was taxiing the aircraft to the taxiway; subsequently, the nose gear collapsed and both propellers struck the asphalt surface.

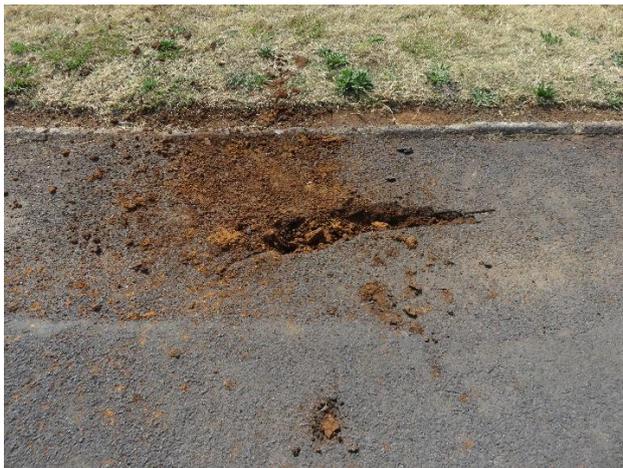
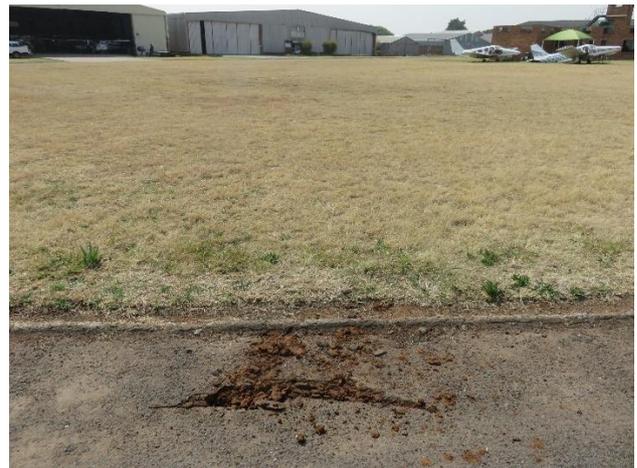
Figure 4: The damage caused by the propeller blades on the (a) right side and (b) left side of the asphalt-covered runway.

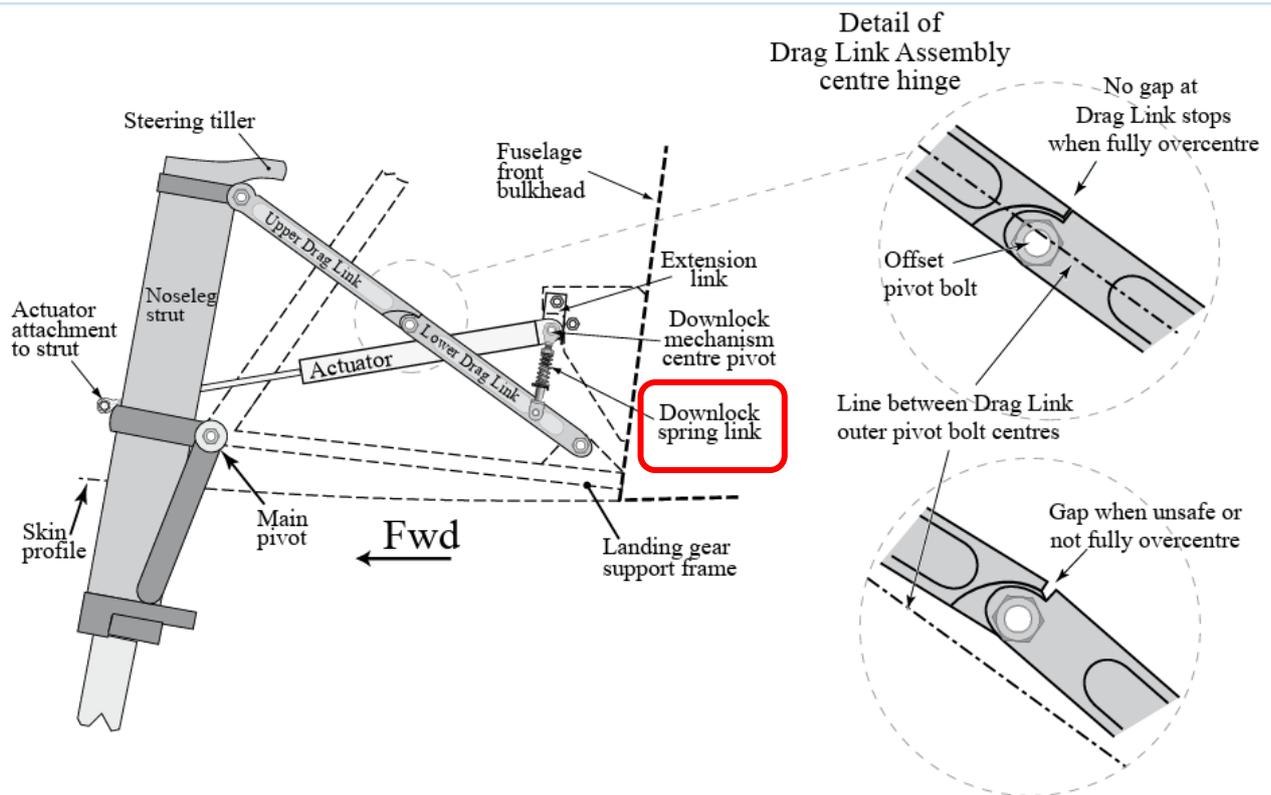
The nose landing gear of the Piper PA-34-200 series is of the forward retracting type, which, when extended, has the wheel axle forward of the oleo pivot. When the gear is retracted, it is held up by hydraulic pressure in the actuator, and when extended, it is held in the down position by a geometric down lock mechanism. There are no locking hooks for either position. When the nose landing gear is extended and under load, the primary brace against collapse is the drag link assembly. When the landing gear is fully extended, the drag link centre pivot should be offset below the line between its

two end pivots. In this position, the fixed stops of the drag link centre joint, which limit the over-centre travel of these links, should be in abutment (see Figure 5).

Diagram 1: A Piper PA-34 drawing showing a side view of the nose landing gear main components in extended position.

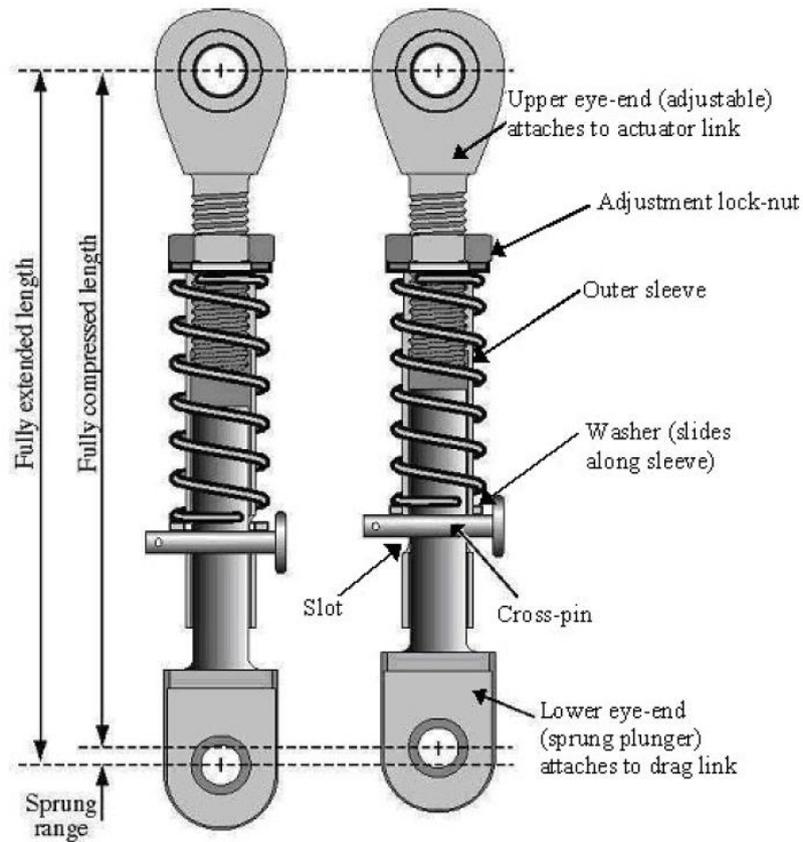
The overall geometry of the landing gear is such that aircraft weight on the nose wheel applies a compressive load to the drag link assembly, which tends to drive it more firmly into the safe over-centre condition when the gear is properly extended. Conversely, it will tend to cause the drag link to fold, and the gear to retract, if the load is applied when the drag link assembly is in an under-centre condition. The down lock spring link helps to maintain the over-centre down lock position by applying a force on the lower drag link. It has a spring and a plunger to permit a small change in its length as it is moved in and out of lock (see Diagram 2).

Diagram 2: Down lock spring link in compressed and extended position.

The difference between the compressed and uncompressed length should be approximately 0.08 inches. The travel of the plunger is limited by a cross-pin, which abuts against a washer that presses against the spring when the link is compressed. The length of the down lock spring link is adjustable and should be rigged such that it is fully compressed when the drag link assembly is driven to the fully over-centre position. If the down lock link is adjusted too short, the drag link will not be driven to the over-centre position, which could result in the nose gear collapsing.

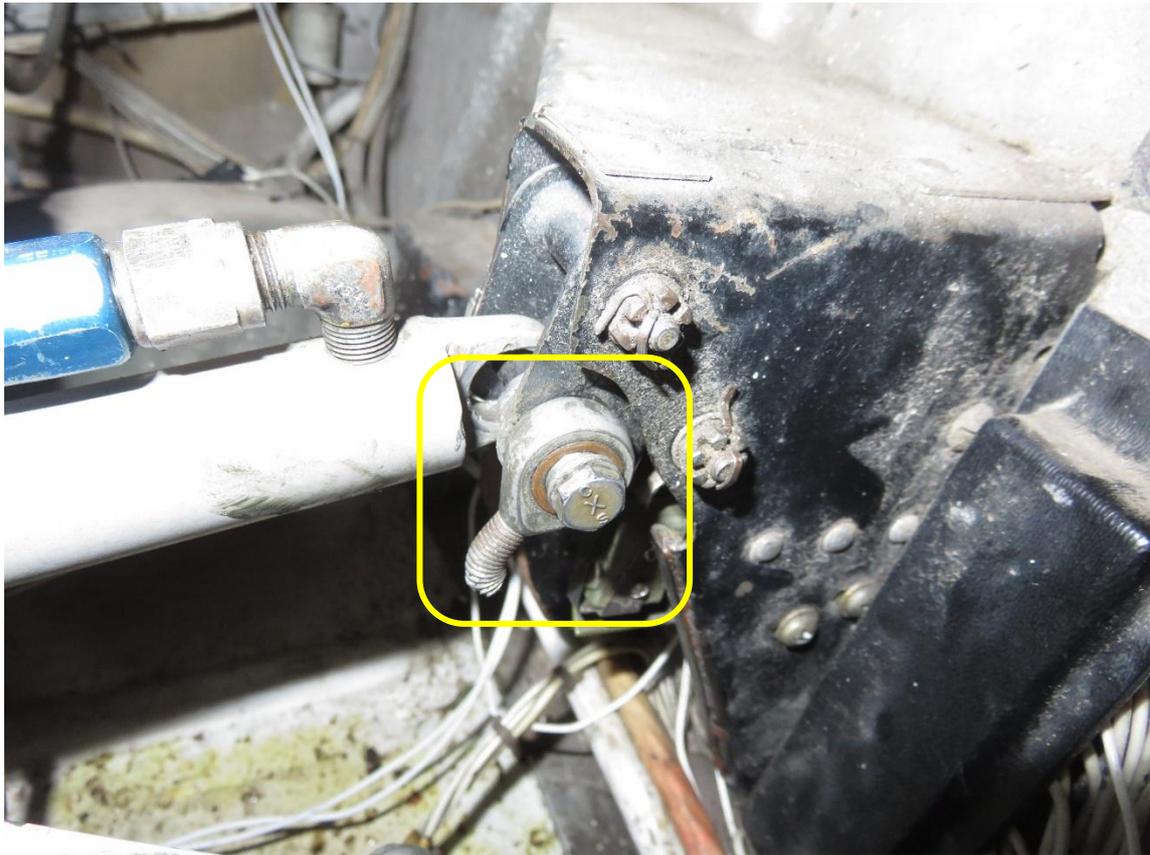
Figure 5: View of the upper end of the actuator attachment to the structure, showing the bent down lock spring link eye end.

The possibility of damage arising from an earlier heavy landing could not be discounted.

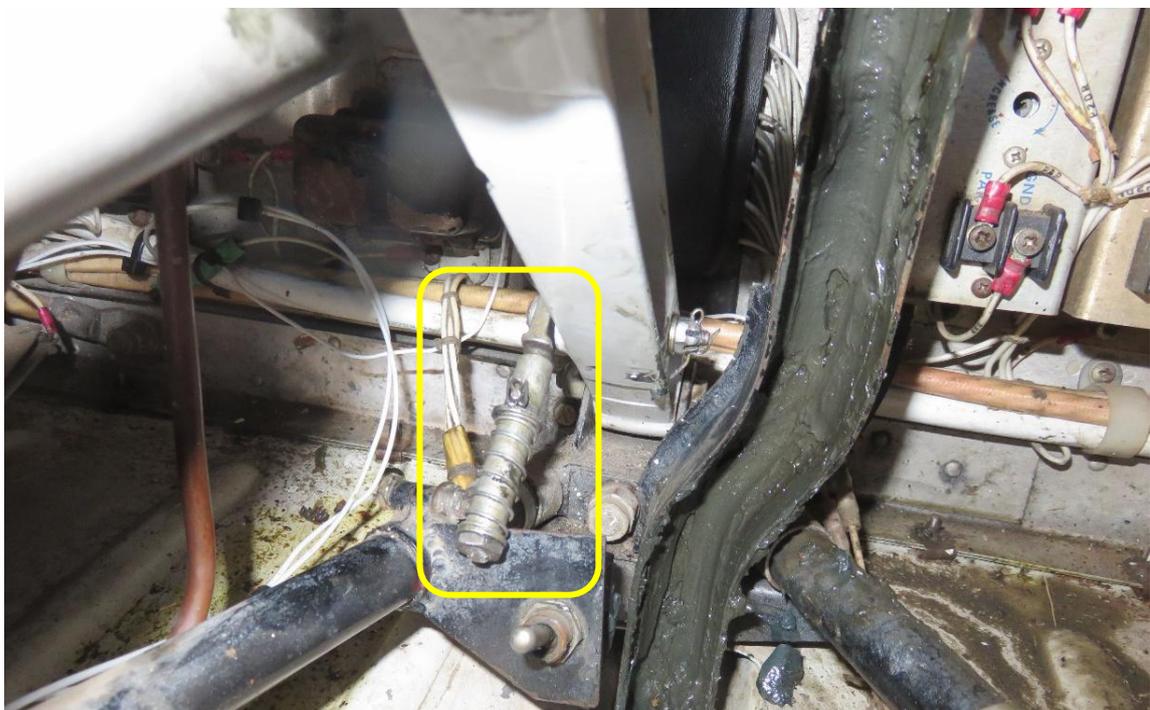
Figure 6: The lower part of the down lock spring link that failed.
