LIMITED OCCURRENCE INVESTIGATION REPORT – FINAL

Reference Number	CA18/3/2/1502						
Classification	Serious Incident	Date	1 September 2025		Time	1505Z	
Type of Operation	Private (Part 94)						
Location							
Place of Departure	Leppan Farm Airstrip, Western Cape province		Place of Intended Landing	Leppan Farm Airstrip, Western Cape province			
Place of Occurrence	Leppan Farm Airstrip Runway 05						
GPS Co-ordinates	Latitude	33°56'27.00" S	Longitude	022°39'55.00" E	Elevation	767 feet	
Aircraft Information							
Registration	ZU-DZH						
Make; Model; S/N	Skystar; Kitfox 7 (Serial Number: 70403055)						
Damage to Aircraft	Minor		Total Aircraft Hours	1 784.9			
Pilot-in-command							
Licence Type	Private Pilot Licence (PPL)		Gender	Male		Age	52
Licence Valid	Yes	Total Hours	1 272.6		Total Hours on Type	101.7	
Total Hours 30 Days	4.8		Total Flying on Type Past 90 Days	14.8			
People On-board	1+0	Injuries	0	Fatalities	0	Other (on ground)	0
What Happened

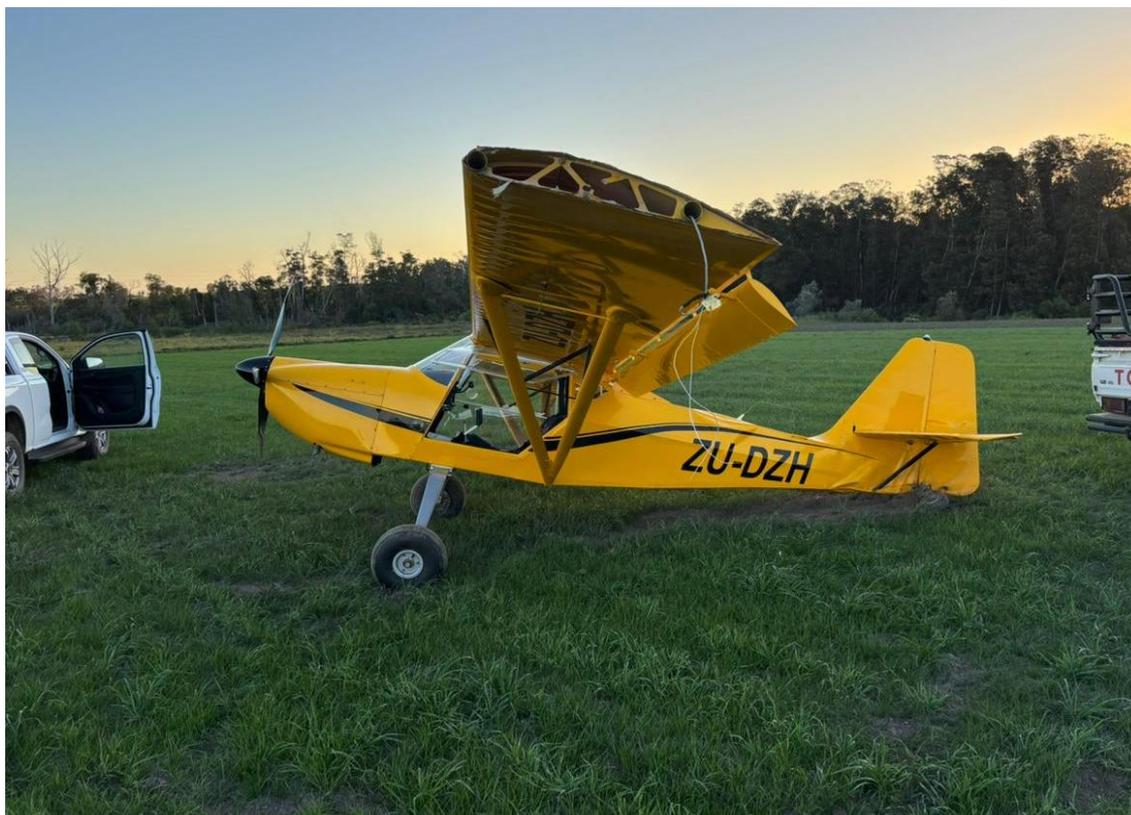
<p>On Monday afternoon, 1 September 2025, a pilot on-board a Skystar Kitfox 7 aircraft with registration ZU-DZH took off on a private scenic flight from Leppan Farm Airstrip, Western Cape province, with the intention to land at the same airstrip. The flight was conducted under visual meteorological conditions (VMC) by day and under the provisions of Part 94 of the Civil Aviation Regulations (CAR) 2011, as amended.</p> <p>The pilot stated that the local scenic flight was uneventful; he returned to Leppan Farm Airstrip to land on Runway 05. Upon touchdown, the aircraft bounced and a sudden gust of wind from the right caused the right wing to lift; as a result, the left-wing tip struck the ground. The pilot stated that the aircraft was too close to the ground, therefore, it was not possible to recover. The aircraft's left wing struck the ground first, and the aircraft ground-looped anticlockwise and rotated approximately 270°. During the ground loop, the right wing also struck the ground. After the aircraft had come to a stop, the pilot switched off the master switch and disembarked from the aircraft; he was not injured. The aircraft sustained damage to the propeller, fuselage, wings, empennage, main landing gear wheels and tailwheel.</p>

Figure 2: The aircraft after it had come to rest. (Source: Pilot)

9.	The airfield is privately owned with a single grass surface runway orientated 05/23. The runway is 780m long and 15m wide at an elevation of 767 ft above mean sea level.
Probable Cause(s)	
Unstable approach during a crosswind landing. A crosswind from the right caused the right wing to lift and the left-wing tip to strike the ground, initiating a ground loop which rotated the aircraft approximately 270° and both wing tips impacted the ground.	
Contributing Factor(s)

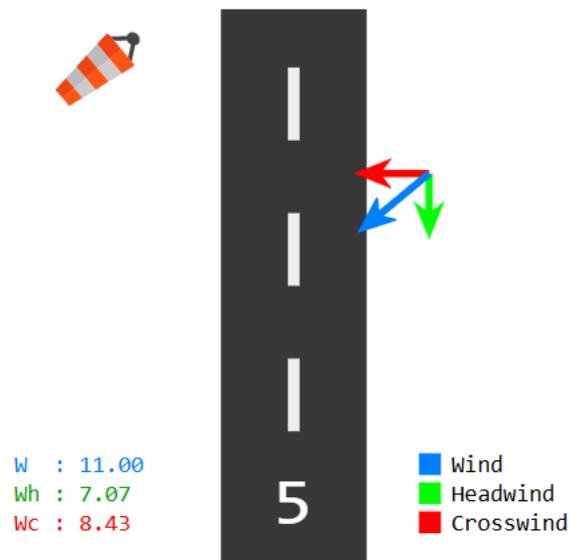
Figure 3: Crosswind component, (Source <https://e6bx.com/wind-components/>)

The the maximum demonstrated crosswind component of the aircraft is 15.6 knots. The pilot encountered a crosswind of 8.43 kts from the right whilst landing on Runway 05. The crosswind component was within the maximum demonstrated crosswind component of the aircraft.
