LIMITED OCCURRENCE INVESTIGATION REPORT – FINAL

Reference Number	CA18/3/2/1503						
Classification	Serious Incident	Date	15 September 2025		Time	0620Z	
Type of Operation	Training (Part 141)						
Location							
Place of Departure	Herminie Farm, near Hartswater, Northern Cape Province		Place of Intended Landing	Herminie Farm, near Hartswater, Northern Cape Province			
Place of Occurrence	On a field in Hermine Farm near Hartswater, Northern Cape Province						
GPS Co-ordinates	Latitude	27°47'48.58" S	Longitude	024°56'49.40" E	Elevation	4 228 feet	
Aircraft Information							
Registration	ZU-FSF						
Make; Model; S/N	Shadow Lite, Jabiru J430 (Serial Number: 825)						
Damage to Aircraft	Minor			Total Aircraft Hours	644.4		
Pilot-in-command							
Licence Type	Student Pilot Licence (SPL)		Gender	Female		Age	42
Licence Valid	Yes	Total Hours	24.5		Total Hours on Type	24.5	
Total Hours 30 Days	14.1		Total Flying on Type Past 90 Days	24.5			
People On-board	1 + 0	Injuries	0	Fatalities	0	Other (on ground)	0

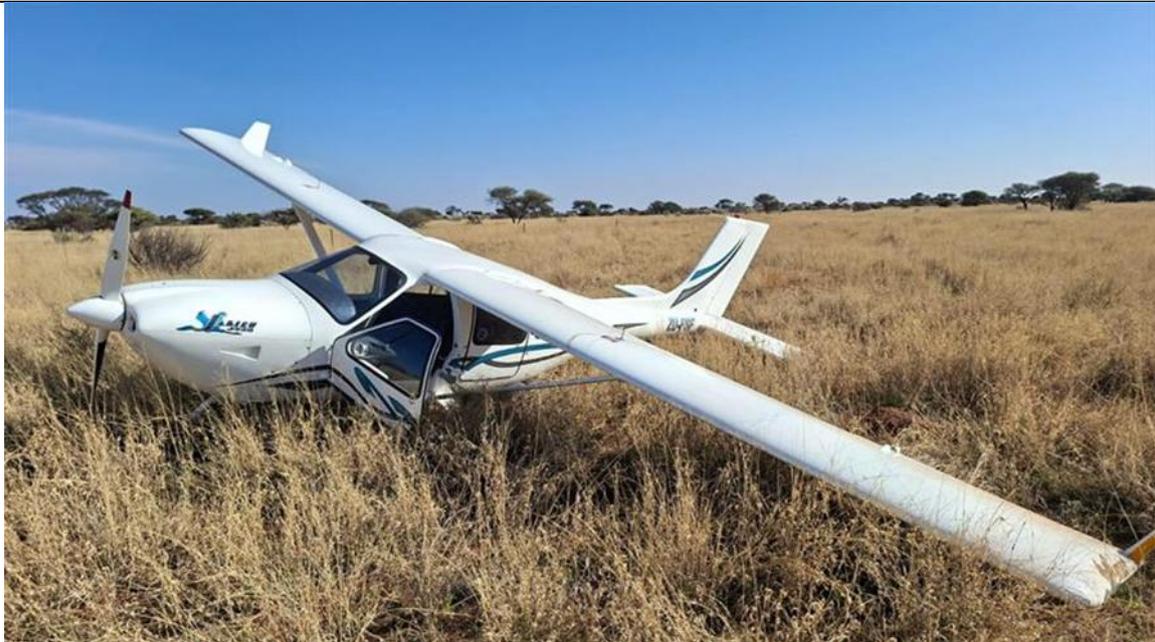
What Happened							
<p>On Monday morning, 15 September 2025, a student pilot (SP) on-board a Jabiru J430 aircraft with registration ZU-FSF took off from Herminie Farm near Hartswater in Northern Cape province with the intention to land back at the same farm. The flight was conducted under visual meteorological conditions (VMC) by day and under the provisions of Part 141 of the Civil Aviation Regulations (CAR) 2011 as amended.</p> <p>Before the SP undertook the solo flight, she flew four circuits with a flight instructor. After landing the aircraft and the flight instructor had disembarked, she continued with her solo circuit training. The first circuit was uneventful. During the second circuit, she decided to conduct a go-around as she was not satisfied with the approach. Whilst at a height of approximately 1 000ft above ground level, she heard an unfamiliar noise emanating from the engine. Shortly thereafter, the engine failed. She tried to restart the engine but was not successful. As a result, she performed a forced landing on a field in a farm.</p> <p>The aircraft sustained damage to the left main gear strut and the left-wing tip which struck the ground. The pilot was not injured.</p>

Figure 2: The aircraft in its final position at the serious incident site. (Source: Pilot)

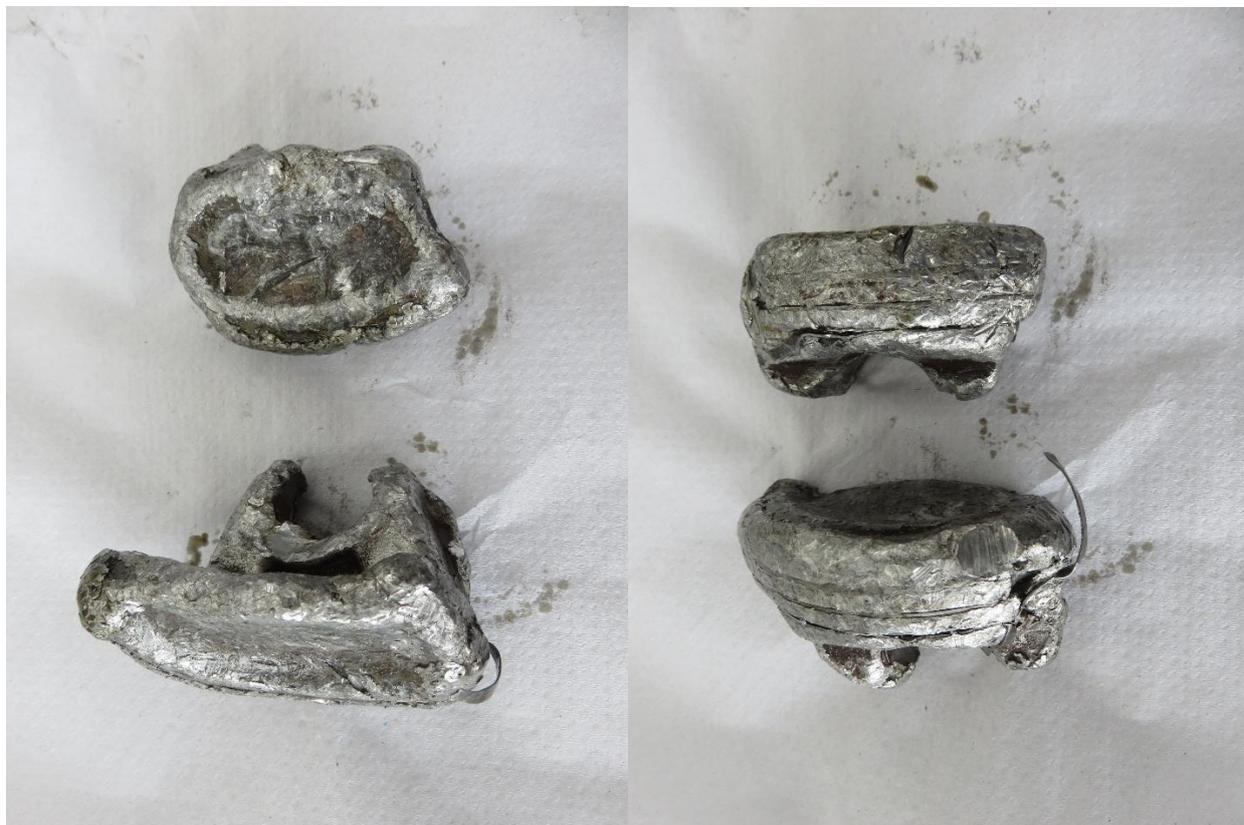
1. The piston from cylinder Number 5 was destroyed, with some debris scattered throughout the engine as observed in the oil sump and oil filter that were cut open.
2. The Number 5 cylinder head displayed damage associated with debris from the broken piston.
3. The exhaust valve was found bent.
4. The connecting rod (Conrod) of cylinder Number 5 was bent, with the gudgeon pin still attached.
5. Witness marks of the Number 5 piston were evident on the trust face of the barrel which were caused by the dislodged circlip.

Figure 3: The damage that was sustained by piston Number 5.

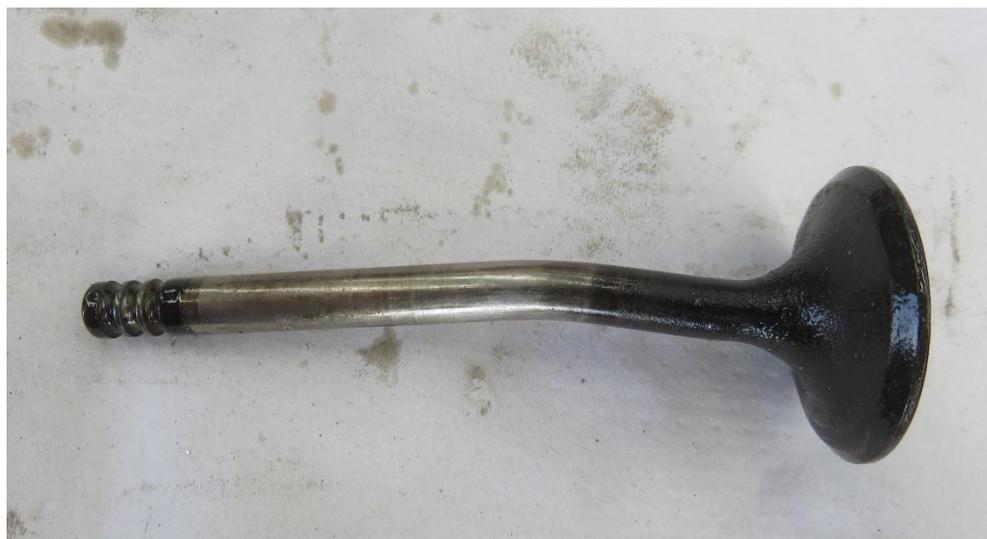
Figure 4: The bent exhaust valve.

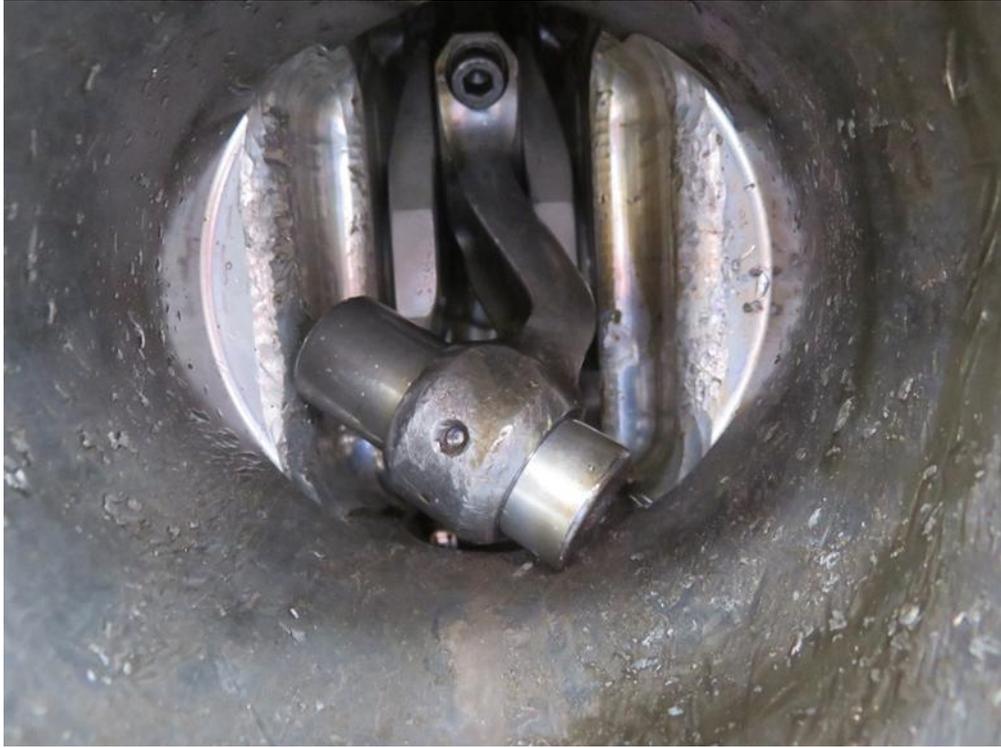
Figure 5: The bent conrod inside the barrel.

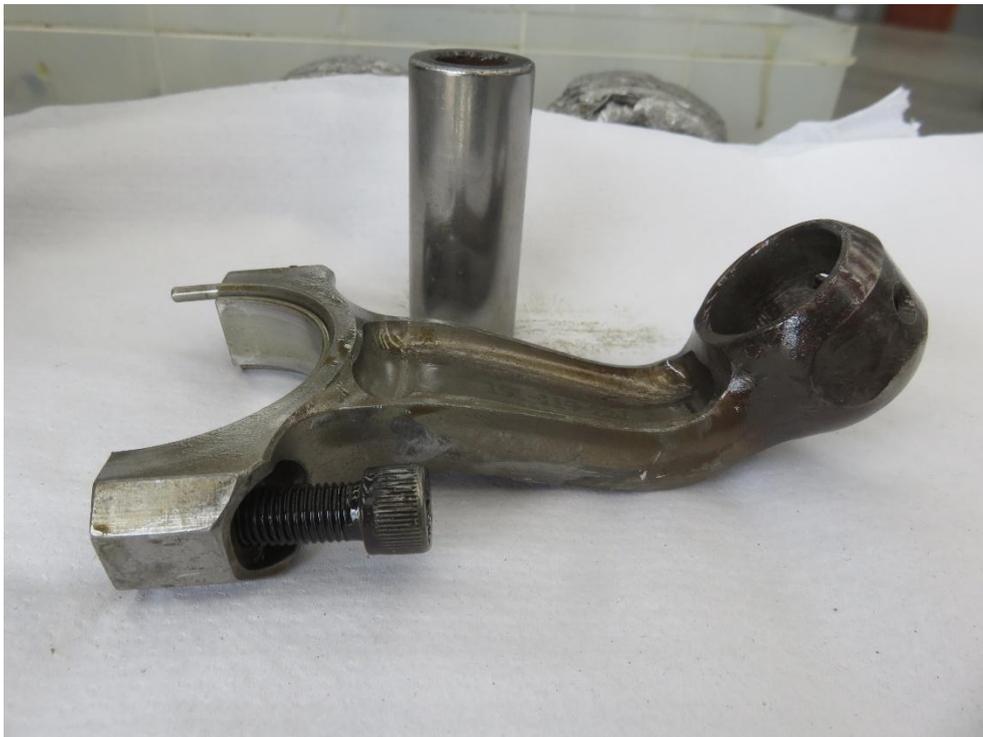
Figure 6: The bent conrod with gudgeon pin.

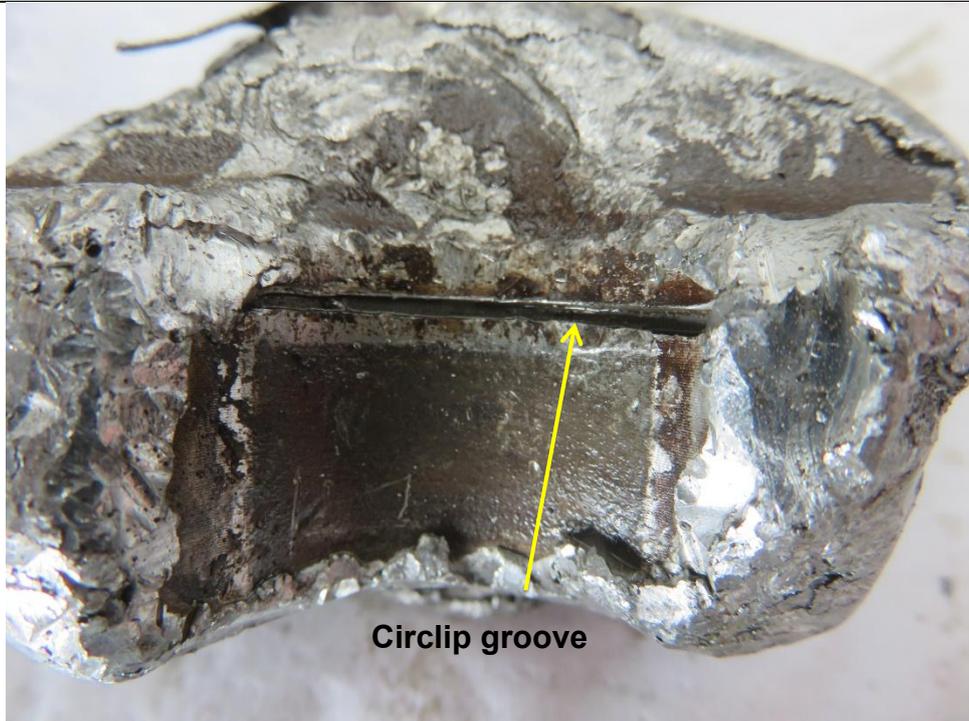
Figure 7: The damaged piston. The yellow arrow shows the damage groove of the circlip that was dislodged.

The circlip groove in Figure 7 is rough (unsmooth) and smaller in size compared to a standard circlip groove. The investigator assessed that the circlip might have dislodged from one of the sides first, as it appeared damaged compared to the one in Figure 8.

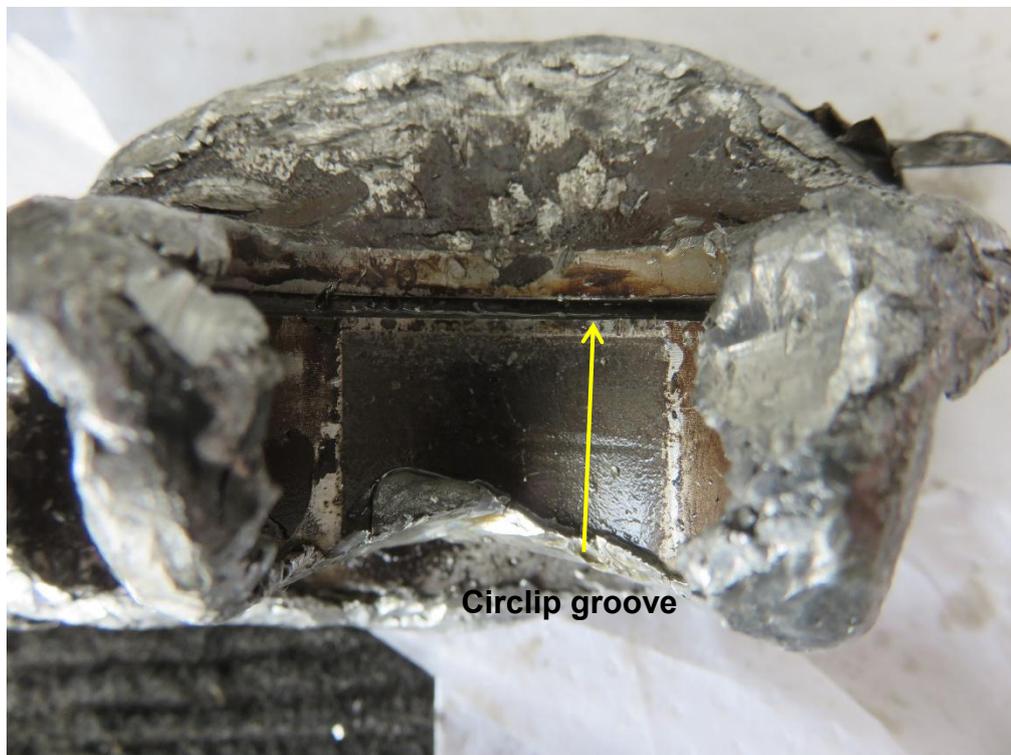
Figure 8: The damaged piston. The yellow arrow shows the undamaged groove of the circlip.

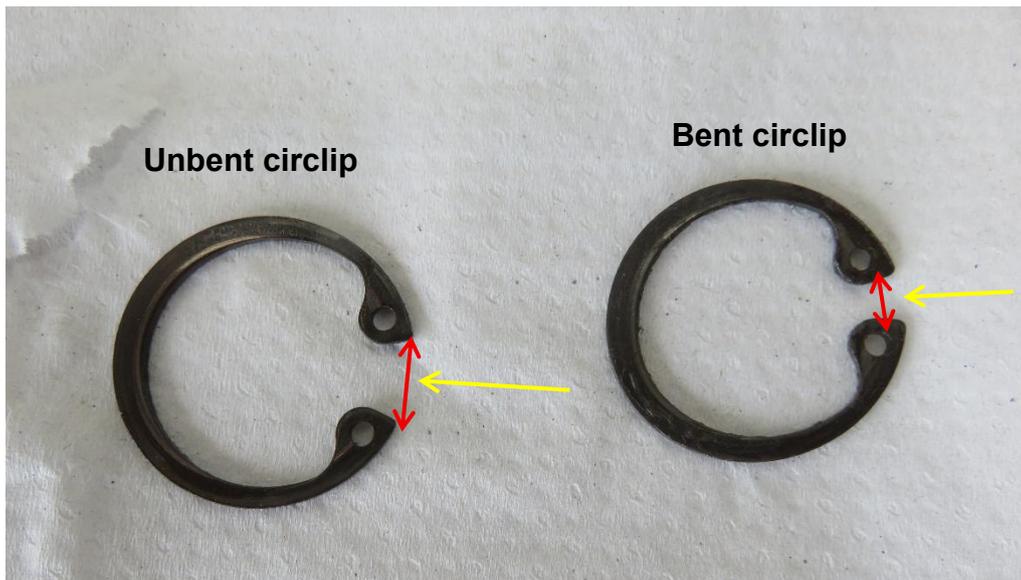
6. One circlip was found amongst the debris in the barrel. The said circlip was bent to the degree that the circumference was reduced in size.
7. The other circlip that had dislodged had become unrecognisable in the debris.

Figure 9: The bent circlip vs an original size circlip.

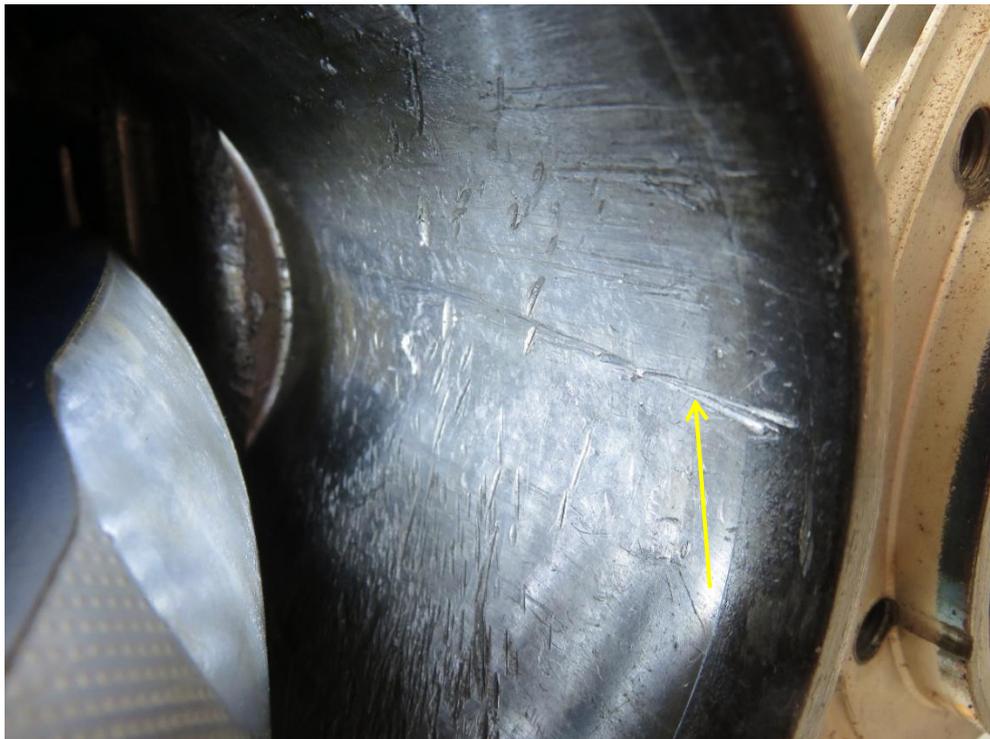
Figure 11: Witness marks on the trust face of the barrel.
