**LIMITED OCCURRENCE INVESTIGATION REPORT – FINAL**

<b>Reference Number</b>	CA18/3/2/1504						
<b>Classification</b>	Accident		<b>Date</b>	24 September 2025		<b>Time</b>	0537Z
<b>Type of Operation</b>	Training (Part 141)						
<b>Location</b>							
Place of Departure	Silver Creek Gorge Airfield, North West Province		Place of Intended Landing	Bapsfontein Airfield (FABA), Gauteng Province			
Place of Occurrence	Approximately 2.3 nautical miles (nm) south-east of Silver Creek Gorge Airfield, North West Province						
GPS Co-ordinates	Latitude	25° 48' 57.33" S	Longitude	27° 33' 30.68" E	Elevation	4 753 ft	
<b>Aircraft Information</b>							
Registration	ZU-CZI						
Make; Model; S/N	Magni Gyro; M16 (Serial Number: 16032174)						
Damage to Aircraft	Substantial			Total Aircraft Hours	687.9		
<b>Pilot-in-command</b>							
Licence Type	National Pilot Licence (NPL)		Gender	Male		Age	63
Licence Valid	Yes	Total Hours	10 362		Total Hours on Type	198	
Total Hours 30 Days	27		Total Flying on Type Past 90 Days	19

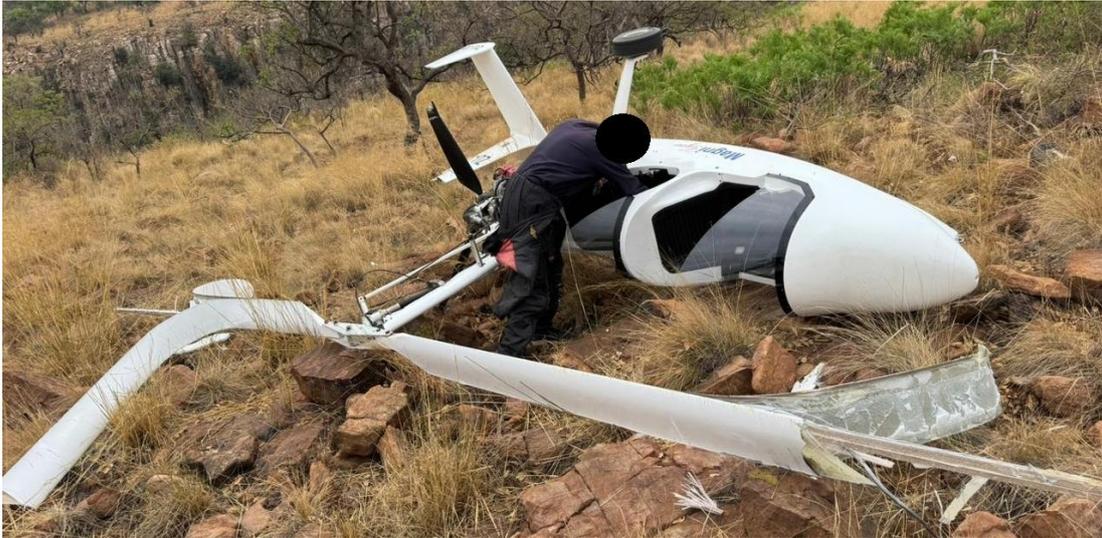
**Figure 1:** The aircraft at the accident site. (Source: Pilot)

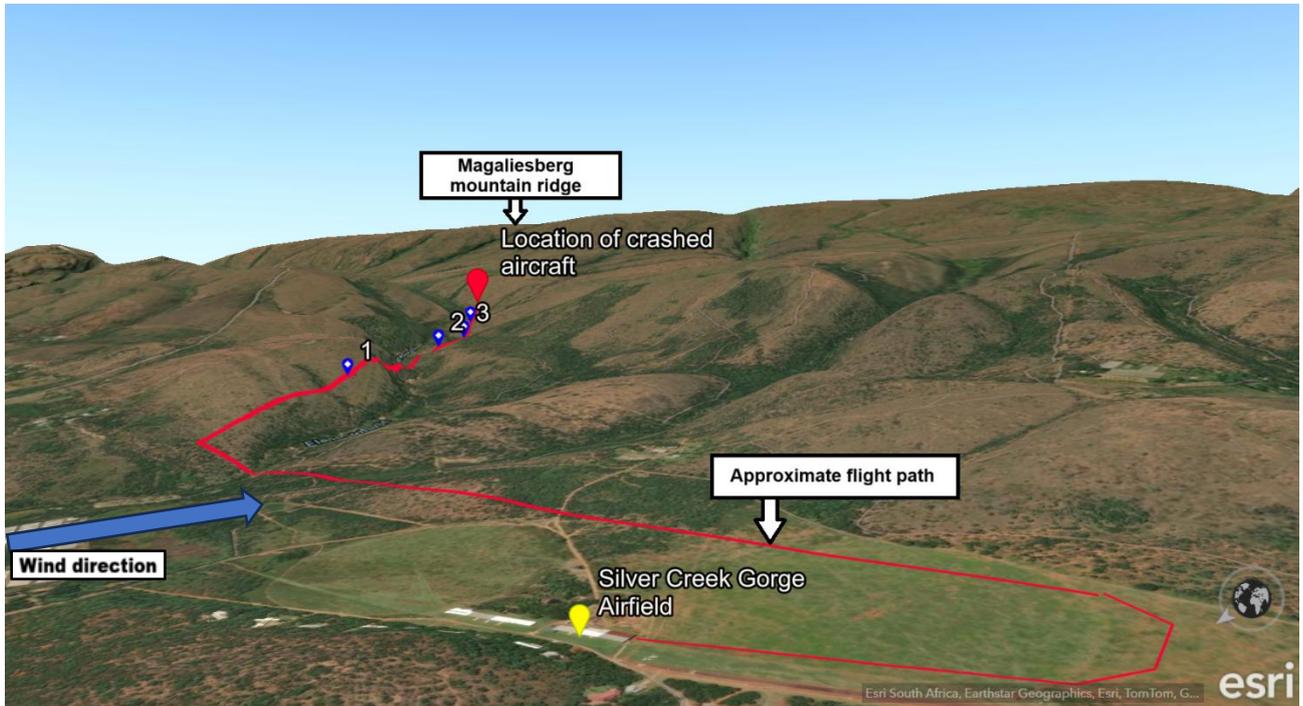
**Figure 2:** The flight path, terrain and approximate wind direction. (Source: ArcGis online map hosted by Esri South Africa)

- After take-off, the flight had a duration of approximately 4 minutes.
- The aircraft flew at an altitude of between 100 ft and 200 ft above ground level until it was forced-landed.
- In Figure 2, the aircraft's ground speed at point 1 was 48.5 kts and when it reached point 3 the ground speed had decreased to 32.5 kts.

2.5 The X Country application data download indicated that prior to the forced landing, the aircraft was flown between 80 ft and 200 ft AGL parallel to the hillside and gradually climbing with the slope towards the Magaliesberg mountain ridgeline, south of its position. The aircraft was also losing speed; and was flying below the manufacturer's suggested best rate of climb speed of 55 kts.

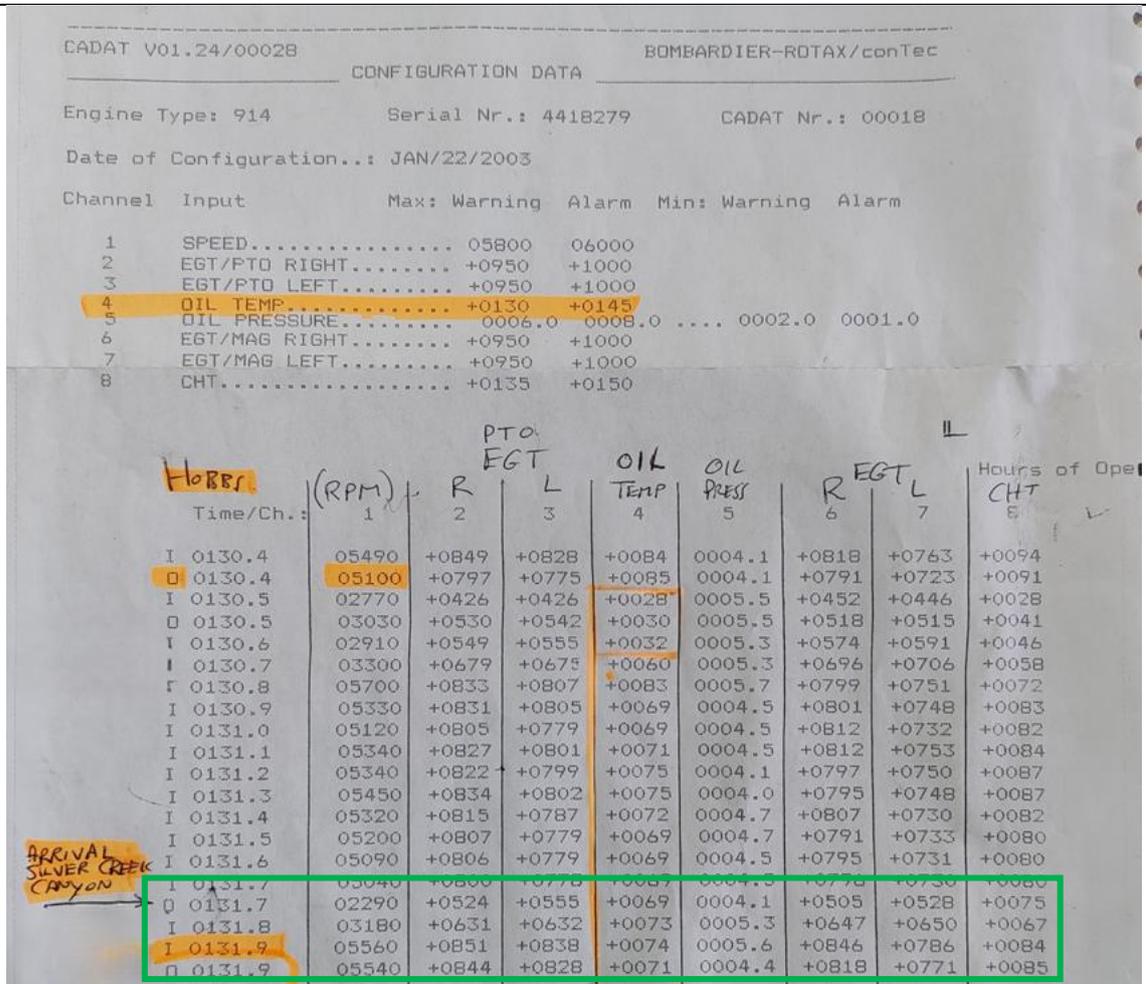
The aircraft was fitted with a Rotax 914 UL engine equipped with a TCU and FLYDAT which recorded engine parameters when the engine was in operation. Data downloaded from both the TCU and FLYDAT indicated that the engine operated normally from take-off to the point of the forced landing with no abnormal drop in engine operating revolutions per minute (RPM), airbox pressure or throttle position. The TCU recorded data in 1-minute intervals and the FLYDAT recorded data in 6-minute intervals.

Figure 6: FLYDAT data download with engine parameters circled in green. (Source: Owner)

2.4 Although the FI initially stated that the aircraft had an engine failure, data downloaded from the engine's TCU and FLYDAT confirmed that the engine was operating normally at the time of the accident.

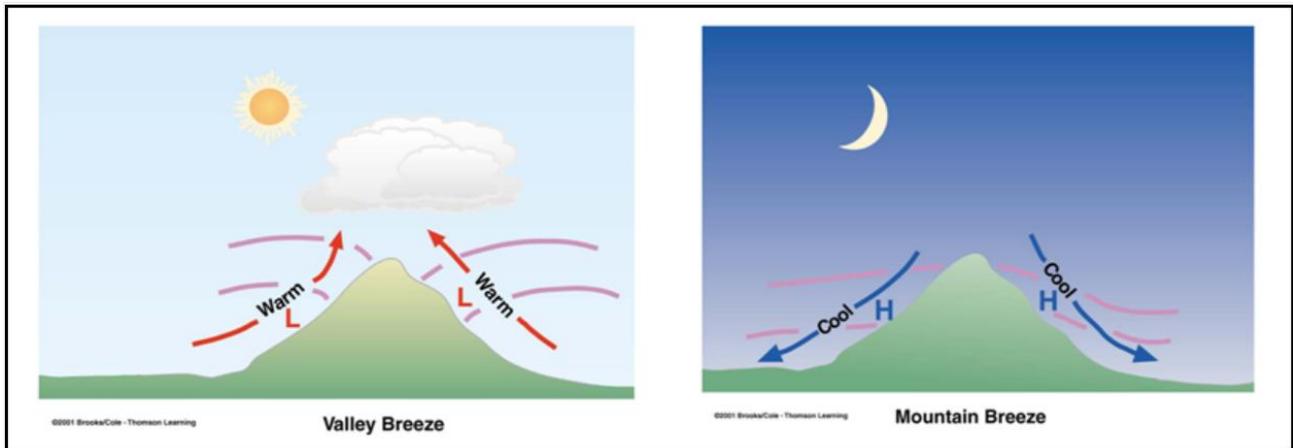
**Figure 7:** Airflow in mountainous areas.

<p>2.6 The take-off weight was 498 kg which was within the take-off weight limitation for the aircraft.</p> <p>3. <u>Environment</u></p> <p>3.1. The aircraft was flown over a mountainous terrain and could have been affected by downdrafts, wind shear and turbulence.</p> <p>4. <u>Organisation</u></p> <p>4.1 The organisation has an approved Declared Training Organisation certificate (DTO 0030) issued on 14 May 2025.</p>
<p><b>Probable Cause(s)</b></p> <p>The aircraft was flown into a mountainous area at a low altitude and was likely affected by downdrafts or turbulent airflow which caused a significant loss of positive rate of climb; the pilot forced-landed the aircraft.</p>
<p><b>Contributing Factor(s)</b></p> <p>None.</p>
<p><b>Safety Action(s)</b></p> <p>None.</p>
<p><b>Safety Message</b></p> <p>Pilots are reminded to exercise extreme caution when flying over mountainous terrain as the local airflow conditions are distorted by the temperature and topography. The best practise is to maintain a 1000 ft altitude clearance when approaching a mountain ridgeline in low to moderate prevailing wind speeds, and to maintain a 2000 ft altitude clearance when approaching a mountain ridgeline in moderate to high prevailing wind speeds.</p>
