AIRCRAFT SERIOUS INCIDENT REPORT AND EXECUTIVE SUMMARY

Reference:		CA18/3/2/1505	
Aircraft Registration	ZS-SJU	Date of Incident	22 September 2025		Time of Incident	1027Z
Type of Aircraft	Boeing 737-800		Type of Operation		Commercial (Part 121)	
Pilot-in-command Licence Type	Airline Transport Pilot Licence		Age	41	Licence Valid	Yes
Pilot-in-command Flying Experience	Total Flying Hours		10 469.5	Hours on Type	3 487.8	
Last Point of Departure	Chief Dawid Stuurman International Airport (FAPE), Eastern Cape Province					
Next Point of Intended Landing	Cape Town International Airport (FACT), Western Cape Province					
Damage to Aircraft	None					
Location of the incident site with reference to easily defined geographical points (GPS readings if possible)						
Abeam George en route to FACT at flight level (FL) 360 and at GPS co-ordinates determined as 34° 00' 29.21"S 022° 28' 24.73"E						
Meteorological Information	Surface wind: 240°/31kt; temperature: 20°C; dew point: 9°C; Visibility: CAVOK

Reference Number : CA18/3/2/1055
Occurrence Category : Serious Incident (Category 2)
Type of Operation : Air Transport Operations (Part 121)
Name of Operator : FlySafair
Aircraft Registrations : Z

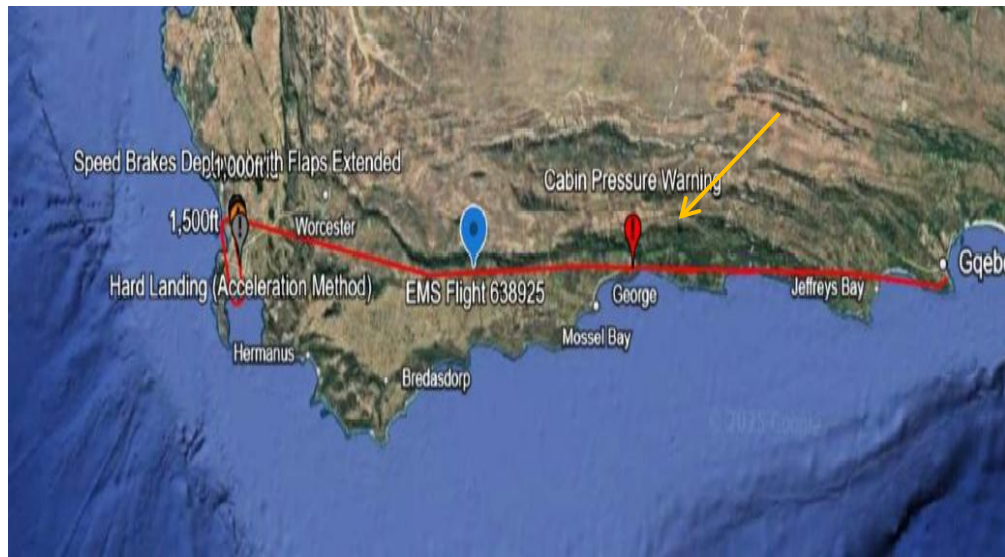
Figure 1: The approximate area where the cabin decompression occurred, the yellow arrow indicates the point of cabin pressure warning activation.

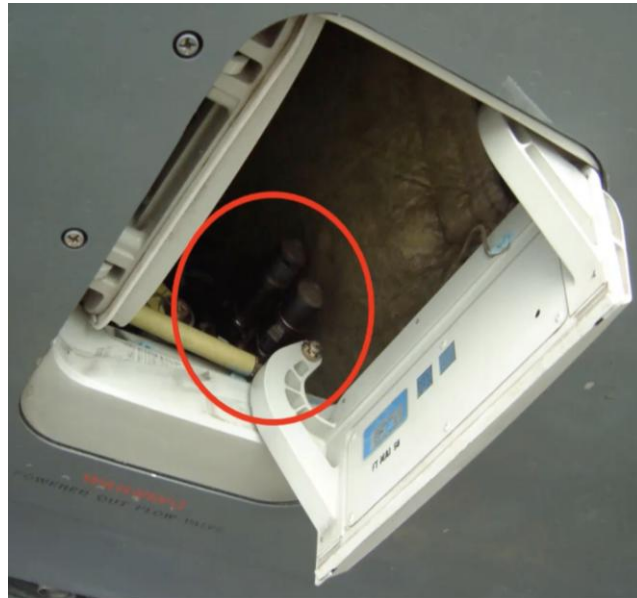
Figure 6: The outflow valve.

1.16.2 A team of engineers later towed the aircraft to the designated engine ground-run area for engineering investigation. The engines were started and the pressurisation system was interrogated. Both cabin pressure controllers indicated a fault code 090. The fault code identified as referenced in the fault identification manual (FIM) suggested a possible defect of the electrical actuator on the outflow valve.

1.16.3 Further testing was performed on the outflow valve in manual mode, and it operated normally, the valve opened and closed correctly. The chief engineer later tested both air conditioning system pack zone temperature controllers to determine if there were faults. The tests on both temperature controllers showed no negative results, meaning that no faults were detected. As part of the investigation, the engineers verified bleed air pressure on both engines and confirmed that both engines were able to deliver bleed air pressure. This confirmed that the bleed air system was operating correctly. In addition, a cabin leak-down check was performed to exclude the possibility of air leaks contributing to the event. The aircraft was pressurised, and the leak-down test results were found to be within the prescribed limits, indicating no evidence of leakage at the time of testing.

- As the fault could not be conclusively isolated during operational testing, a precautionary decision was taken to replace CPC 2, the P5 pressurisation control panel, and the outflow valve. These components were removed and submitted for detailed shop analysis to identify any latent or intermittent defects.
- Following completion of maintenance actions, a confidence flight was conducted to verify correct pressurisation system operation. The flight was completed successfully; after management approval, the aircraft was released back into service.

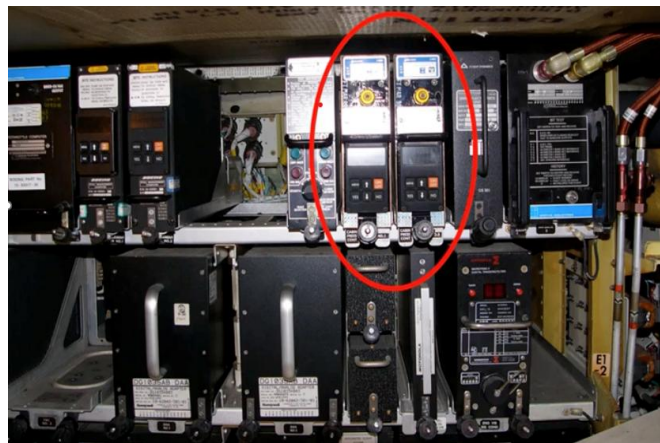
1.16.8 The CPC 1 with serial number 9912007 was sent to the United States of America (USA) for investigation. Upon its arrival, normal wear and tear of the unit was noted. On 27 October 2025, the CPC with part number 7121-19971-01AC, serial number 9912007 was bench-tested and the non-volatile memory (NVM) readout indicated multiple faults with the following codes: 17,18,24,25,30,90 and 254.

1.16.9 Functional test failed due to the electronic temperature control (ETC) values being too high. Explanation: Elapsed time counter validation. If the initial incoming ETC value is already at values around 45010 flight hours (FH) (e.g. ≥ 45005 FH), it is advisable to perform an initialisation to avoid an unintended failure during test operation as per step G, page 1019 of Component Maintenance Manual (CMM) 21-33-20. The Service Bulletin (SB) 737-SL-21-094 was incorporated at the request of the operator. The SB required that an additional layer of tape for copper tape protection. The repair included setting the ETC to 45.000 hours. Time counter was initialised and the CPC was returned to the operator serviceable.

Figure 7: The CPCs as installed in the aircraft electrical and electronics bay.

3.3.1 Cabin decompression en route to FACT at FL360 caused by a latent internal failure of cabin pressure controller 1 prevented automatic pressurisation control and inhibited a successful transfer to the alternate controller; thus, resulting in the aircraft's loss of automatic cabin pressure regulation during cruise.
