LIMITED OCCURRENCE INVESTIGATION REPORT – FINAL

Reference Number	CA18/3/2/1506						
Classification	Serious Incident		Date	25 September 2025		Time	1123Z
Type of Operation	Commercial (Part 121)						
Location							
Place of Departure	Hoedspruit Eastgate Airport (FAHS), Limpopo Province		Place of Intended Landing	O.R. Tambo International Airport, Gauteng Province			
Place of Occurrence	Taxiway Alpha at Hoedspruit Eastgate Airport, Limpopo Province						
GPS Co-ordinates	Latitude	24°20'25.27"S	Longitude	31°2'37.23" E	Elevation	1 740ft	
Aircraft Information							
Registration	ZS-CMX						
Make; Model; S/N	Bombardier Aerospace; CRJ-700 (Serial Number: 10246)						
Damage to Aircraft	Minor		Total Aircraft Hours	34 951.56			
Pilot-in-command							
Licence Type	Airline Transport Pilot Licence (ATPL)		Gender	Male		Age	41
Licence Valid	Yes	Total Hours	6 747.4		Total Hours on Type	108.8	
Total Hours 30 Days	35		Total Flying on Type Past 90 Days	90.6			
People On-board	2 + 2 + 45	Injuries	0	Fatalities	0	Other (on ground)	0

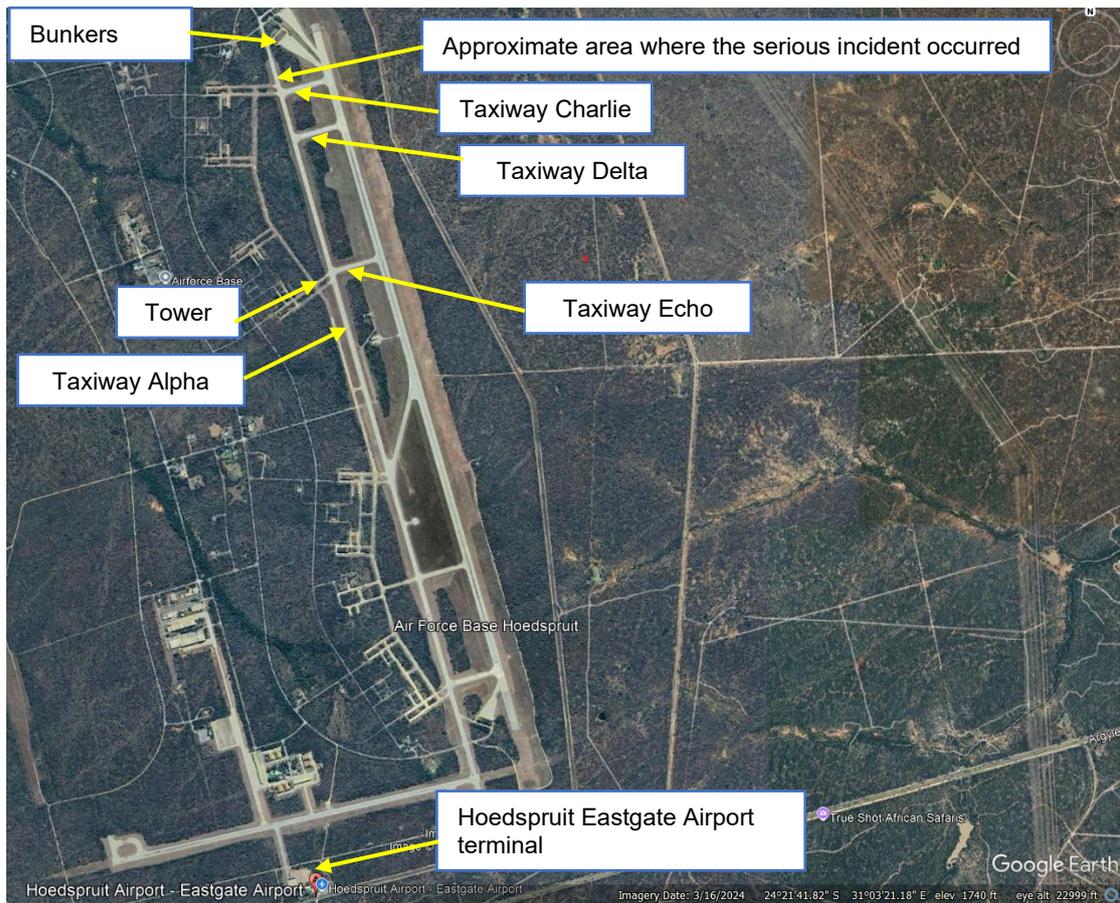
Figure 1: An aerial view of Hoedspruit Eastgate Airport (FAHS) terminal area; taxiways Alpha, Delta, Charlie and the approximate area where the serious incident occurred. (Source: Google Earth)

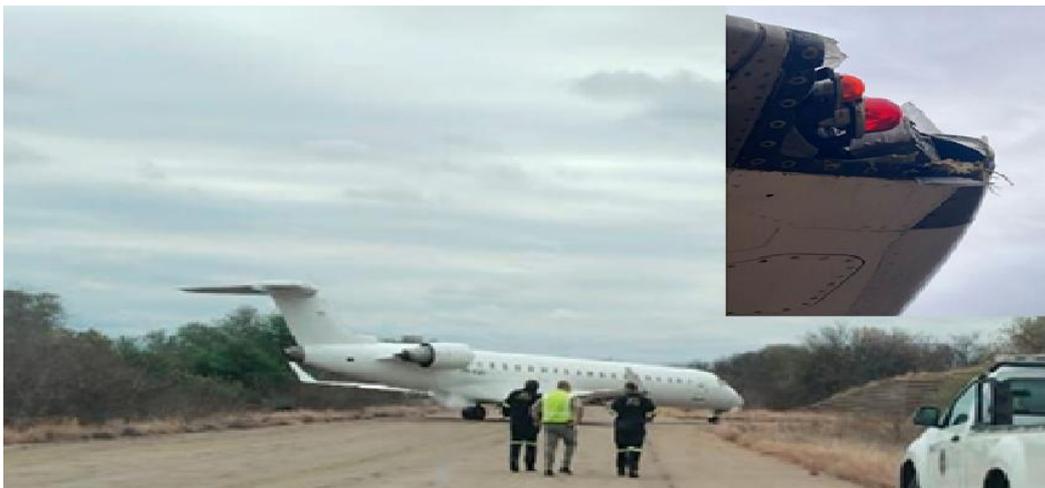
Therefore, the Cpt taxied/manoeuvred the aircraft in the direction of the bunkers during which the aircraft struck some trees with its left-wing tip. One of the passengers witnessed the occurrence and informed the cabin crew members who reported it to the flight crew. Later, the Cpt turned the aircraft slightly to the right and brought it to a stop next to the bunkers. The flight crew followed the engine shutdown procedure as stipulated in the aircraft flight manual (AFM). The ATCO was notified about the occurrence and she instantly dispatched a fire truck to the site; therefore, the departure clearance for ZS-CMX was cancelled. The FO disembarked from the aircraft through the airstair to inspect it; he noted minor damage on the left-wing navigation light. The navigation light glass cover was broken and the strobe light was damaged. The passengers disembarked from the aircraft and were transported by bus to FAHS terminal area. No person was injured. The occurrence was reported to the operator's operational control centre (OCC) at FAOR.

Figure 2: The aircraft facing the bunkers. The inset shows the damaged left wing navigation light.

A team of aircraft maintenance engineers (AMEs) rated on the aircraft model were flown from FAOR to FAHS; they had the required spares with them. Upon their arrival at FAHS, they replaced both the damaged strobe light and the navigation light glass cover, and the aircraft was returned to service (the defect was captured in the flight folio page serial number 22828). The aircraft was taxied back to FAHS terminal. Later the same evening, passengers checked in and boarded the aircraft. Around 1604Z, the aircraft departed from FAHS; it later landed safely at FAOR.

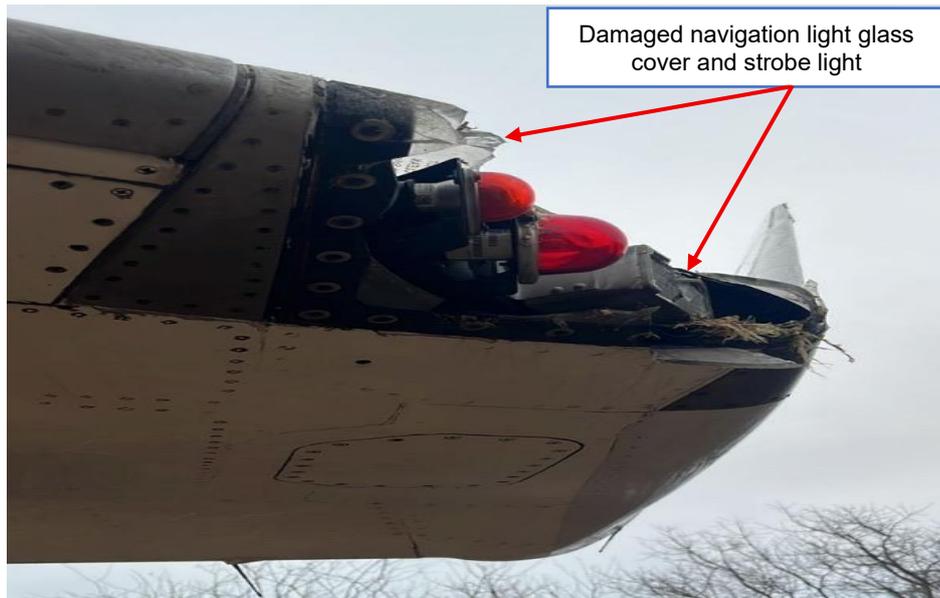
Figure 3: The left-wing navigation light showing the damaged glass cover (left red arrow) and strobe light.

The flight crew missed the Delta intersection during taxi on their way to Runway 18 holding point and proceeded to the prohibited area during which the aircraft struck some trees with the left-wing tip. The aircraft sustained minor damage to the navigation light.

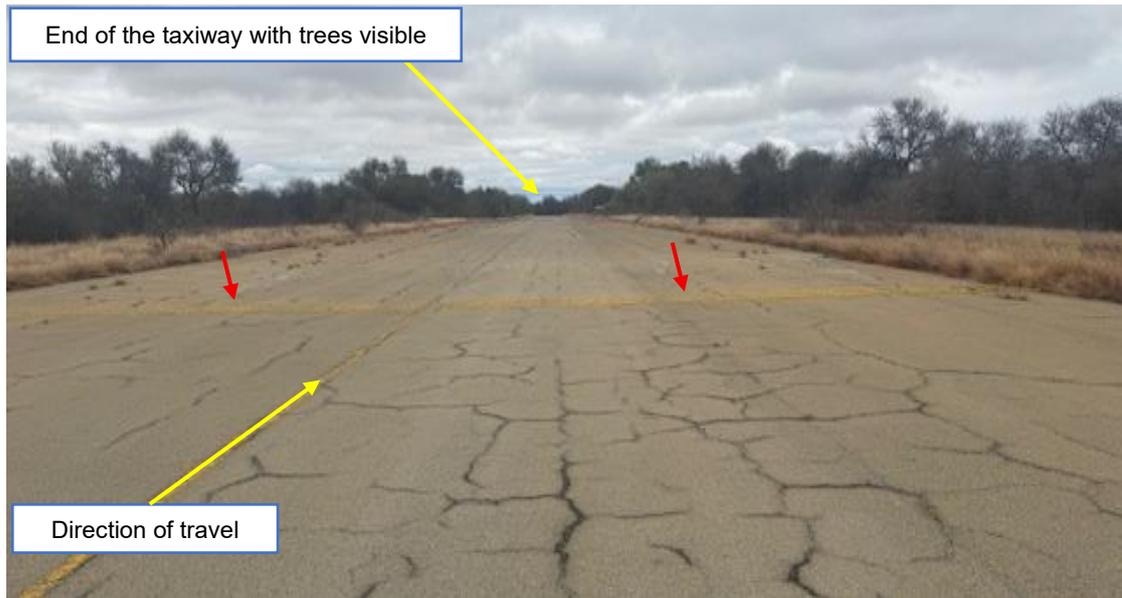
On Monday morning, 29 September 2025, the investigating team travelled to FAHS to examine the runway and taxiways. Taxiway A was in good condition; however, no information/guidance boards were erected for intersections D and C. Immediately after the D intersection, five (5) yellow lines were painted across the tarmac taxiway surface indicating a non-movement area (Figure 4); the area is not controlled by tower (ATC). *The taxiway from C intersection gets narrow with trees lining it on the sides.* Evidence at the site showed that the aircraft travelled approximately 19 metres (m), striking tall trees on the left side of the taxiway. The ATCO had no visual of the position of the aircraft from the tower after the Cpt had informed her that he would make a 180-degree turn.

Figure 4: The five yellow lines across the taxiway (red arrows) indicating a non-movement area (uncontrolled), as well as the direction of travel and the end of the taxiway A (yellow arrows).

The safety officer at FAHS was briefed about the findings of the on-site investigation and he committed to erecting signs/guide boards that will show all intersections, as well as a no entry board after the C intersection in addition to the five yellow lines painted across the taxiway (see Figure 4).

Intersection sign/guidance boards for taxiways Delta and Charlie to be erected and a no entry board to be erected after Charlie intersection before the five yellow lines painted across taxiway Alpha.

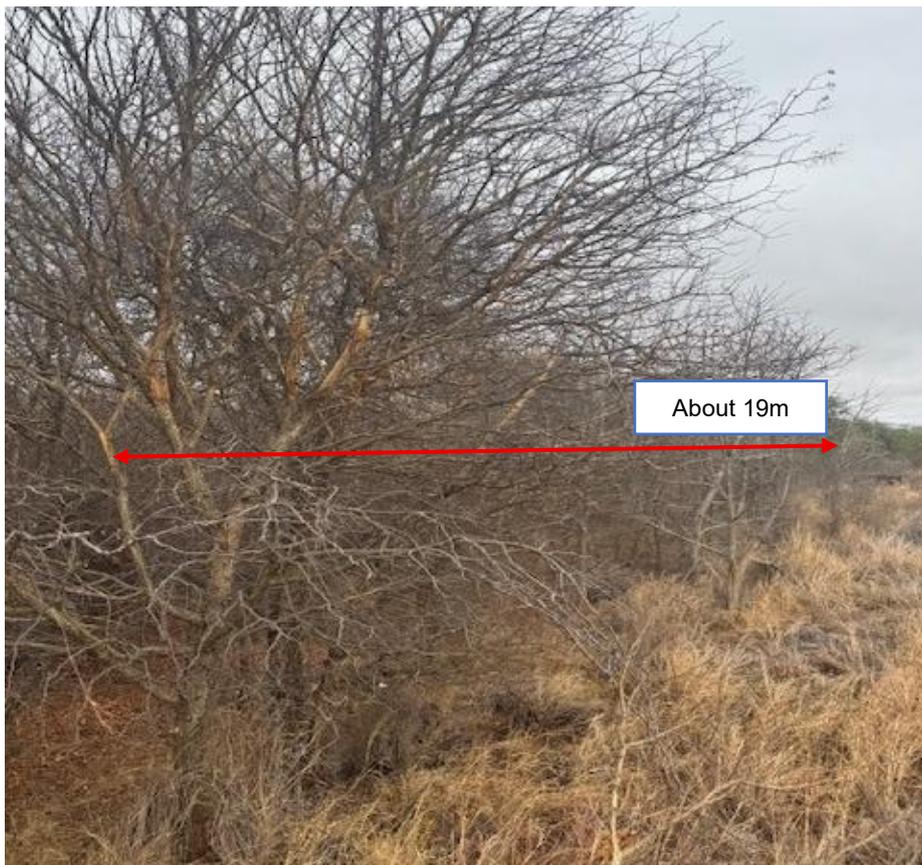
Figure 5: One of the trees struck by the aircraft's left-wing tip during taxi (red line).
