**LIMITED OCCURRENCE INVESTIGATION REPORT – FINAL**

<b>Reference Number</b>	CA18/3/2/1507						
<b>Classification</b>	Serious Incident		<b>Date</b>	26 September 2025		<b>Time</b>	1005Z
<b>Type of Operation</b>	Private (Part 94)						
<b>Location</b>							
Place of Departure	Robertsvale Airfield in Gonubie Broads, East London, Eastern Cape Province		Place of Intended Landing		Robertsvale Airfield in Gonubie Broads, East London, Eastern Cape Province		
Place of Occurrence	Open area to the right of Runway 12, approximately 7.2 nautical miles (nm) north-east of Robertsvale Airfield in Gonubie Broads, East London, Eastern Cape Province						
GPS Co-ordinates	Latitude	32°55'34.79" S	Longitude	27°59'39.53" E	Elevation	656.17 ft	
<b>Aircraft Information</b>							
Registration	ZU-TEL						
Make; Model; S/N	I.C.P. Aviazione; Ventura 4 (Serial Number: 21-01-64-0018K)						
Damage to Aircraft	Minor			Total Aircraft Hours	18.1		
<b>Pilot-in-command</b>							
Licence Type	Private Pilot Licence (PPL)		Gender	Male		Age	60

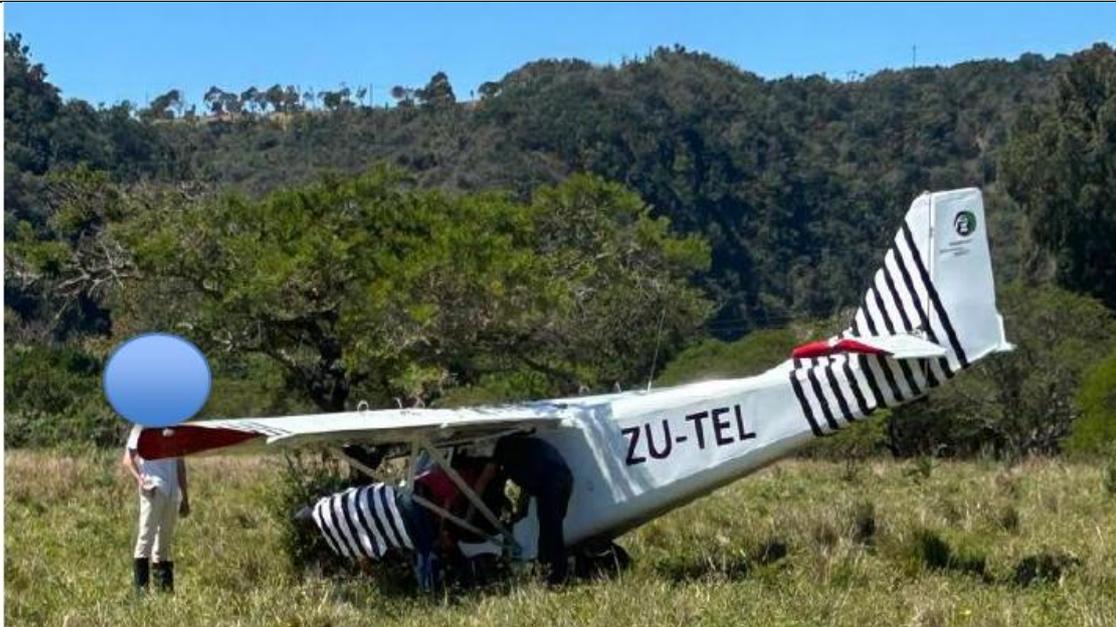
The pilot initiated an immediate right turn toward a pre-identified emergency landing zone immediately outside the airfield and executed a forced landing. During the landing roll, the aircraft impacted a tree before it came to rest on the grass-covered grounds. After the aircraft had stopped, the pilot shut down the engine and, together with the engineer, exited the aircraft safely and uninjured. The aircraft was damaged during the serious incident sequence.

**Figure 2:** The aircraft at the serious incident site. (Source: Operator)

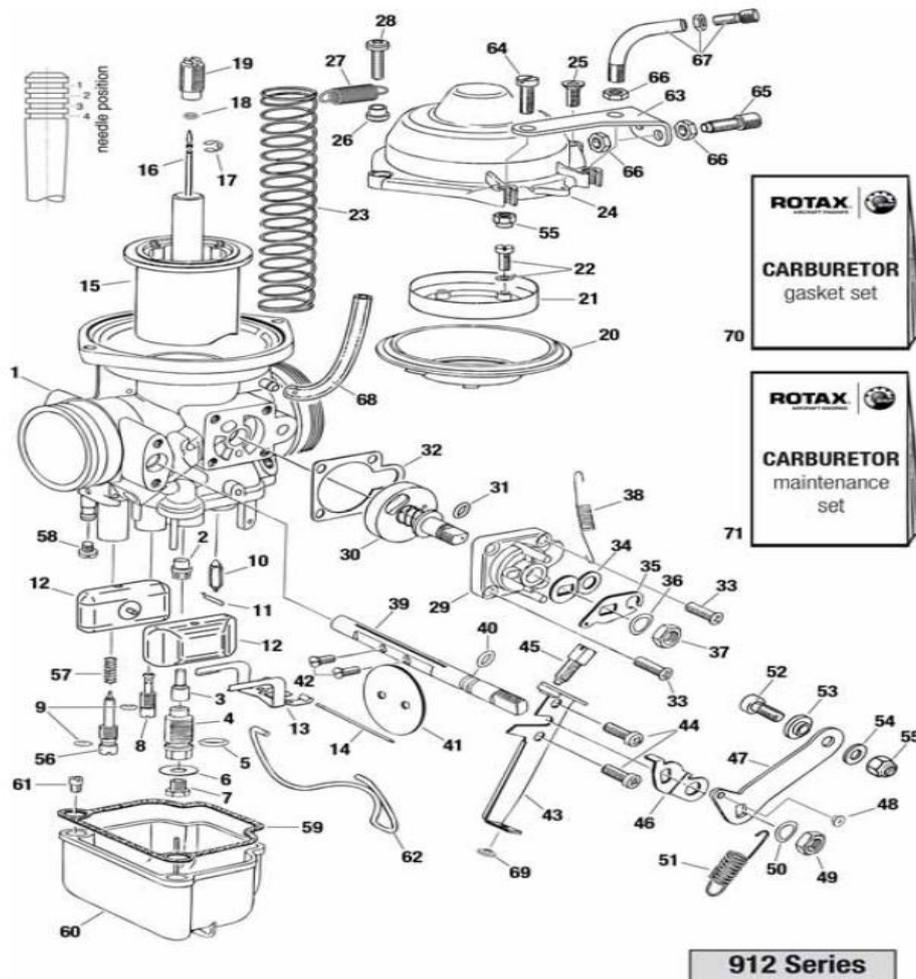
Fig. 73-00-00-2

The aircraft was recovered to a SACAA-approved maintenance facility in East London where a detailed inspection was conducted by engineers. The ZU-TEL aircraft was equipped with a Rotax 912 ULS engine (Serial Number 10005629). Upon inspection, no mechanical damage was found with the engine. A shock-load inspection was performed on the reduction gearbox, and it did not reveal any mechanical defects. Both carburettors were dismantled and examined; no sign of damage was observed. However, the right-side carburettor bowl/float chamber (Figure 73-00-00-2, Item no 60) contained dirt (foreign objects) in the main jet chambers.

In conclusion, the engine was found to be intact with no evidence of pre-impact damage or internal failure. An obstruction (foreign material) was discovered within the float chamber of the right-side carburettor, likely obstructing the main jet which caused fuel starvation to the right-side bank cylinders. This contamination resulted in an uneven air-fuel mixture (abnormally lean mixture) which led to reduced intermittent combustion efficiency and the subsequent loss of engine power. The source of foreign material could not be determined. At the time of the occurrence, the aircraft had accumulated approximately 18.1 flight hours of the 25-hour proving flight regime. Prior to the flight, the pitot-static test, mass and balance, equipment list and airframe logbook were completed and

Figure 3: The 73-00-00-2 carburettor single parts 912 series.  
(Source: Rotax Illustrated Parts Catalogue [IPC])

<b>Probable Cause(s)</b>
The engine power loss was due to fuel starvation on the right-side cylinder bank that was caused by foreign material in the right carburettor float chamber which obstructed the main jet.
<b>Contributing Factor(s)</b>
None.
<b>Safety Action(s)</b>
None.
<b>Safety Message and/or Safety Recommendation/s</b>
None.
<b>About this Report</b>
<i>The decision to conduct a limited investigation is based on factors including whether the cause is known and the evidence supporting the cause is clear, the level of safety benefit likely to be obtained from an investigation and that will determine the scope of an investigation. For this occurrence, a limited investigation has been conducted, and the Accident and Incident Investigations Division (AIID) has relied on the information submitted by the affected person/s and organisation/s to compile this limited report. The report has been compiled using information supplied in the initial notification, as well as from follow-up desk top enquiries to bring awareness</i>
