LIMITED OCCURRENCE INVESTIGATION REPORT – FINAL

Reference Number		CA18/3/2/1508					
Classification	Serious Incident	Date	26 September 2025		Time	1105Z	
Type of Operation	Private (Part 91)						
Location							
Place of Departure	Calvinia Airfield (FACV), Northern Cape Province		Place of Intended Landing	Rosebank Private Airstrip, Northern Cape Province			
Place of Occurrence	Roseback Private Airstrip, Northern Cape.						
GPS Co-ordinates	Latitude	30° 49' 21.34" S	Longitude	022° 02' 38.82" E	Elevation	3190 ft	
Aircraft Information							
Registration	ZS-LBS						
Make; Model; S/N	Mooney; M20J (Serial Number: 24-0205)						
Damage to Aircraft	Minor			Total Aircraft Hours	1818.5		
Pilot-in-command							
Licence Type	Private Pilot Licence (PPL)		Gender	Male		Age	66
Licence Valid	Yes	Total Hours	288.4	Total Hours on Type	96.8		
Total Hours 30 Days	4		Total Flying on Type Past 90 Days			4	
People On-board	1+1	Injuries	0	Fatalities	0	Other (on ground)	0
What Happened

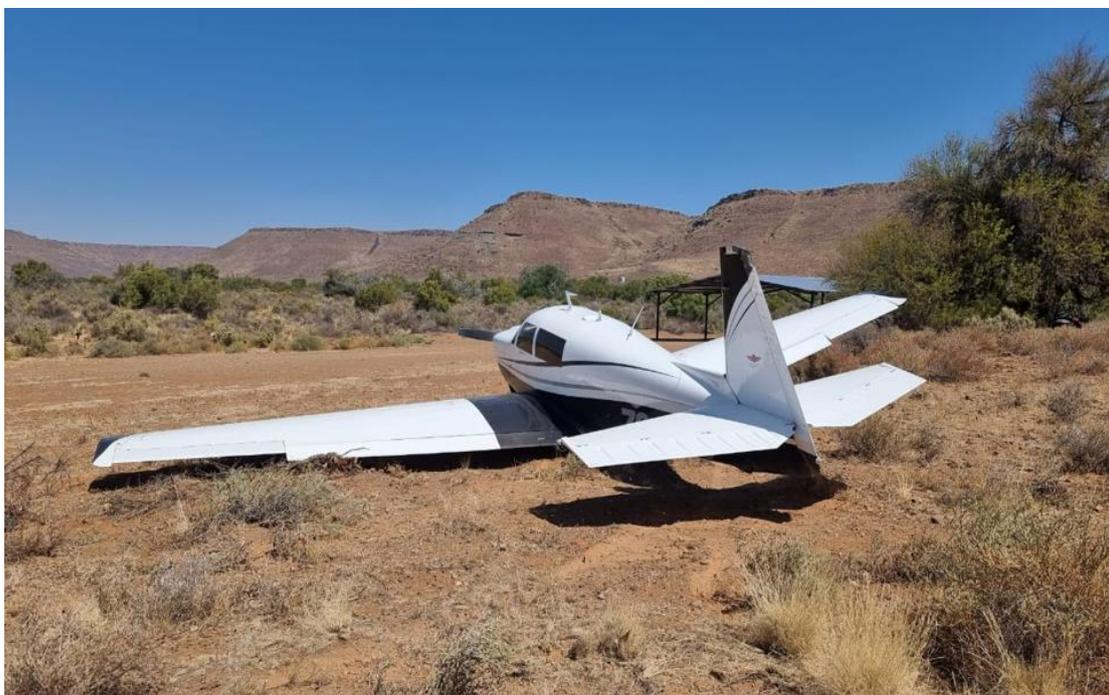
The aircraft sustained substantial damage to the left main landing gear assembly and wing structure. The pilot and the passenger were not injured.

Figure 2: The aircraft as it came to rest. (Source: Pilot)

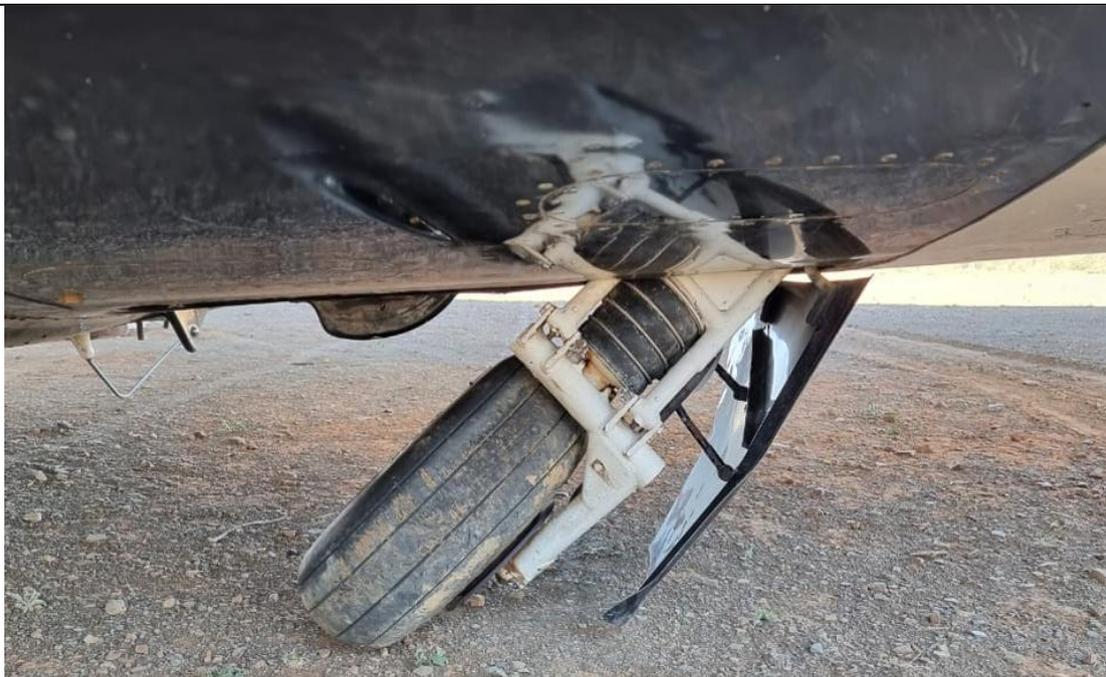
Figure 3: The damaged sustained by the left main landing gear. (Source: Pilot)

7. During landing, the aircraft encountered strong tailwind conditions that increased the landing speed and the subsequent landing distance. The aircraft, upon touchdown, drifted to the right side of the runway and the right main wheel rolled over an uneven terrain which caused the landing gear to collapse. The aircraft came to a full stop a few metres from the runway.

8. The pilot elected to land on Runway 24 despite the prevailing wind from 060° at 13 kts, gusting 23 kts which resulted in a significant tailwind component during landing. The aircraft touched down with an increased landing distance which, consequently, reduced the available stopping distance. The combination of excessive ground speed due to the tailwind, the reduced landing distance available, and the uneven surface beyond the runway edge contributed to the subsequent runway excursion and the collapse of the left main landing gear after the aircraft departed the prepared surface.

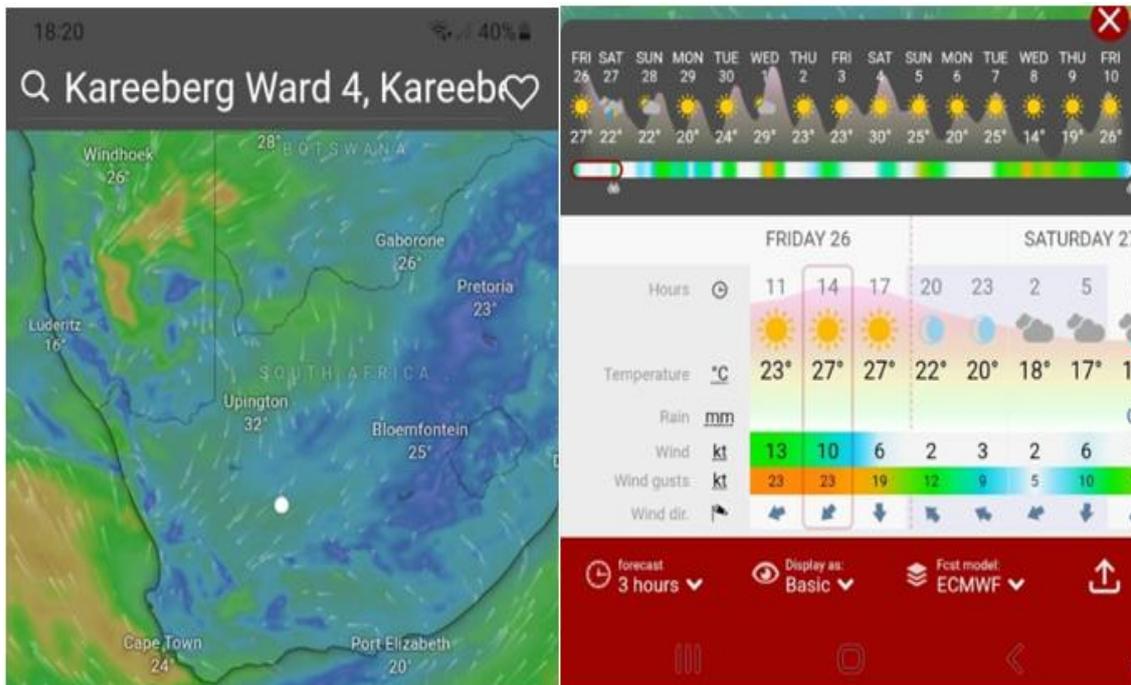
Figure 4: The meteorological weather conditions record from the electronic weather application. (Source: Pilot)

Wind direction: 060°; wind temperature: 23 °C; wind speed: 13 kt; wind gust: 23 kt; visibility: 9999

The above weather conditions indicated a tailwind component. The wind was blowing north-easterly.

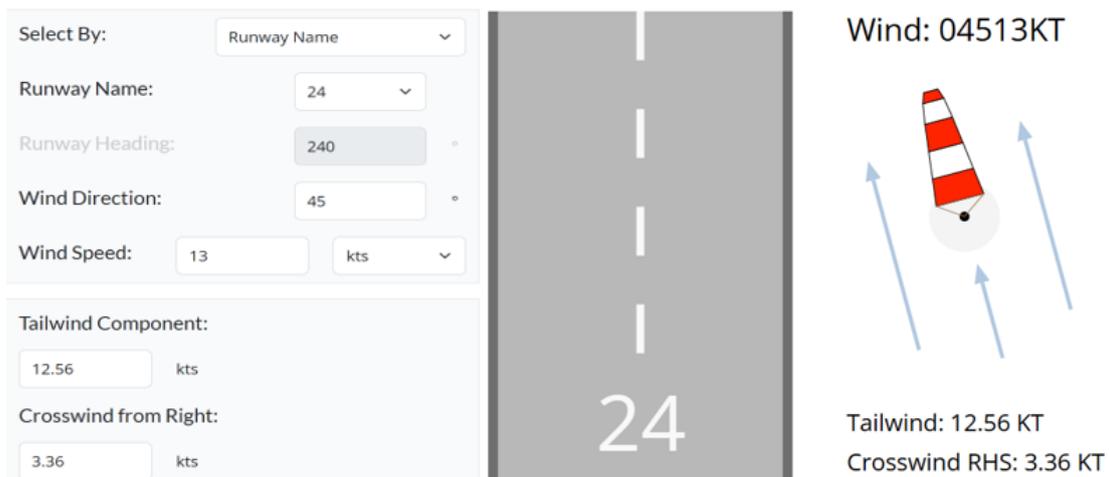
Figure 5: The windsock, associated wind conditions and crosswind component calculation on the day of the serious incident.

6. Strong weather conditions of approximately 13 kts with a tailwind component prevailed at the time of the flight as indicated by the windsock and as observed by the pilot; the weather was an attribute to this accident.
