## LIMITED OCCURRENCE INVESTIGATION REPORT – FINAL

<b>Reference Number</b>	CA18/3/2/1509						
<b>Classification</b>	Serious Incident		<b>Date</b>	3 October 2025		<b>Time</b>	0630Z
<b>Type of Operation</b>	Training (Part 141)						
<b>Location</b>							
Place of Departure	Morningstar Airfield, Western Cape Province		Place of Intended Landing	Morningstar Airfield, Western Cape Province			
Place of Occurrence	Runway 20 at Morningstar Airfield, Western Cape Province						
GPS Co-ordinates	Latitude	34° 45' 34.49" S	Longitude	018° 32' 57.79" E	Elevation	221 ft	
<b>Aircraft Information</b>							
Registration	ZU-IAZ						
Make; Model; S/N	Airplane Factory; Sling 2 (Serial Number: 069)						
Damage to Aircraft	Minor			Total Aircraft Hours	1 095.8		
<b>Pilot-in-command</b>							
Licence Type	Student Pilot Licence (SPL)		Gender	Male		Age	64
Licence Valid	Yes	Total Hours	33.6		Total Hours on Type	33.6	
Total Hours 30 Days	3.6		Total Flying on Type Past 90 Days	11.1

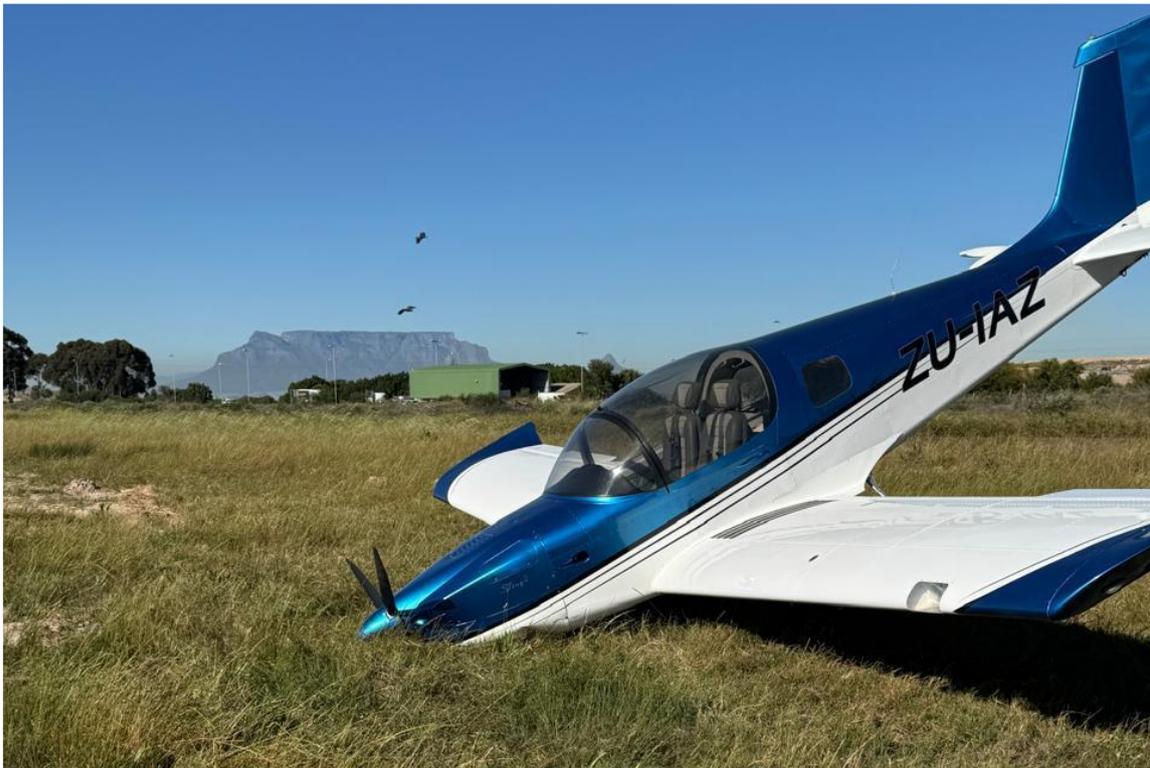
**Figure 2:** The aircraft at the serious incident site. (Source: Pilot)

2.6 The SP lost directional control of the aircraft during the take-off run in crosswind conditions. The aircraft veered off to left and exited the runway surface and onto the grass area. The nose gear strut broke, and the propeller blades made contact with the ground before the aircraft came to rest in a nose-down attitude. The pilot was not injured.

The aircraft veered off to the left of centreline and the pilot lost directional control of the aircraft which led to the subsequent excursion to the left of the runway.

The pilot did not compensate for the crosswind during take-off.

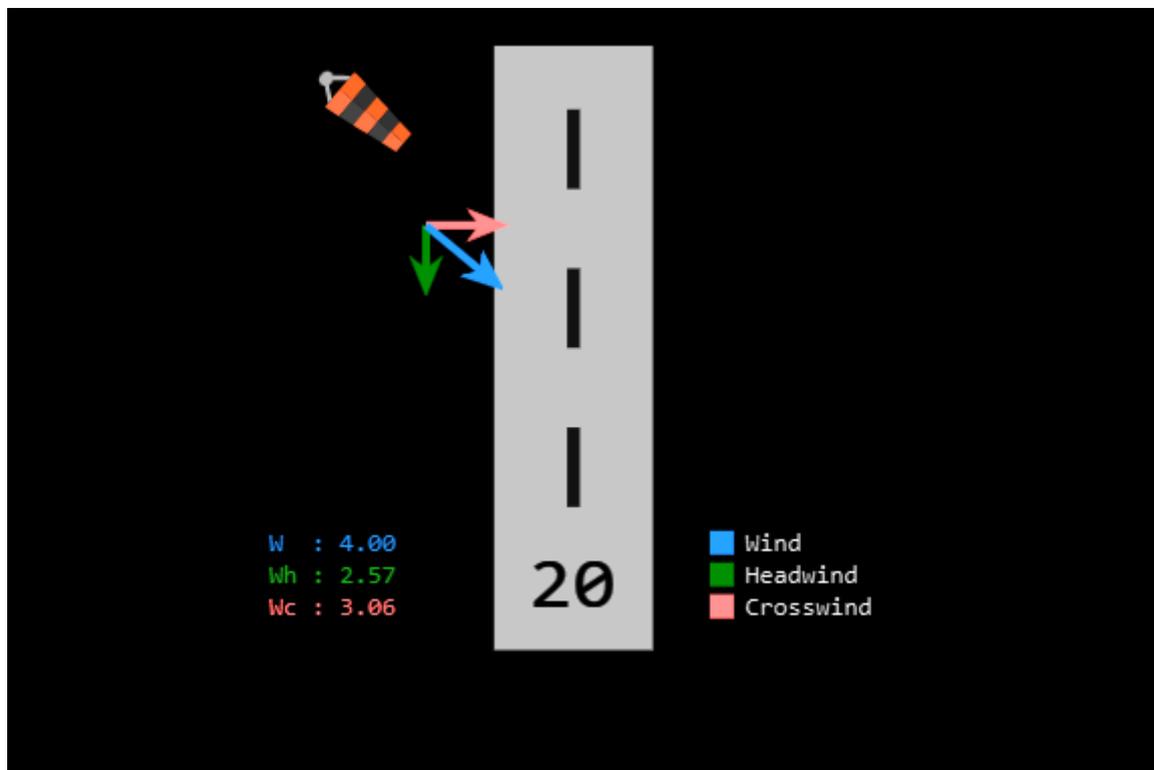
**Figure 3:** The wind component at take-off. (Source: <https://e6bx.com/wind-components/>)

3.1 The weather was a contributory factor to this serious incident with an average left crosswind of 3 knots.
