LIMITED OCCURRENCE INVESTIGATION REPORT – FINAL

Reference Number	CA18/3/2/1510						
Classification	Serious Incident		Date	4 October 2025		Time	0740Z
Type of Operation	Private (Part 94)						
Location							
Place of Departure	Mossel Bay Aerodrome (FAMO), Western Cape Province		Place of Intended Landing		Highway Airfield, Western Cape Province		
Place of Occurrence	Runway 31, Highway Airfield near Knysna, Western Cape Province						
GPS Co-ordinates	Latitude	33° 57' 01.26" S	Longitude	022° 58' 42.60" E	Elevation	787 ft	
Aircraft Information							
Registration	ZU-EGF						
Make; Model; S/N	Jabiru J430 (Serial Number: 299)						
Damage to Aircraft	Minor			Total Aircraft Hours	1 345.0		
Pilot-in-command							
Licence Type	Private Pilot Licence (PPL)		Gender	Female		Age	58
Licence Valid	Yes	Total Hours	160.7		Total Hours on Type	67.6	
Total Hours 30 Days	11.5		Total Flying on Type Past 90 Days		28		
People On-board	1 + 1	Injuries	0	Fatalities	0	Other (on ground)	0

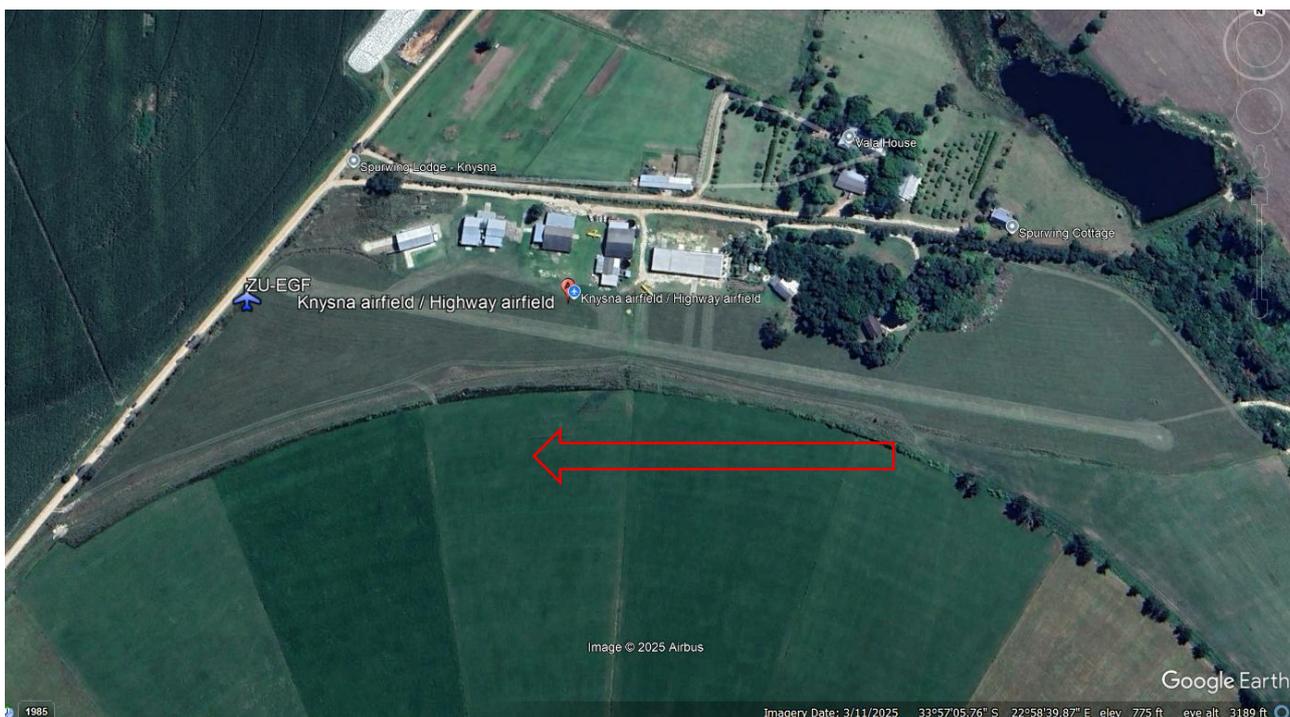
Figure 1: An aerial view of the Highway Airfield and the approximate serious incident site. The red arrow indicates the direction of flight. (Source: Google Earth)

2.5 The pilot landed the aircraft close to the end of the grass runway whilst attempting to execute a short-field landing. There was insufficient runway length available to bring the aircraft to a stop on the runway. The pilot steered the aircraft to the left of the runway to avoid impacting a perimeter fence; the aircraft came to rest in dense grass to the left of the runway.

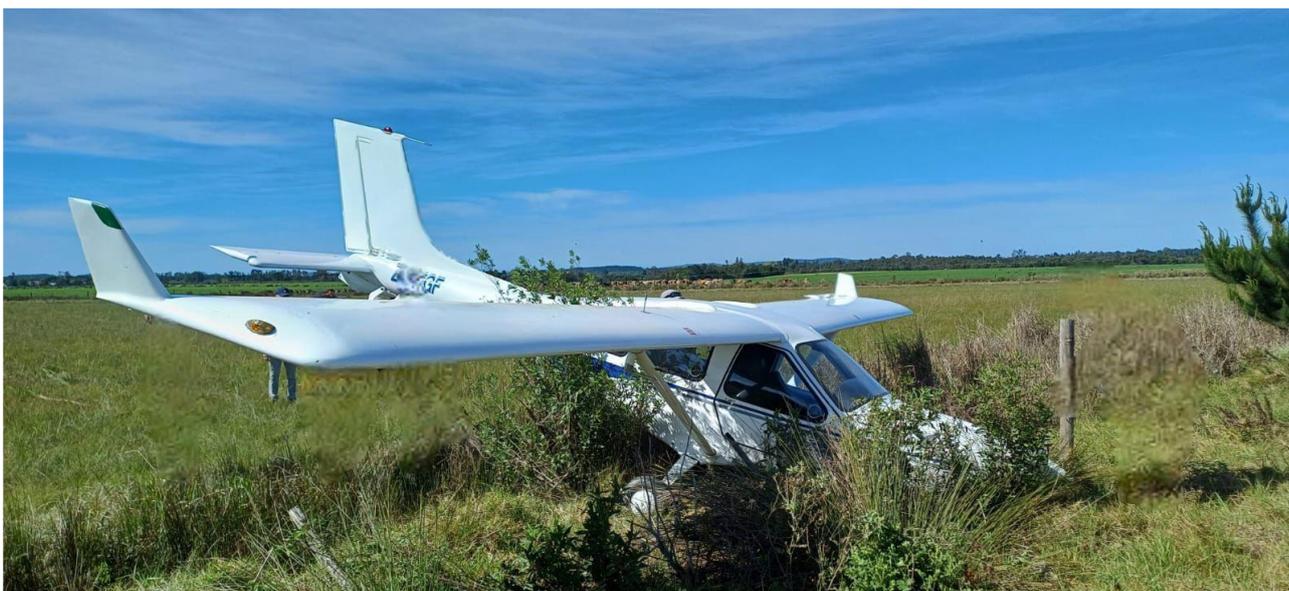
The pilot stated that she turned left and exited the runway to avoid impacting a perimeter fence that was beyond the end of the runway. As the aircraft exited the runway, the nose gear broke off, and the propeller blades struck the ground. The aircraft came to a stop on dense grass to the left of the runway. A video footage from the airfield showed the aircraft as it landed close to the end of the runway before it drifted to the left.

The two occupants were not injured, but the aircraft sustained damage to the nose gear, propeller blades, right main gear and right wing.

Figure 2: The aircraft after it had stopped. (Source: Pilot)

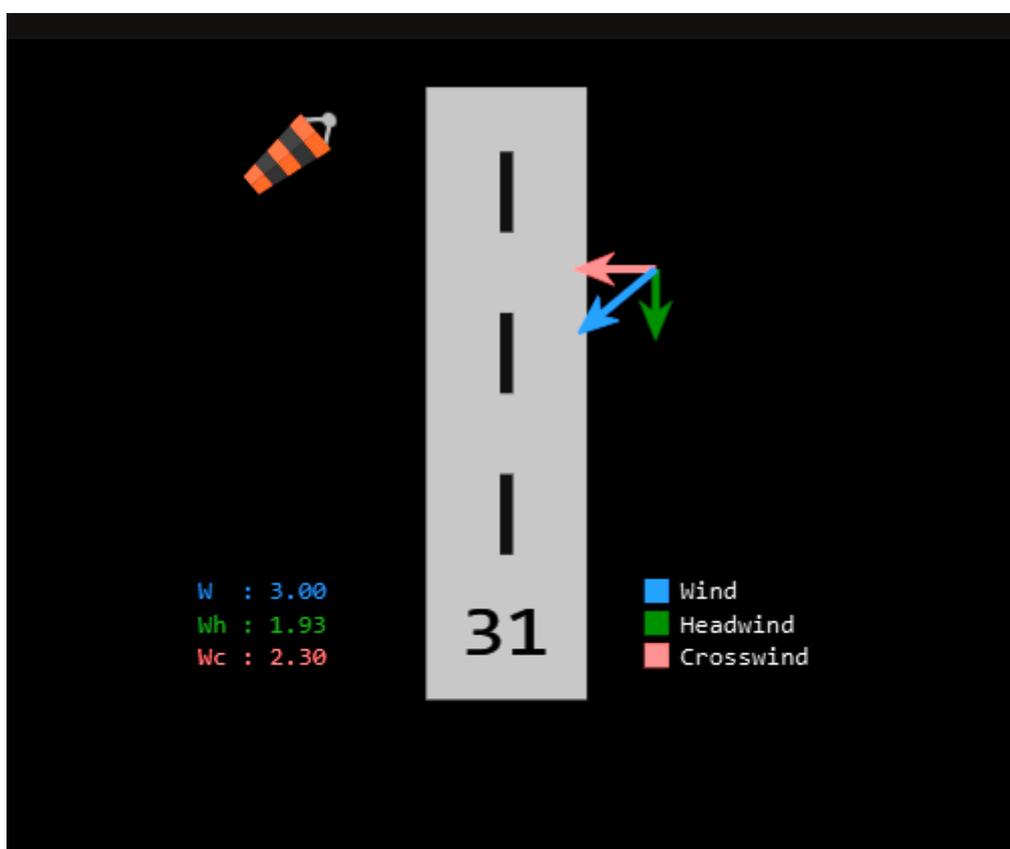
Figure 3: The wind component during the landing phase. (Source: <https://e6bx.com/wind-components/>)

3.1 The wind was light at the time; the weather was not a contributory factor to this serious incident.
