LIMITED OCCURRENCE INVESTIGATION REPORT – FINAL

Reference Number	CA18/3/2/1511						
Classification	Serious Incident		Date	11 October 2025		Time	0754Z
Type of Operation	Training (Part 141)						
Location							
Place of Departure	Ultimate Heliport, Midrand, Gauteng Province		Place of Intended Landing	Grand Central Airport (FAGC), Gauteng Province			
Place of Occurrence	Approximately 1 kilometre (km) east of Ultimate Heliport, Midrand, Gauteng Province						
GPS Co-ordinates	Latitude	26°01'39" S	Longitude	28°06'40" E	Elevation	4 843ft	
Aircraft Information							
Registration	ZS-RMN						
Make; Model; S/N	Robinson, R44 Raven II (Serial Number: 0910)						
Damage to Aircraft	Minor		Total Aircraft Hours	7 290.7			
Pilot-in-command							
Licence Type	Commercial Pilot Licence (CPL) H		Gender	Male		Age	49
Licence Valid	Yes	Total Hours	445.8		Total Hours on Type	328.3	
Total Hours 30 Days	31		Total Flying on Type Past 90 Days	102.9			
People On-board	2+0	Injuries	0	Fatalities	0	Other (on the ground)	0

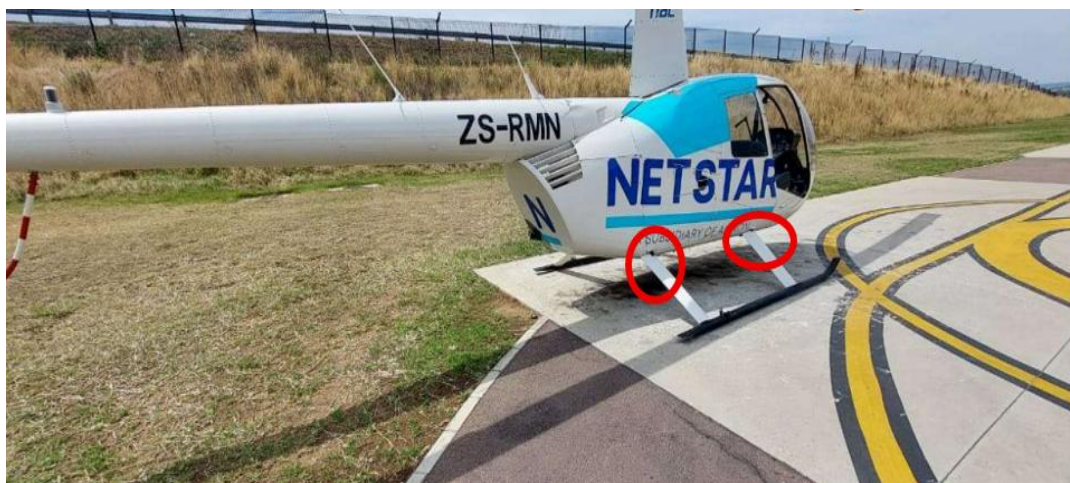
The helicopter rapidly lost height and the FI instantly took control and initiated an emergency landing. The FI flared the helicopter but (helicopter) it landed hard on the grass-covered area, approximately 1 kilometre (km) east Ultimate Heliport facility. The FI switched off the engine, and the pair disembarked from the helicopter; they were not injured. The FI inspected the helicopter and noticed minor damage to the skid landing gears which had stretched out slightly due to overload. Later, the FI restarted the engine and flew back to Ultimate Heli facility. The helicopter landed safely on helipad 14.

Figure 1: Red circles indicate minor damage on the helicopter's upper portions of the landing gear skids caused by overload. (Source: Operator)
