## LIMITED OCCURRENCE INVESTIGATION REPORT – FINAL

<b>Reference Number</b>	CA18/3/2/1512						
<b>Classification</b>	Serious Incident	<b>Date</b>	13 October 2025		<b>Time</b>	0813Z	
<b>Type of Operation</b>	Private (Part 91)						
<b>Location</b>							
Place of Departure	Virginia Aerodrome (FAVG), KwaZulu-Natal Province	Place of Intended Landing	Mkambati Airfield, Eastern Cape Province				
Place of Occurrence	Runway 03 at Mkambati Airfield, Eastern Cape Province						
GPS Co-ordinates	Latitude	31°17'07.40"S	Longitude	029°59'17.50" E	Elevation	360ft	
<b>Aircraft Information</b>							
Registration	ZS-PEN						
Make; Model; S/N	Cessna 210M Centurion II (Serial Number: 210-62204)						
Damage to Aircraft	None		Total Aircraft Hours	5 202.8			
<b>Pilot-in-command</b>							
Licence Type	Commercial Pilot Licence (CPL)		Gender	Male		Age	27
Licence Valid	Yes	Total Hours	1 110.0		Total Hours on Type	20.4	
Total Hours 30 Days	5.5		Total Flying on Type Past 90 Days	5.5

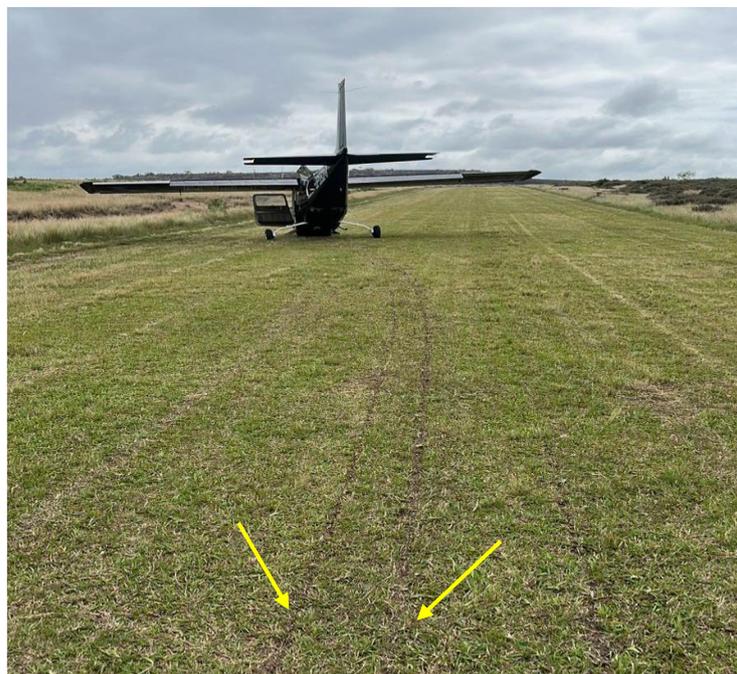
**Figure 2:** The aircraft at the serious incident site and the witness marks of the propeller blades (yellow arrows). (Source: Pilot)

The nose landing gear collapsed during the landing roll on the grass-covered Runway 03 at Mkambati Airfield, consequently, the propeller blades struck the ground. The cause was undetermined.

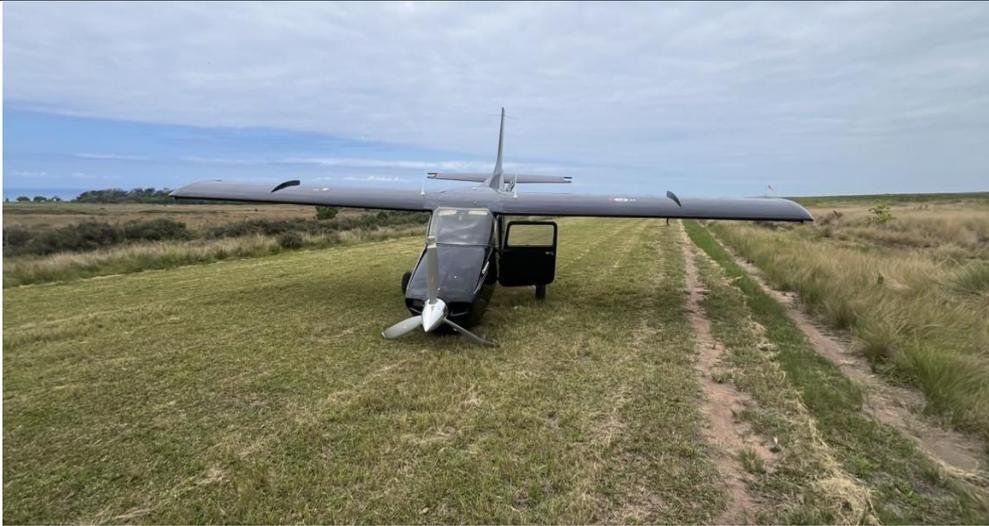
**Figure 3:** The front view of the aircraft at the serious incident site. (Source: Pilot)

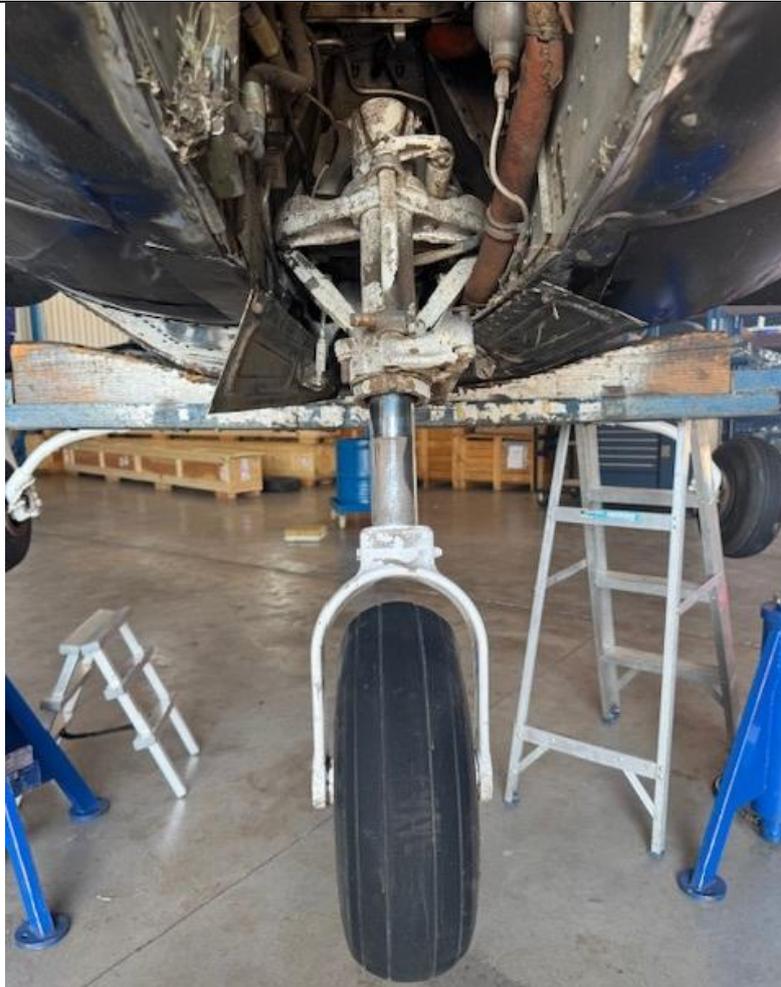
On Friday morning, 24 October 2025, the investigation team drove to the AMO facility where the aircraft was stored. The aircraft was placed on jacks (see Figure 5) and visual inspection of the landing gear and wheel-well area revealed nothing abnormal. External power was connected to the aircraft fuselage, and the ignition was turned on. Multiple retraction and extension checks which included inspection of the landing gear warning system were conducted IAW the aircraft maintenance manual (AMM); no faults were found. In addition, the landing gear unsafe warning system operated normal IAW the AMM. Each time the landing gear lever was selected to the down position, it locked into position with no signs of misrigging. The nose gear down lock pins and indication switches showed no signs of anomaly. The landing gear was later retracted and all three gears retracted in their respective wheel-wells. The manual extension test was conducted using the hand-handle and all three landing gears extended and locked into position; therefore, the cause of the nose gear collapse could not be determined.

**Figure 4:** The extended and locked into position nose landing gear.

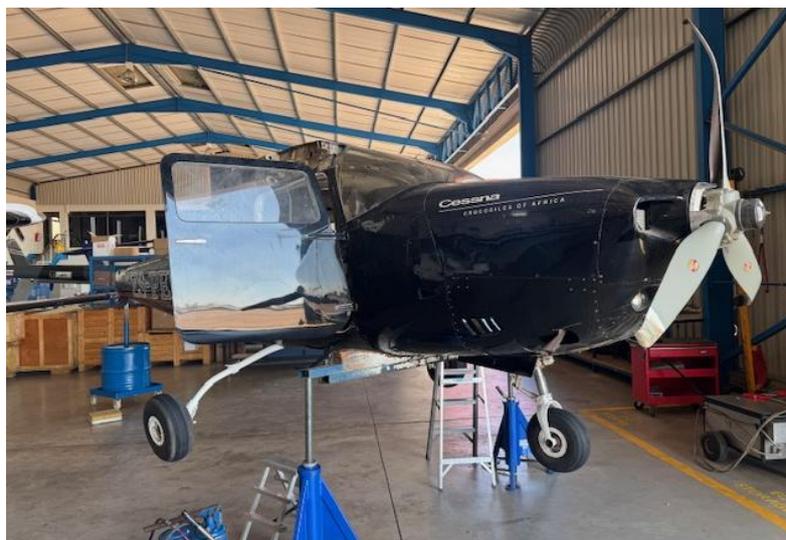
**Figure 5:** The aircraft on jacks with all three main landing gears in down and locked position.
