**LIMITED OCCURRENCE INVESTIGATION REPORT – FINAL**

<b>Reference Number</b>	CA18/3/2/1513					
<b>Classification</b>	Serious Incident	<b>Date</b>	16 October 2025		<b>Time</b>	0700Z
<b>Type of Operation</b>	Training (Part 141)					
<b>Location</b>						
<b>Place of Departure</b>	Lydenburg Aerodrome (FALL), Mpumalanga Province		<b>Place of Intended Landing</b>	Lydenburg Aerodrome (FALL), Mpumalanga Province		
<b>Place of Occurrence</b>	On a field which is the extension of the centreline of Runway 04 at Lydenburg Aerodrome					
<b>GPS Co-ordinates</b>	<b>Latitude</b>	25°06'57.02" S	<b>Longitude</b>	030°24'33.37" E	<b>Elevation</b>	4 890 feet
<b>Aircraft Information</b>						
<b>Registration</b>	ZU-FXH					
<b>Make; Model; S/N</b>	Micro Aviation SA; Bat Hawk (Serial Number: MA12-11)					
<b>Damage to Aircraft</b>	Substantial		<b>Total Aircraft Hours</b>	1 374.7		
<b>Pilot-in-command</b>						
<b>Licence Type</b>	Recreational Student Pilot Licence		<b>Gender</b>	Male		<b>Age</b> 45

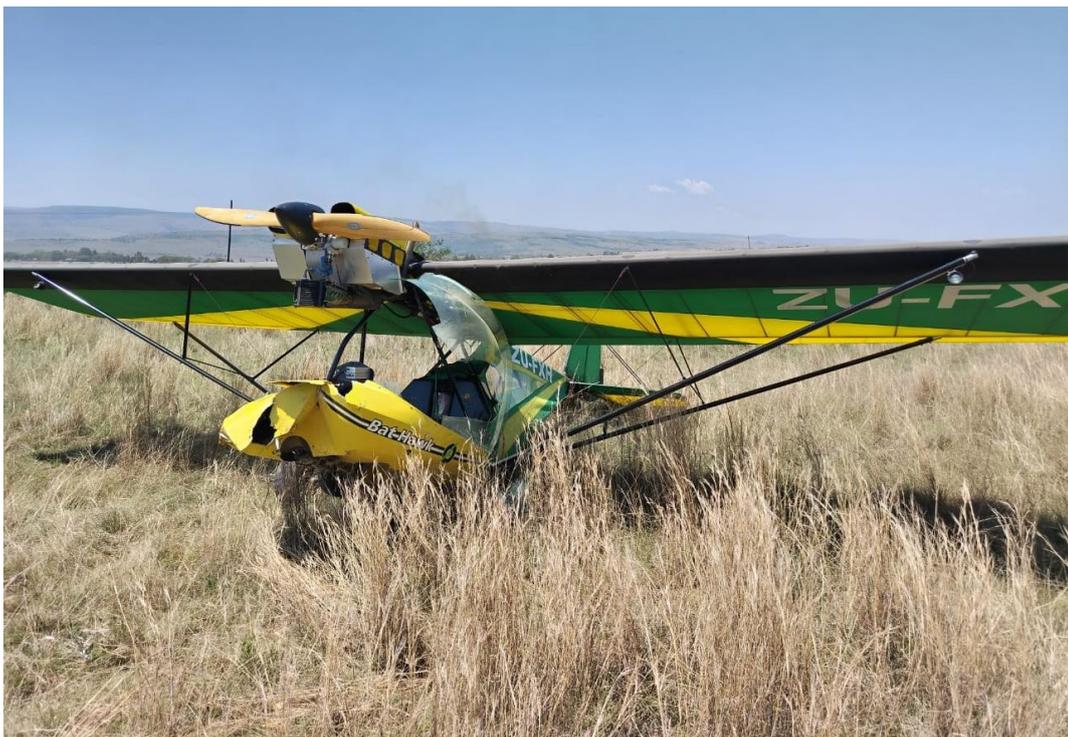
**Figure 2:** The aircraft after it had come to rest. (Source: Pilot)

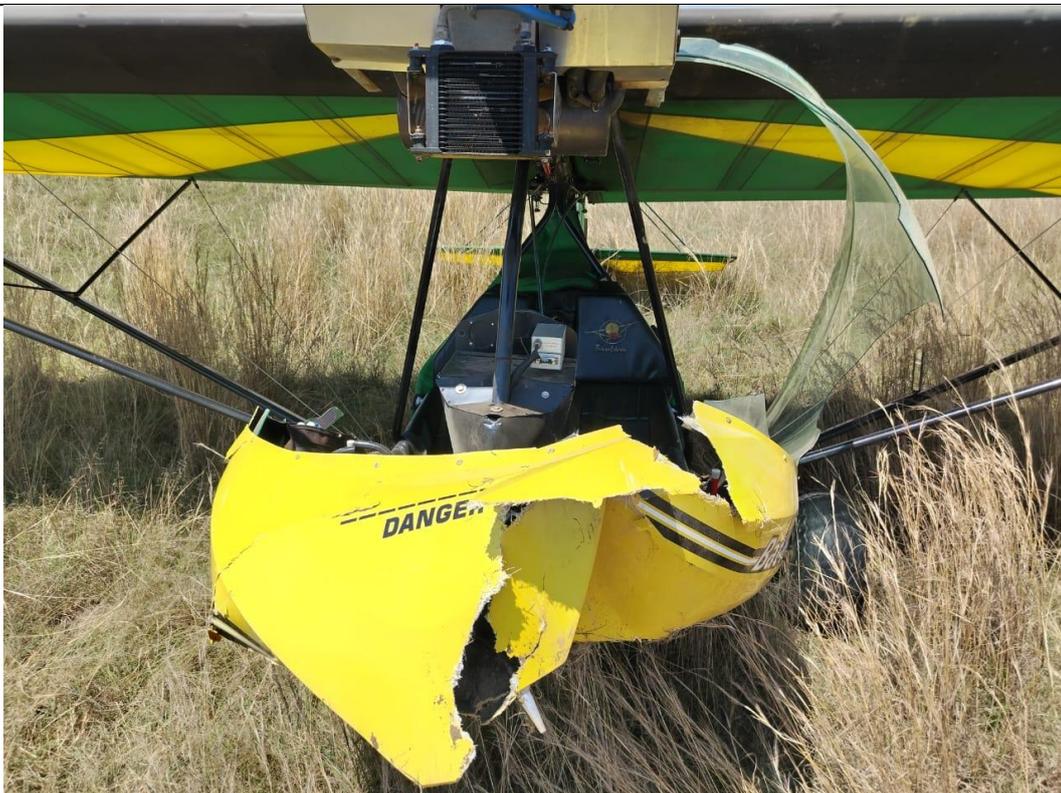
**Figure 3:** The front view of the aircraft. (Source: Pilot)

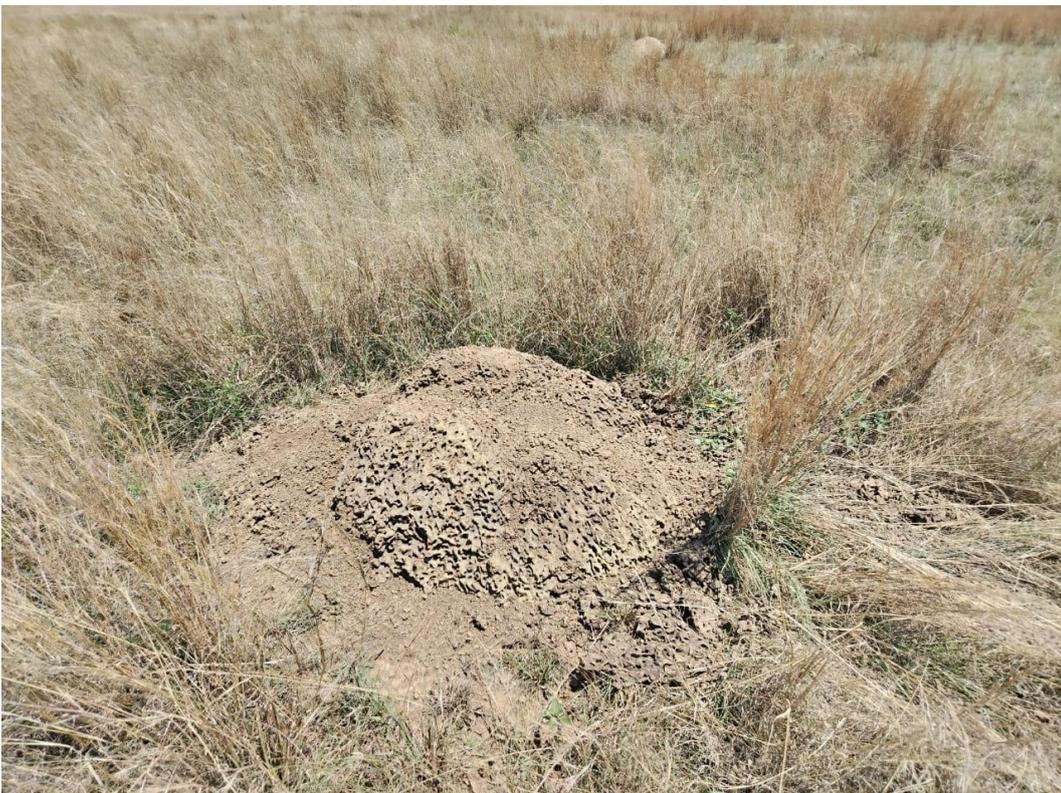
**Figure 4:** The anthill with which the aircraft impacted. (Source: Pilot)

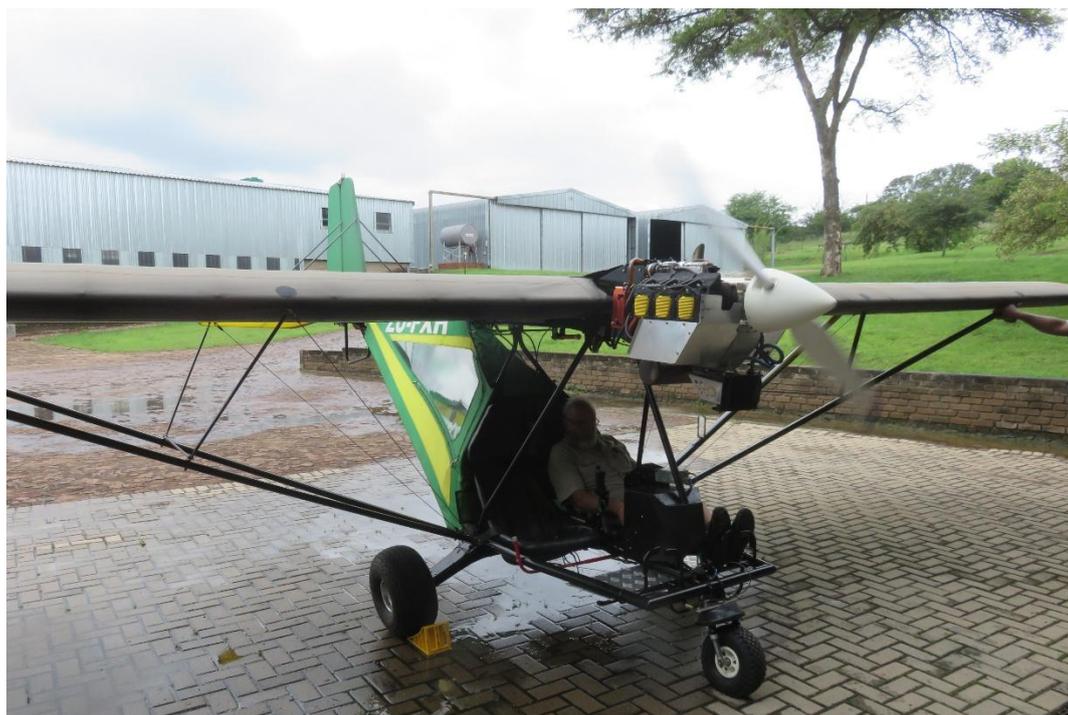
An engine ground run was conducted with the engine still secured to the airframe. The engine started without difficulty and kept running until the oil pressure and temperature had stabilised. The throttle was then advanced to approximately 2 000 revolutions per minute (RPM) and held at this setting for a few minutes; thereafter, the engine was throttled back to ground idle and then shut down. The cylinder differential pressures (blow-by) were taken for all six cylinders; all six readings were within the normal operating range between 77 and 73 over 80 pounds per square inch (psi). (*Blow-byes is an inherent byproduct of all internal combustion engines, including those on aircraft. It refers to the leakage of a small amount of combustion gases from the cylinder, past the piston rings, into the crankcase.*)

**Figure 5:** The aircraft during the engine ground run.

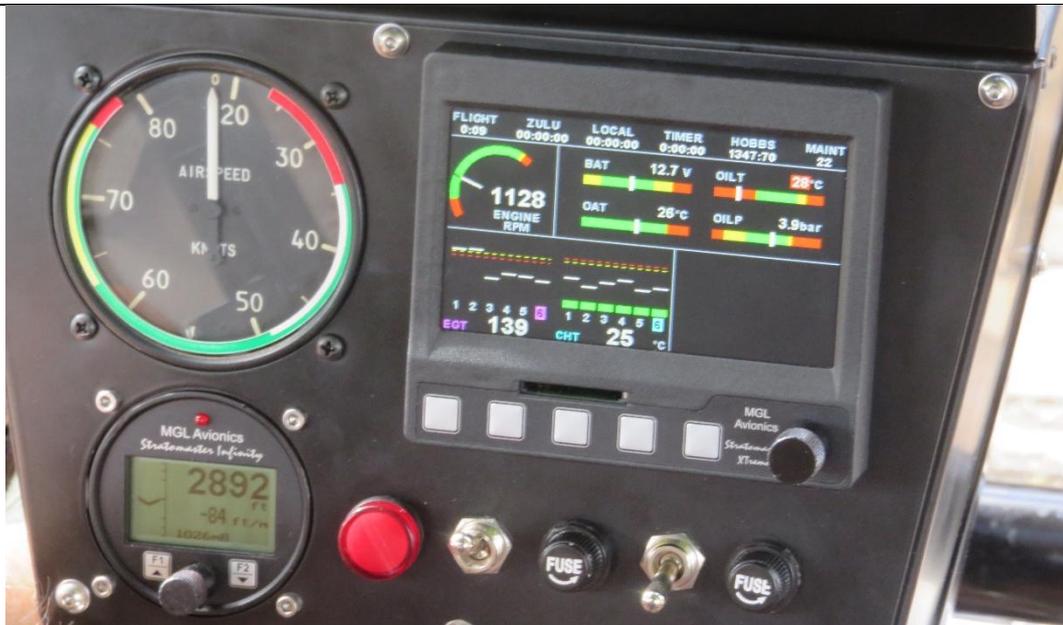
**Figure 6:** The engine monitoring display during the ground run.
