LIMITED OCCURRENCE INVESTIGATION REPORT – FINAL

Reference Number	CA18/3/2/1514						
Classification	Serious Incident		Date	4 November 2025		Time	0950Z
Type of Operation	Training (Part 141)						
Location							
Place of Departure	Bram Fischer International Airport, (FABL) Free State Province			Place of Intended Landing	New Tempe Aerodrome (FATP), Free State Province		
Place of Occurrence	On Runway 28 at New Tempe Aerodrome (FATP)						
GPS Co-ordinates	Latitude	29° 01' 48.33" S	Longitude	026° 09' 49.64" E	Elevation	4 501 ft	
Aircraft Information							
Registration	ZU-IEI						
Make; Model; S/N	Airplane Factory; Sling 2 (Serial Number: 159)						
Damage to Aircraft	Minor			Total Aircraft Hours	4 145.4		
Pilot-in-command							
Licence Type	Student Pilot Licence (SPL)		Gender	Male		Age	47
Licence Valid	Yes	Total Hours	44.1		Total Hours on Type	44.1	
Total Hours 30 Days	16.6			Total Flying on Type Past 90 Days	16.6		
People On-board	1 + 0	Injuries	0	Fatalities	0	Other (on ground)	0

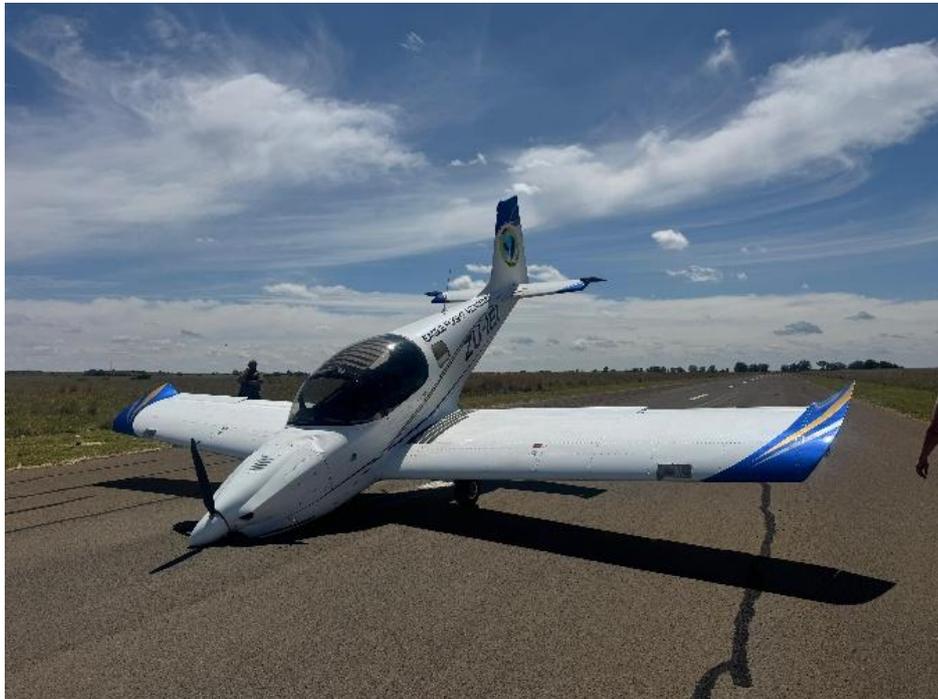
control. The aircraft skidded for approximately 7 metres (m) before it stopped on the runway. The SP was not injured. The aircraft sustained damage to the nose wheel and the propeller.

Figure 1: The aircraft with the collapsed nose wheel after it had come to rest.

5. The aircraft Certificate of Release to Service (CRS) was issued on 23 September 2029 at 4 071.7 hours with an expiry date of 22 September 2026 or at 4 171.7 hours, whichever comes first.
Probable Cause(s)
The propeller impacted the runway surface and the nose wheel collapsed inwards due to the student pilot's overcorrection using the right rudder which caused excessive side-loading and the subsequent loss of directional control. The student pilot had steered the aircraft to the left to avoid impacting a deer during the landing phase.
Contributing Factor(s)
None.
Safety Action(s)
None.
Safety Message and/or Safety Recommendation/s
None.
About this Report
<i>The decision to conduct a limited investigation is based on factors including whether the cause is known and the evidence supporting the cause is clear, the level of safety benefit likely to be obtained from an investigation and that will determine the scope of an investigation. For this occurrence, a limited investigation has been conducted, and the Accident and Incident Investigations Division (AIID) has relied on the information submitted by the affected person/s and organisation/s to compile this limited report. The report has been compiled using information supplied in the initial notification, as well as from follow-up desk top enquiries to bring awareness of potential safety issues to the industry in respect of this occurrence, as well as possible safety action/s that the industry might want to consider in preventing a recurrence of a similar occurrence.</i>
