LIMITED OCCURRENCE INVESTIGATION REPORT – FINAL

Reference Number		CA18/3/2/1518								
Classification		Serious Incident		Date	27 December 2025		Time	0425Z		
Type of Operation			Private (Part 91)							
Location										
Place of Departure		Bram Fischer International Airport (FABL), Free State Province			Place of Intended Landing		Wonderboom Airport (FAWB), Gauteng Province			
Place of Occurrence		Runway 11 Wonderboom Airport (FAWB)								
GPS Co-ordinates		Latitude	25° 39' 19.00" S		Longitude	028° 13' 25.00" E		Elevation	4 095ft	
Aircraft Information										
Registration		ZS-NTT								
Make; Model; S/N		Beechcraft; King Air B200 (Serial Number: BB-350)								
Damage to Aircraft		Substantial			Total Aircraft Hours		9 056.9			
Pilot-in-command										
Licence Type		Airline Transport Pilot Licence (ATPL)			Gender	Male		Age	31	
Licence Valid		Yes		Total Hours	5 314		Total Hours on Type		14	
Total Hours 30 Days		27			Total Flying on Type Past 90 Days		66

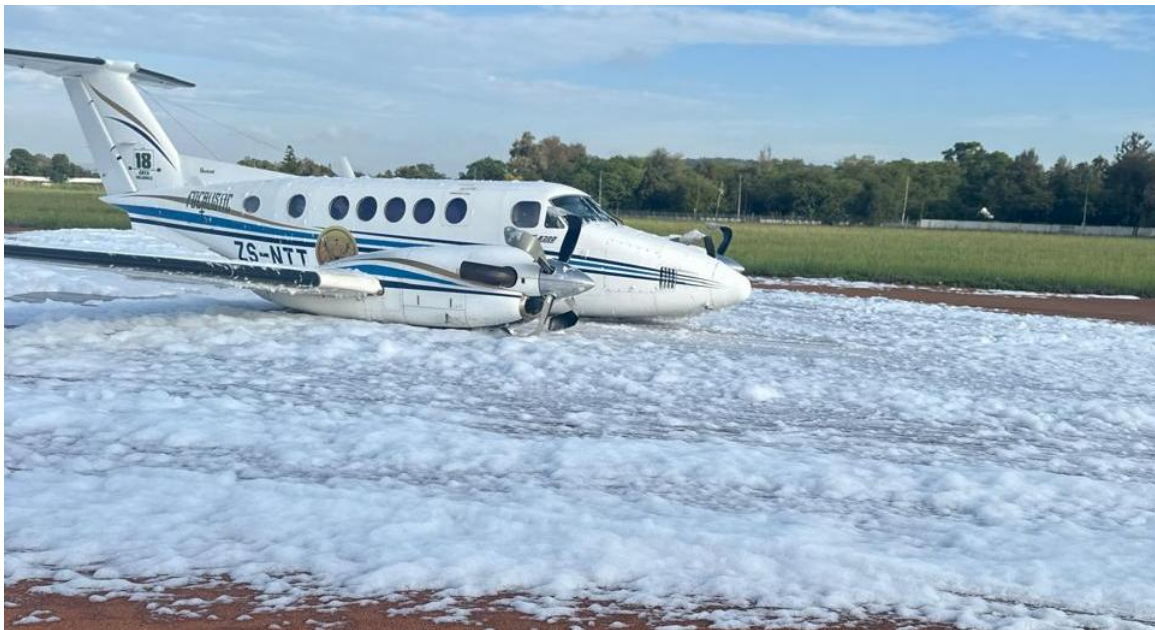
Figure 2: The fire-retardant foam sprayed on the runway during the serious incident. (Source: Operator)

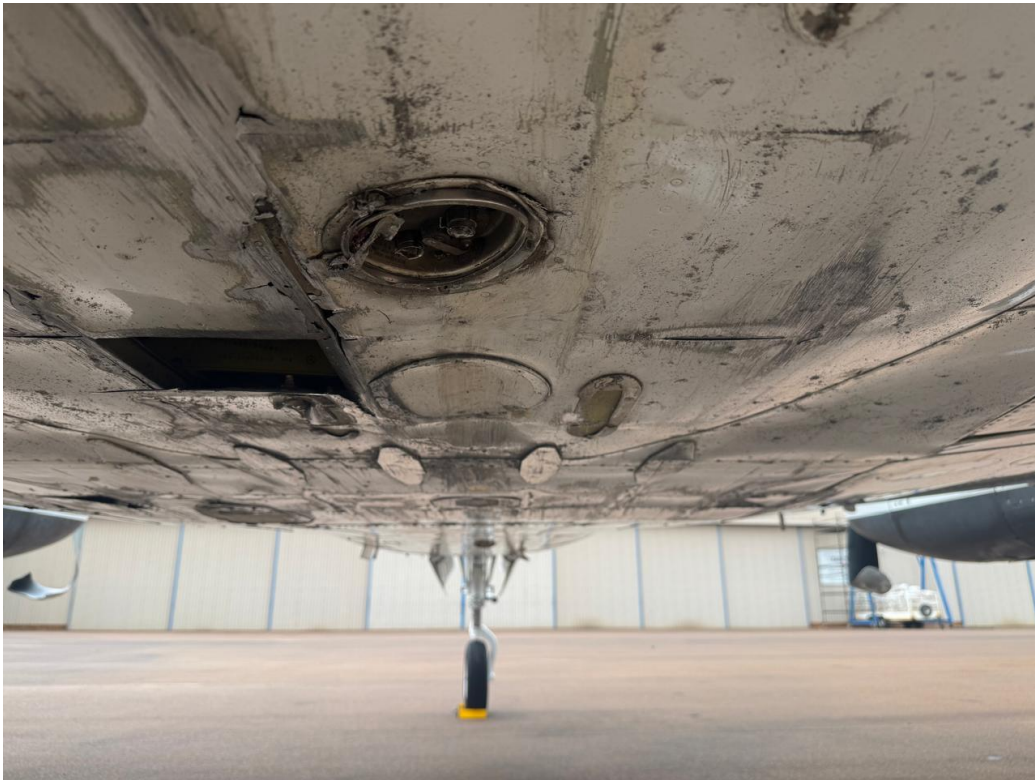
The pilot followed the redundancy (manual) gear extension method but could not get the left main landing gear to extend to down and locked position. Whilst circling above FAWB vicinity, he contacted FAWB Aircraft Rescue and Firefighting (ARFF) personnel who responded to the active Runway 11 and sprayed fire-retardant foam to prevent a possible fire when the pilot conducts a belly landing. At approximately 0420Z, the aircraft approached Runway 11 and the pilot performed a belly landing. The aircraft sustained substantial damage; the radio antennas and the underside airframe panels abraded and both propellers sustained rotational contact damage after striking the runway surface. The pilot and the passengers were not injured.

Figure 3: Abraded underbelly.

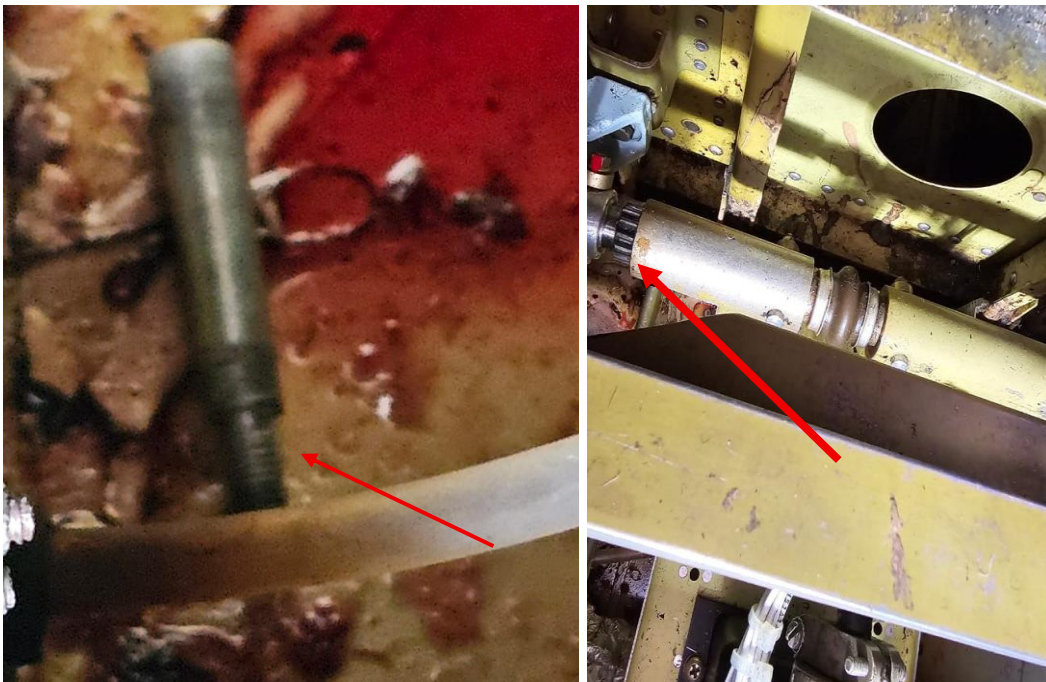
After the examination of the landing gear system at the site, accessed through the main cabin floor panels, the investigator-in-charge (IIC) found that the nut which secures the pin that connects the left main landing gear torque shaft to the motor gearbox was missing; consequently, the shaft detached from the gearbox motor, disabling the left gear from extending to the down and locked position when selected.

Figures 4 and 5: The detached left main landing gear torque shaft pin (left picture). The red arrow indicates the area where the shaft had separated and the exposed torque tube support bearing (right picture).

<u>Conclusion</u>
1.10 The pin which secured the left main landing gear torque shaft to the landing gearbox motor had dislodged due to the missing nut. The left main landing gear torque shaft separated from the landing gear motor located in the cockpit under floorboards and forward of the main spar. Consequently, the left main landing gear could not extend, and the pilot performed a belly landing after a fire-retardant foam was sprayed on Runway 11.
Probable Cause(s)
The left main landing gear failed to extend because of the pin that had dislodged due to the nut that was missing, resulting in the separation of the torque shaft from the landing gear motor. The aircraft landed with the retracted undercarriage at FAWB Runway 11.
Contributing Factor(s)
Inadequately secured left main landing gear torque shaft during maintenance.
Safety Action(s)
None.
Safety Message and/or Safety Recommendation/s
None.

The left main gear torque shaft was temporarily secured, and the aircraft was recovered to an aircraft maintenance organisation (AMO) for further engineering examination. Nothing abnormal was noted on the right main landing gear and the nose gear systems. The aircraft was placed on jacks, and a loaner pin and nut were fitted to the left main landing gear torque shaft in accordance with (IAW) the aircraft maintenance manual (AMM). The gear was cycled and it operated normally. All three down and locked indication lights illuminated after the gear lever was selected to the down position.

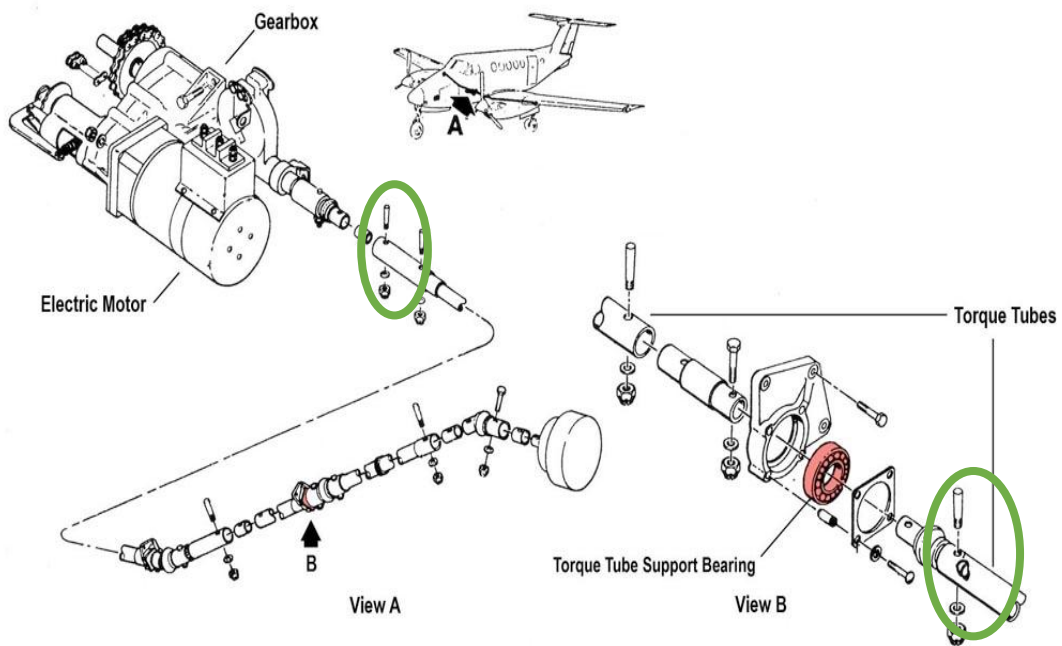
Illustration 2: A breakdown of the main gear retraction mechanism detailing the torque shaft and gearbox arrangement. The green circles indicate the pin that was found as well as the nut that was missing.
