LIMITED OCCURRENCE INVESTIGATION REPORT – FINAL

Reference Number	CA18/3/2/1519						
Classification	Serious Incident		Date	5 January 2026		Time	1600Z
Type of Operation	Private (Part 94)						
Location							
Place of Departure	Potchefstroom Airfield (FAPS), North West Province		Place of Intended Landing	Potchefstroom Airfield (FAPS), North West Province			
Place of Occurrence	On Runway 03 at Potchefstroom Airfield (FAPS), North West Province						
GPS Co-ordinates	Latitude	26° 38' 28.31" S	Longitude	27° 11' 0.16" E	Elevation	5 420 ft	
Aircraft Information							
Registration	ZU-IMY						
Make; Model; S/N	Van's; RV-7 (Serial Number: 71031)						
Damage to Aircraft	Substantial			Total Aircraft Hours	376.9		
Pilot-in-command							
Licence Type	Private Pilot Licence (PPL)		Gender	Female		Age	48
Licence Valid	Yes	Total Hours	208.7		Total Hours on Type	28.9	
Total Hours 30 Days	1.8		Total Flying on Type Past 90 Days	3.9			
People On-board	1+1	Injuries	0	Fatalities	0	Other (on ground)	0

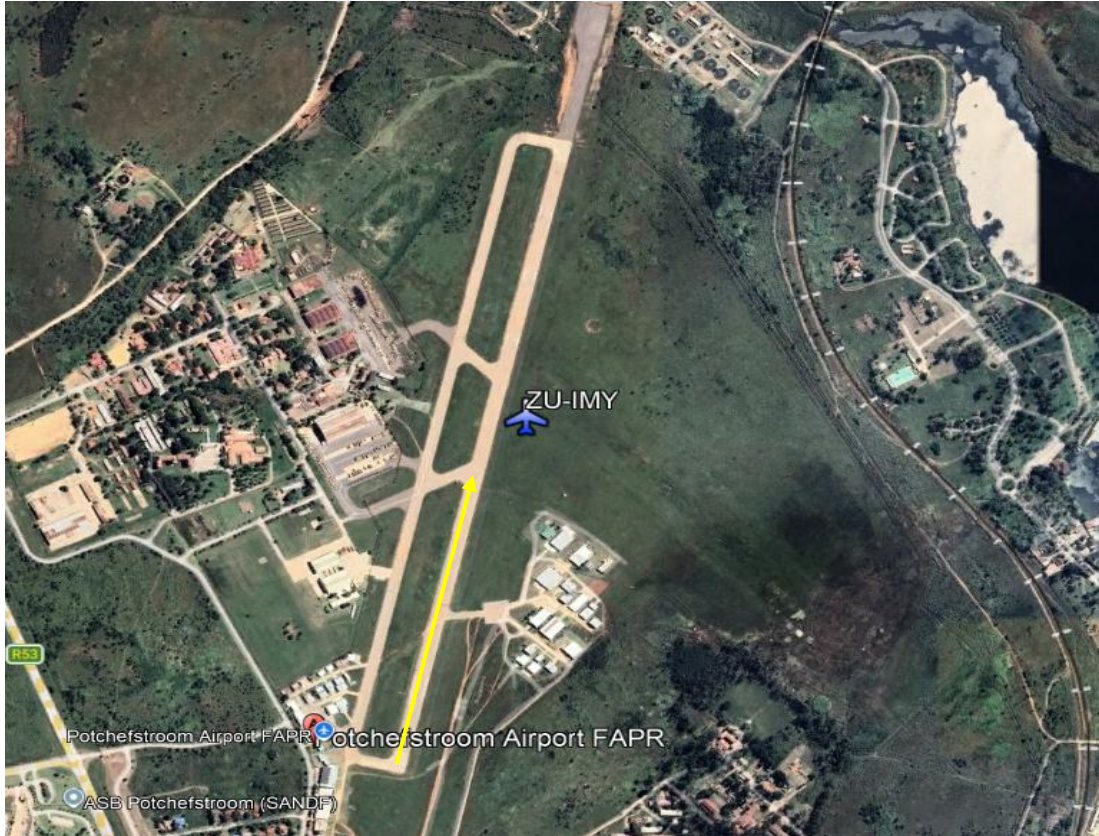
Figure 1: The runway used (yellow line) and the approximate area where the aircraft stopped on the right side of the runway. (Source: Google Earth)

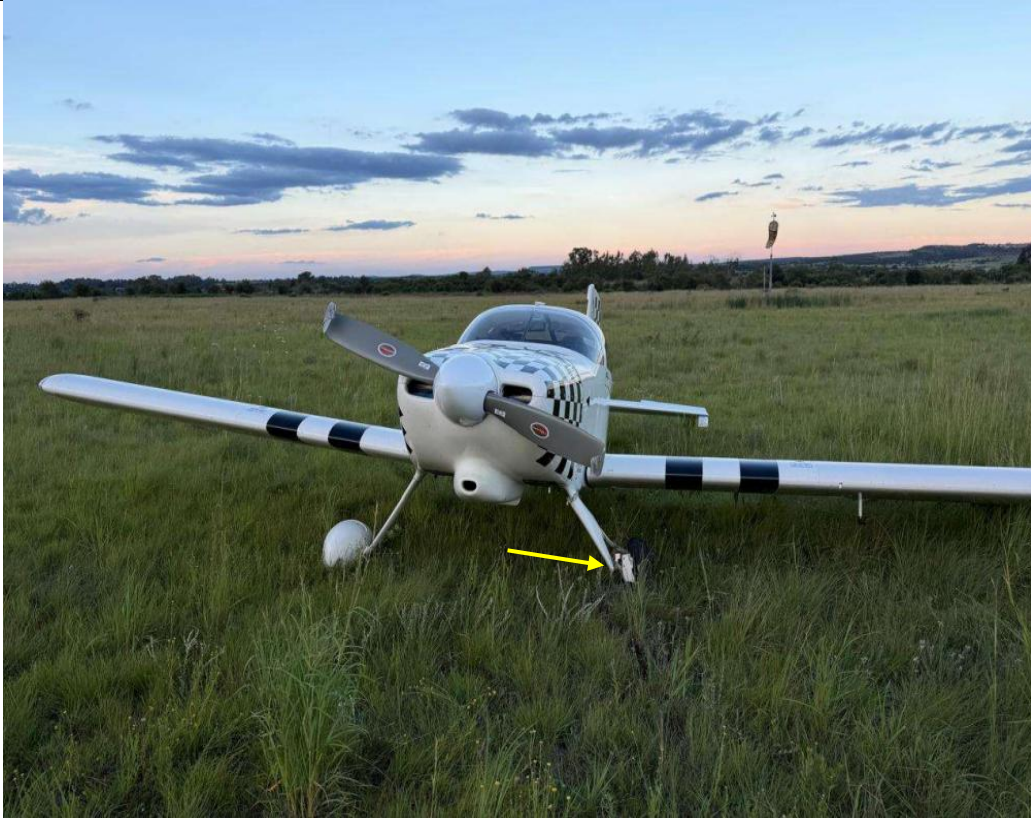
opposite direction (which is the right side of the runway) during which the nose pitched down. This resulted in propeller strikes on the ground. The aircraft exited the runway and came to a stop on the grass area. No person was injured; the aircraft sustained damage to the propeller and the left main landing gear.

Figure 2: The aircraft with the bent left main landing gear at the serious incident site. (Source: Pilot)

The aircraft was unstable during approach, and it landed deep; consequently, the pilot lost directional control of the aircraft, and it veered off to the right side of the runway.
