**LIMITED OCCURRENCE INVESTIGATION REPORT – FINAL**

<b>Reference Number</b>	CA18/3/2/1520						
<b>Classification</b>	Serious Incident		<b>Date</b>	6 January 2026		<b>Time</b>	1030Z
<b>Type of Operation</b>	Training (Part 141)						
<b>Location</b>							
Place of Departure	Wonderboom Airport (FAWB), Gauteng Province		Place of Intended Landing	Wonderboom Airport (FAWB), Gauteng Province			
Place of Occurrence	On Runway 34 at Rustenburg Airfield (FARG), North West Province						
GPS Co-ordinates	Latitude	23° 38' 28" S	Longitude	27° 15' 47" E	Elevation	3 674ft	
<b>Aircraft Information</b>							
Registration	ZS-SGI						
Make; Model; S/N	Piper; PA-28-140 Cherokee (Serial Number: 28-26096)						
Damage to Aircraft	Substantial			Total Aircraft Hours	7 853.8		
<b>Pilot-in-command</b>							
Licence Type	Student Pilot Licence (SPL)		Gender	Male		Age	28
Licence Valid	Yes	Total Hours	46		Total Hours on Type	46	
Total Hours 30 Days	1.7		Total Flying on Type Past 90 Days	13.6

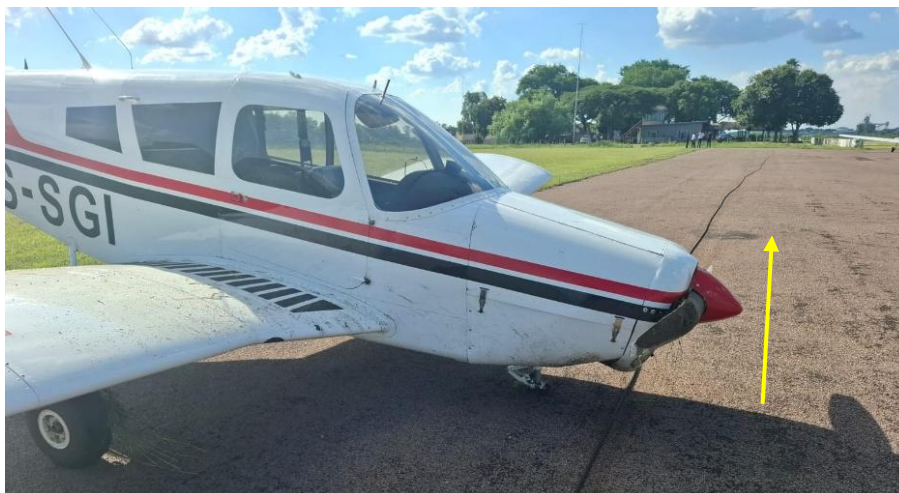
landed hard with the nose wheel first. Thus, the nose gear strut broke, and the propeller struck the runway surface. The aircraft skidded on its nose gear oleo and, later, stopped on the left side of the runway. Thereafter, the SP switched off the master switch and disembarked from the aircraft; he was not injured. The aircraft was substantially damaged.

**Figure 2:** The aircraft on the left side of the runway with the yellow arrow indicating the direction of landing. (Source: Operator)

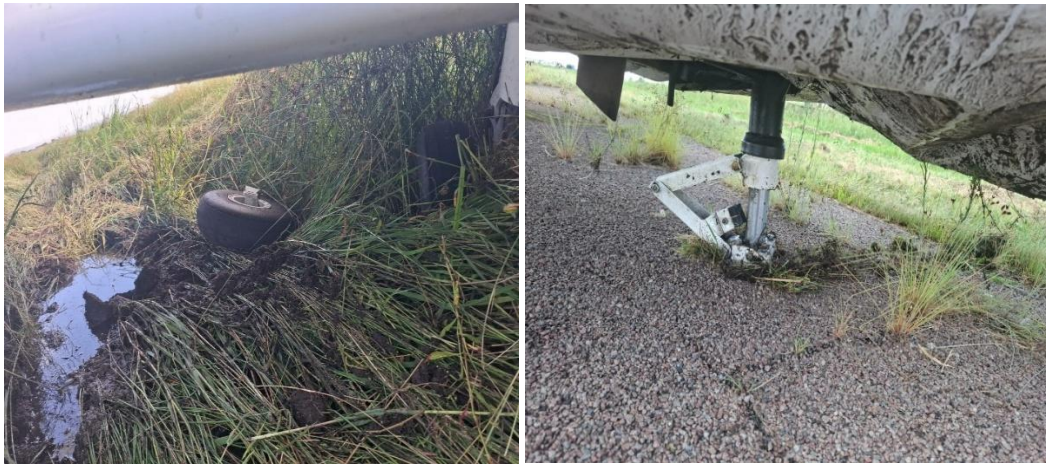
**Figures 3 and 4:** The broken bottom part of the nose gear with the nose wheel still secured to the axle (left picture). The top part of the nose gear strut with the torque link still attached to the oleo (right picture).  
(Source: Operator)
