## LIMITED OCCURRENCE INVESTIGATION REPORT – FINAL

<b>Reference Number</b>	CA18/3/2/1521					
<b>Classification</b>	Serious Incident	<b>Date</b>	9 January 2026		<b>Time</b>	1500Z
<b>Type of Operation</b>	Private (Part 91)					
<b>Location</b>						
<b>Place of Departure</b>	Tzyfontein Farm near Mokopane, Limpopo Province		<b>Place of Intended Landing</b>	Portion 2 Schaaphok 279 Farm, Sterkrivier District, Limpopo Province		
<b>Place of Occurrence</b>	Grass runway on Portion 2 Schaaphok 279 Farm in Sterkrivier District, Limpopo Province					
<b>GPS Co-ordinates</b>	<b>Latitude</b>	24°15'57.52" S	<b>Longitude</b>	028°45'48.39" E	<b>Elevation</b>	3 811 feet
<b>Aircraft Information</b>						
<b>Registration</b>	ZS-ICE					
<b>Make; Model; S/N</b>	Piper; PA-25-235 (Serial Number 25-5038)					
<b>Damage to Aircraft</b>	Substantial		<b>Total Aircraft Hours</b>	5 442.1		
<b>Pilot-in-command</b>						
<b>Licence Type</b>	Airline Transport Pilot Licence (ATPL)		<b>Gender</b>	Male		<b>Age</b> 56

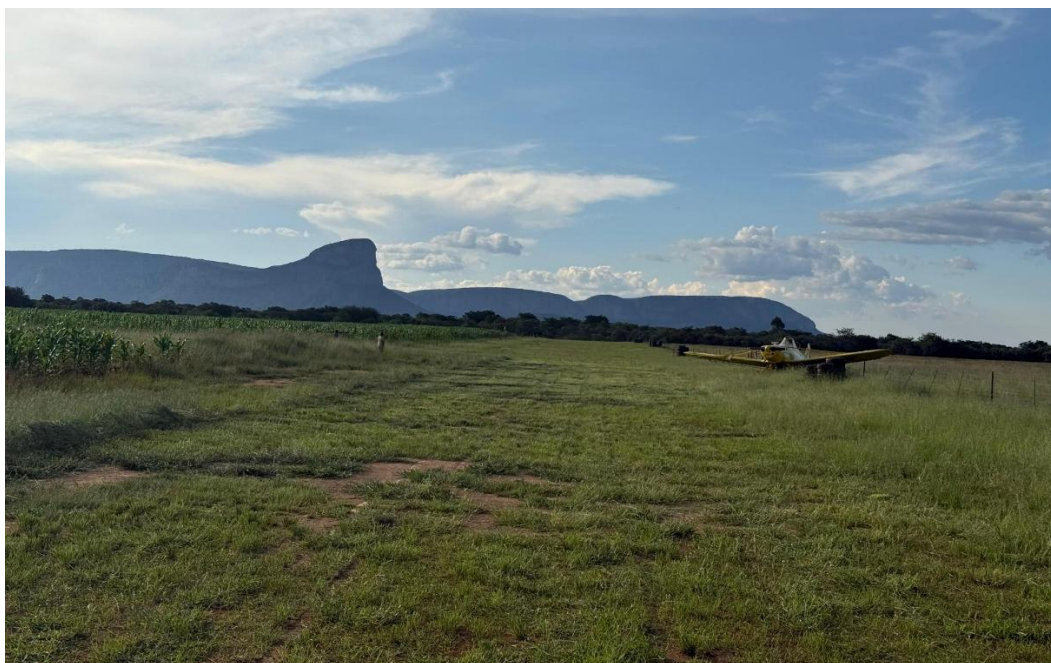
<b>Licence Valid</b>	Yes	<b>Total Hours</b>	3 745.0		<b>Total Hours on Type</b>	80.4
<b>Total Hours 30 Days</b>	26.1		<b>Total Flying on Type Past 90 Days</b>	42.7		
<b>People On-board</b>	1 + 0	<b>Injuries</b>	0	<b>Fatalities</b>	0	<b>Other (on ground)</b> 0
<b>What Happened</b>						
<p>On Friday afternoon, 9 January 2026, a pilot on-board a Piper PA-25-235 aircraft with registration ZS-ICE took off on a positioning flight from Tzyfontein Farm near Mokopane in Limpopo province to Portion 2 Schaaphok 279 Farm in the same province. The flight was conducted under visual meteorological conditions (VMC) by day and under the provisions of Part 91 of the Civil Aviation Regulations (CAR) 2011, as amended.</p> <p>The pilot stated that the aircraft was to be used for maize crop-spraying operation on Saturday, 10 January 2026. Shortly after touchdown in a westerly direction on the grass-covered runway of Portion 2 Schaaphok 279 Farm, a warthog ran out of the maize field on the left side of the runway and crossed it; the aircraft was approximately 10 to 15 metres (m) from the warthog. The pilot applied the right brake to avoid colliding with the animal; as a result, the aircraft swerved to the right and the right wing impacted a stack of tyres (see Figure 3) that were filled with sand and placed next to the runway. The tyres were used as anchors for the fence. After impact, the aircraft ground looped and the tail section landing over the fence. The aircraft faced the direction of landing after coming to a stop; it partially flattened the perimeter fence which caused minor damage to the left wing.</p>

**Figure 2:** The aircraft facing the direction of landing after the serious incident. (Source: Pilot)

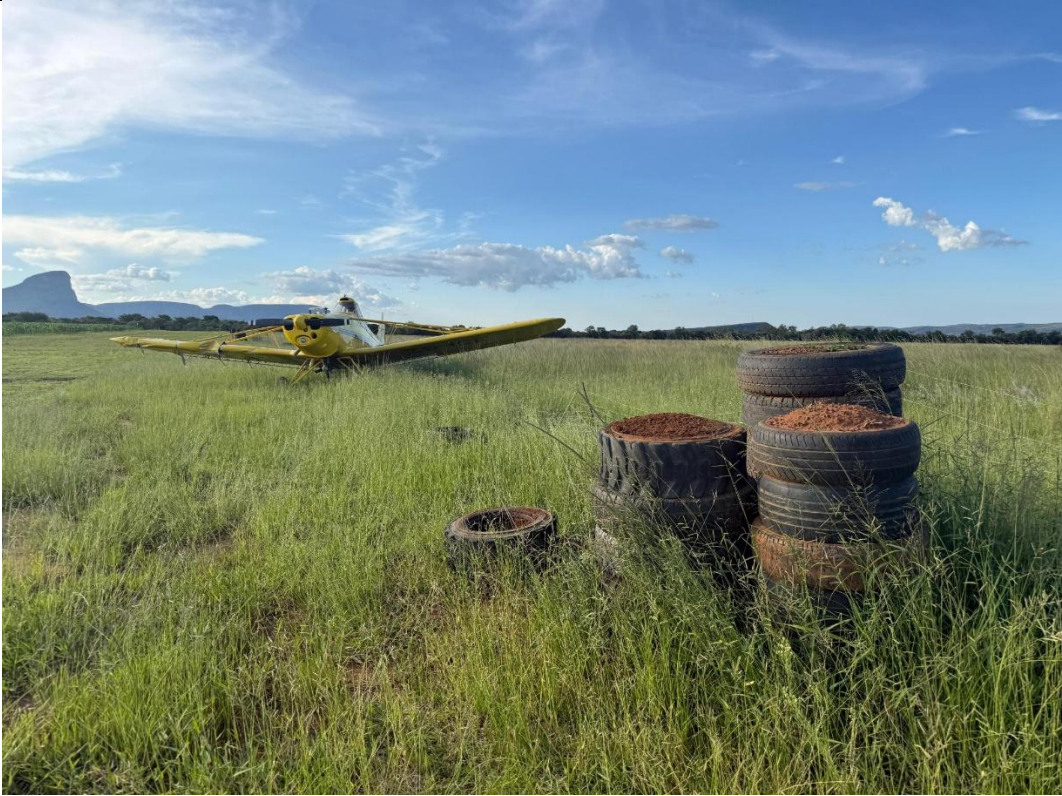
**Figure 3:** Tyres filled with sand that were placed next to the runway. (Source: Pilot)

The pilot applied the right brake to avoid colliding with the warthog that was crossing the runway and, subsequently, the right wing impacted a stack of tyres filled with sand that were positioned close to the runway.

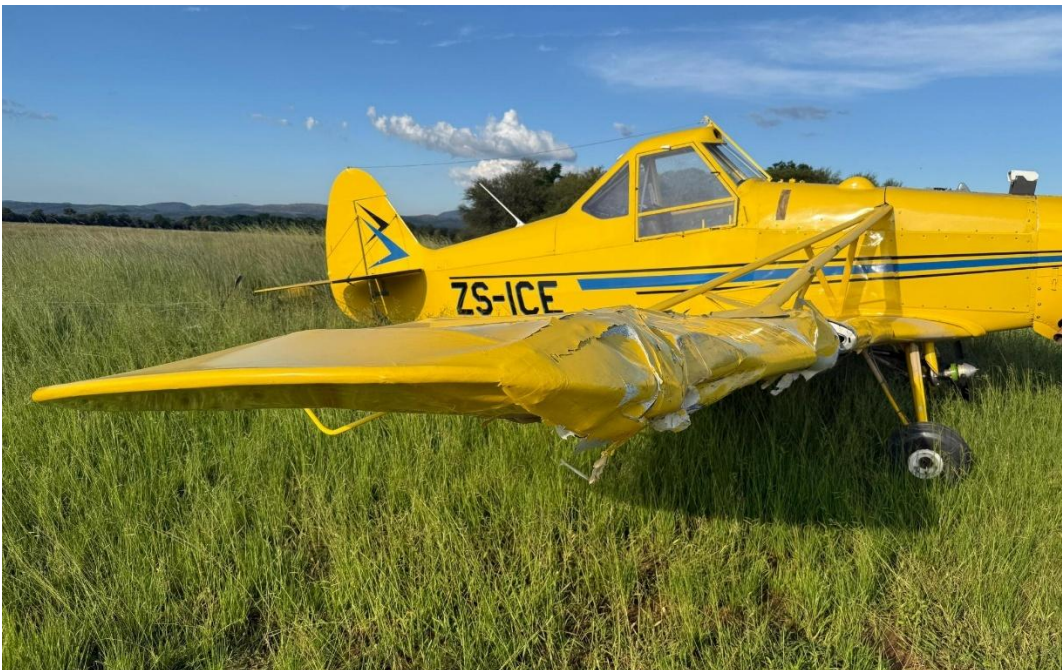
**Figure 4:** Damage to the right-wing leading edge. (Source: Pilot)
