## LIMITED OCCURRENCE INVESTIGATION REPORT – FINAL

<b>Reference Number</b>		CA18/3/2/1522						
<b>Classification</b>	Serious Incident		<b>Date</b>	17 January 2026		<b>Time</b>	1555Z	
<b>Type of Operation</b>	Aerial Work Operations (Part 137)							
<b>Location</b>								
Place of Departure		Porterville Airstrip, Western Cape Province		Place of Intended Landing		Darling Cellar Airstrip, Western Cape Province		
Place of Occurrence		On the grass runway at Darling Cellar Airstrip, Western Cape Province						
GPS Co-ordinates		Latitude	33° 25' 56.31" S	Longitude	018° 31' 12.76" E	Elevation	118 ft	
<b>Aircraft Information</b>								
Registration		ZS-TAN						
Make; Model; S/N		Air Tractor; AT-802A (Serial Number: 802A-0193)						
Damage to Aircraft		Minor		Total Aircraft Hours		2 510.6		
<b>Pilot-in-command</b>								
Licence Type		Commercial Pilot Licence (CPL)		Gender		Male	Age	68
Licence Valid		Yes	Total Hours		5191.3	Total Hours on Type		651.5
Total Hours 30 Days		14.3		Total Flying on Type Past 90 Days			14.3

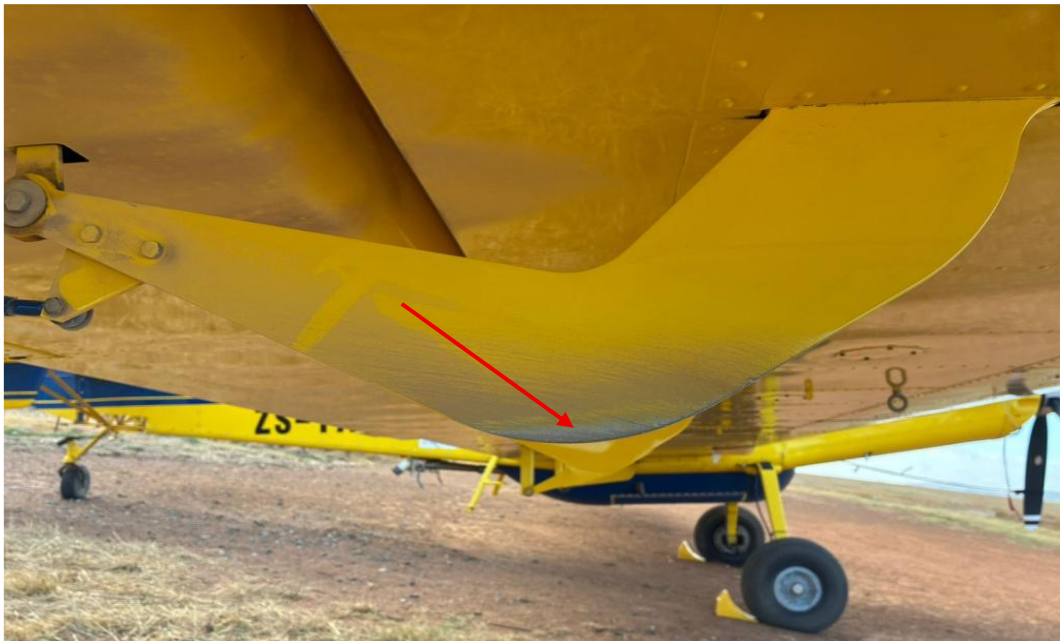
A post-flight inspection revealed dents on the right-wing tip trailing edge as well as chafing marks on the outer right-side flap bracket. Minor damage was also observed on the right-wing tip upper surface and trailing edge. The pilot was not injured.

**Figure 1:** Chafing on the right-wing outer flap bracket (red arrow). (Source: Operator)

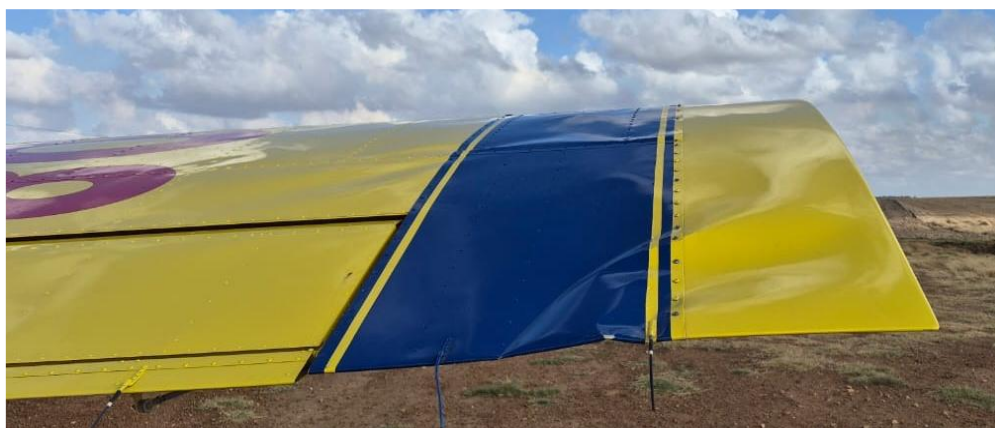
The aircraft exited the runway and entered a shallow ditch which caused it to oscillate on the main landing gear. It was during this time that the right-wing tip touched the ground. Later, the pilot taxied the aircraft back to the runway; the ground speed was down to a walking speed. After stopping at the water-loading area, he was informed of the damage on the right-wing tip by the person on the ground. He then shut down the engine and assessed the damage. The flight duration was 1.1 hour.

**Figure 2:** Dents on the right-wing tip trailing edge. (Source: Operator)
