LIMITED OCCURRENCE INVESTIGATION REPORT – FINAL

Reference Number	CA18/3/2/1525						
Classification	Serious Incident	Date	01 February 2026		Time	0735Z	
Type of Operation	Training (Part 141)						
Location							
Place of Departure	Lanseria International Airport (FALA), Gauteng Province		Place of Intended Landing		Lanseria International Airport (FALA), Gauteng Province		
Place of Occurrence	On a field approximately 3.4 nautical miles (nm) south-west of Runway 07 at Lanseria International Airport (FALA)						
GPS Co-ordinates	Latitude	25° 59' 17" S	Longitude	27° 59' 12" E	Elevation	4 517 ft	
Aircraft Information							
Registration	ZS-SDR						
Make; Model; S/N	Piper, PA-28-181 Acher II (Serial Number: 28-7890063)						
Damage to Aircraft	None			Total Aircraft Hours	1 521.9		
Pilot-in-command							
Licence Type	Commercial Pilot Licence (CPL)		Gender	Male		Age	24
Licence Valid	Yes	Total Hours	2 148.5		Total Hours on Type	1 530.3	
Total Hours 30 Days	95.2		Total Flying on Type Past 90 Days	209.3

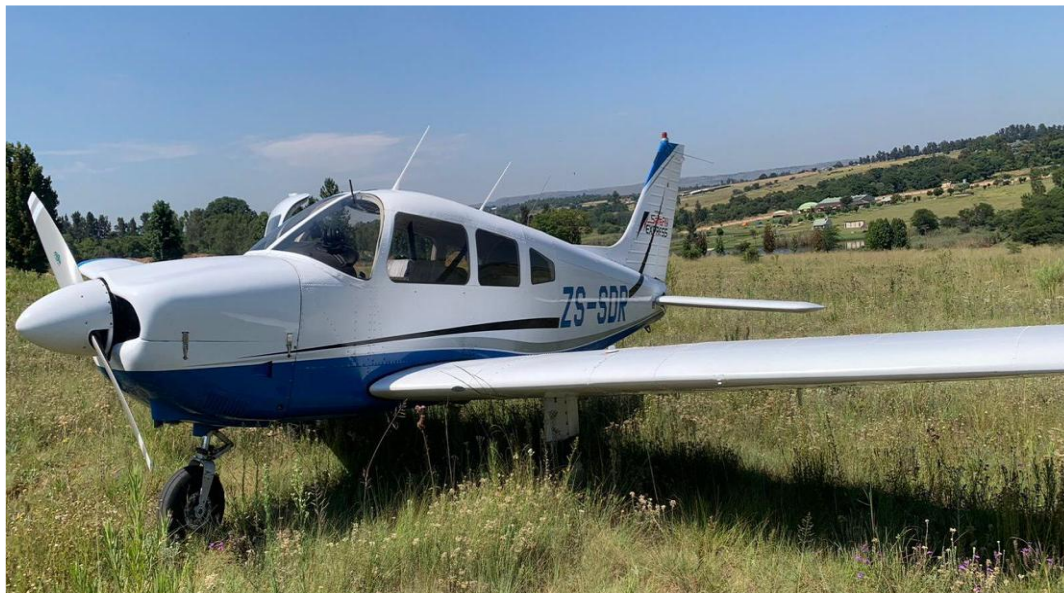
The FI assumed control of the aircraft and troubleshooted the engine to restore power but without success. He then elected to execute a forced landing on a field approximately 3.4nm south-west of Runway 07. The approach was stable and the aircraft landed safely on the field which had an uphill gradient. Immediately after the aircraft came to a stop, the pair completed the after-landing checklist and switched off the master switch. Both occupants were unharmed; the aircraft was not damaged.

Figure 1: The aircraft after the successful forced landing.

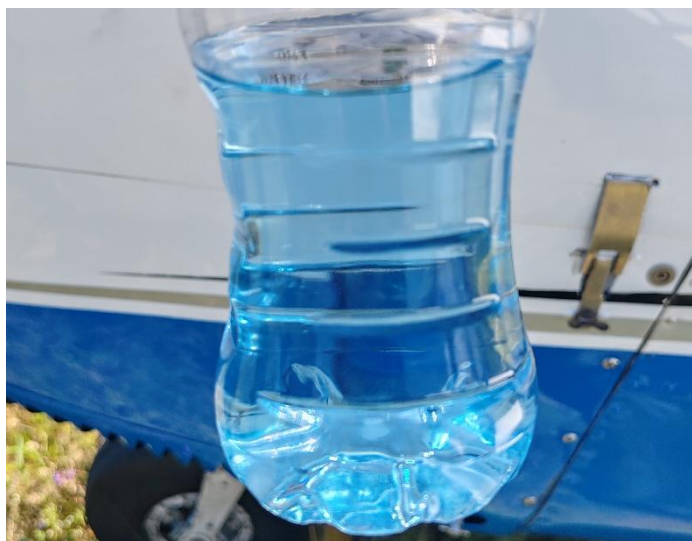
The fuel tank caps were in place and properly latched. The investigating team removed the fuel caps to examine the fuel level in the tanks. Both tanks contained sufficient fuel and the total fuel in the tanks equated to approximately 34 US gallons (17 US gallons in each tank). The investigators also sampled fuel from the aircraft underwing drain points and the gascolator; all samples were of the correct fuel type, clear and contained no sediment or water.

Figure 2: Fuel sample from the gascolator of ZS-SDR.

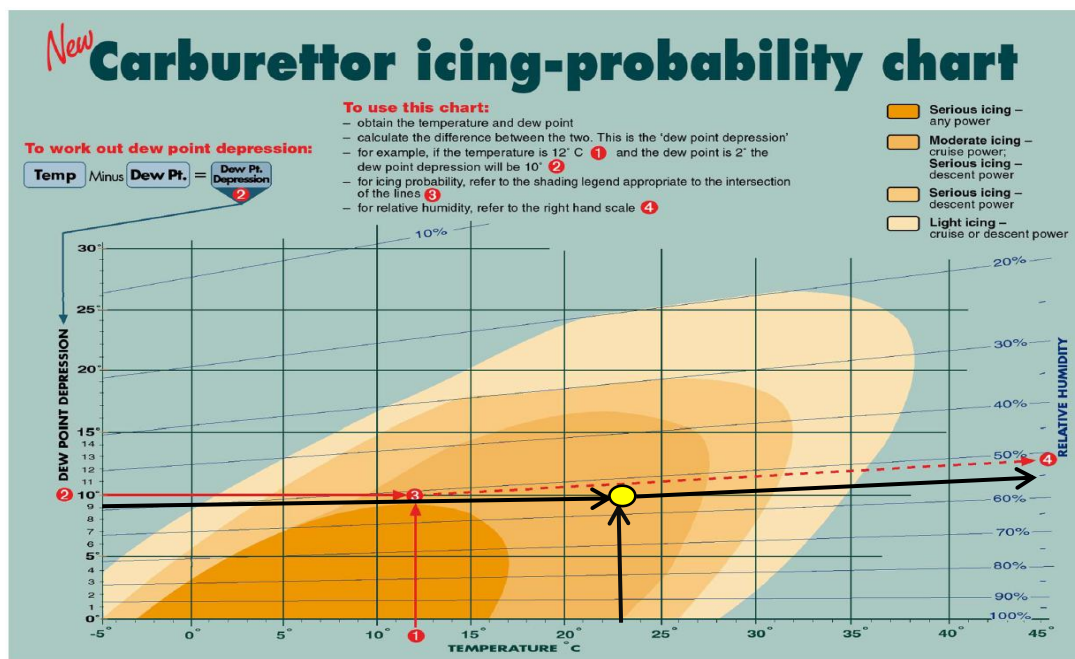
The temperature (23°C) and dew point (14°C) information obtained from the METAR for FALA was used to calculate the probability of carburettor icing on the day and time of the serious incident flight. The calculation revealed a serious risk of carburettor icing at decent power settings, a moderate risk of carburettor icing at cruise power settings, and a relative humidity of 56%.

$$\text{Dew point depression} = 23^{\circ}\text{C} - 14^{\circ}\text{C} = 9^{\circ}\text{C}$$

Figure 3: Carburettor icing-probability calculation shown in black.

3.1. Weather conditions at the time of the serious incident were conducive to the formation of carburettor icing. Relative humidity was approximately 53.58%, temperature was 23°C, and dew point was 14°C. This created a moderate risk for the formation of carburettor icing at cruise power settings.

The aircraft's engine partially lost engine power due to the formation of carburettor ice, thus prompting the flight instructor to execute a forced landing after being unable to restore full engine power.

Contributing Factor(s)
Non-opening of the carburettor heat as part of the in-flight troubleshooting intervention likely prevented the restoration of full engine power.
Safety Action(s)
None.
Safety Recommendation/s
It is recommended that the flight school operator provides training to its flight instructors on the early recognition of carburettor icing symptoms and in-flight emergency procedures to be followed when it is suspected that such a condition might exist.
About this Report
<p><i>The decision to conduct a limited investigation is based on factors including whether the cause is known and the evidence supporting the cause is clear, the level of safety benefit likely to be obtained from an investigation and that will determine the scope of an investigation. For this occurrence, a limited investigation has been conducted, and the Accident and Incident Investigations Division (AIID) has relied on the information submitted by the affected person/s and organisation/s to compile this limited report. The report has been compiled using information supplied in the initial notification, as well as from follow-up desk top enquiries to bring awareness of potential safety issues to the industry in respect of this occurrence, as well as possible safety action/s that the industry might want to consider in preventing a recurrence of a similar occurrence.</i></p> <p><i>All times given in this report are Co-ordinated Universal Time (UTC) and will be denoted by (Z). South African Standard Time is UTC plus 2 hours.</i></p>
