**LIMITED OCCURRENCE INVESTIGATION REPORT – FINAL**

<b>Reference Number</b>	CA18/3/2/1526						
<b>Classification</b>	Serious Incident		<b>Date</b>	31 January 2026		<b>Time</b>	1530Z
<b>Type of Operation</b>	Private (Part 91)						
<b>Location</b>							
Place of Departure	Port Alfred Aerodrome (FAPA), Eastern Cape Province			Place of Intended Landing	Grahamstown Aerodrome (FAGT), Eastern Cape Province		
Place of Occurrence	Runway 16 at Grahamstown Aerodrome						
GPS Co-ordinates	Latitude	33° 16' 53.06" S	Longitude	026° 29' 40.04" E	Elevation	2 109 ft	
<b>Aircraft Information</b>							
Registration	ZS-SOK						
Make; Model; S/N	Cessna; C210A (Serial Number: 21057658)						
Damage to Aircraft	Minor			Total Aircraft Hours	2 588		
<b>Pilot-in-command</b>							
Licence Type	Private Pilot Licence (PPL)		Gender	Male		Age	50
Licence Valid	Yes	Total Hours	606		Total Hours on Type	118	
Total Hours 30 Days	7.5			Total Flying on Type Past 90 Days	15.8		
<b>People On-board</b>	1 + 0	<b>Injuries</b>	0	<b>Fatalities</b>	0	<b>Other (on ground)</b>	0

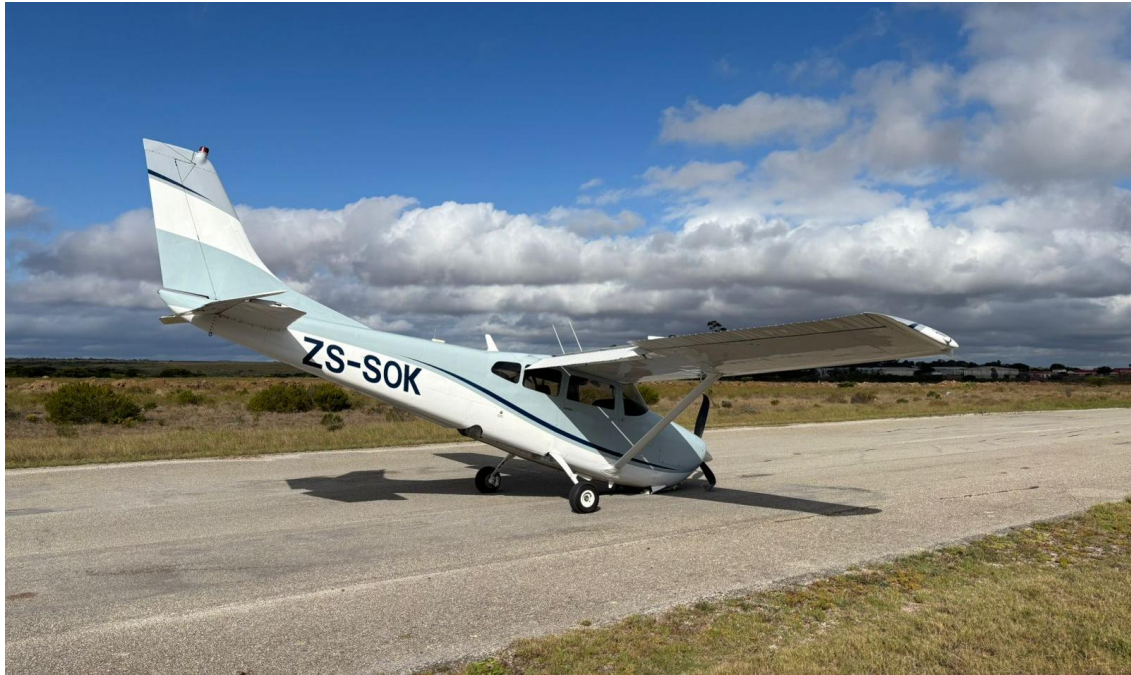
The pilot was unharmed after the serious incident; the aircraft sustained damage to the propeller blades, lower nacelle of the engine, and nose landing gear doors.

**Figure 2:** The aircraft on the runway post-serious accident. (Source: Pilot)

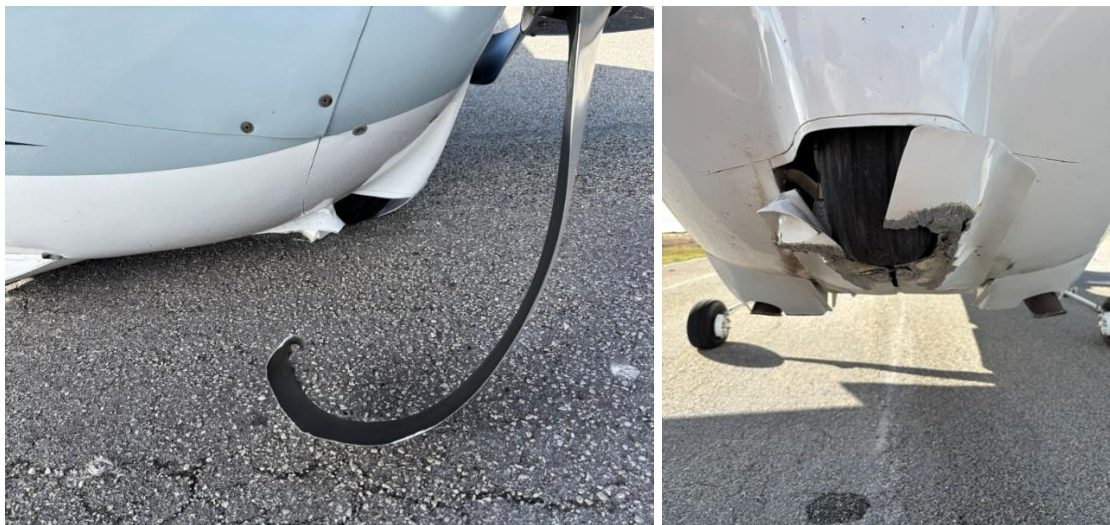
**Figures 3 and 4:** The propeller blade (left) and landing gear doors (right) that were damaged from abrasion with the runway. (Source: Pilot)

The aircraft maintenance engineers (AMEs) recovered the aircraft from the runway, and the nose landing gear wheel well was subjected to a thorough visual inspection. The AMEs noticed that the nose gear keel (trunnion support) was twisted due to possible previous hard landings; consequently, it prohibited the “up” lock hook from disengaging (or releasing) the nose gear to the down and locked position.
