LIMITED OCCURRENCE INVESTIGATION REPORT – FINAL

Reference Number	CA18/3/2/1529						
Classification	Serious Incident	Date	8 February 2026		Time	0505Z	
Type of Operation	Commercial Operation of Non-type Certified Aircraft (Part 96)						
Location							
Place of Departure	Ballito Aerodrome, KwaZulu-Natal Province		Place of Intended Landing	Ballito Aerodrome, KwaZulu-Natal Province			
Place of Occurrence	Apron at Ballito Aerodrome						
GPS Co-ordinates	Latitude	29°29'25.85" S	Longitude	031°10'38.26" E	Elevation	220 feet	
Aircraft Information							
Registration	ZU-BBN						
Make; Model; S/N	Solo Wings; Windlass Aquilla (Serial Number: WA 560468)						
Damage to Aircraft	Substantial		Total Aircraft Hours	490.9			
Pilot-in-command							
Licence Type	National Pilot Licence		Gender	Male		Age	51
Licence Valid	Yes	Total Hours	547.0		Total Hours on Type	404.4	
Total Hours 30 Days	8.1		Total Flying on Type Past 90 Days	13.8			
People On-board	1 + 1	Injuries	0	Fatalities	0	Other (on ground)	0

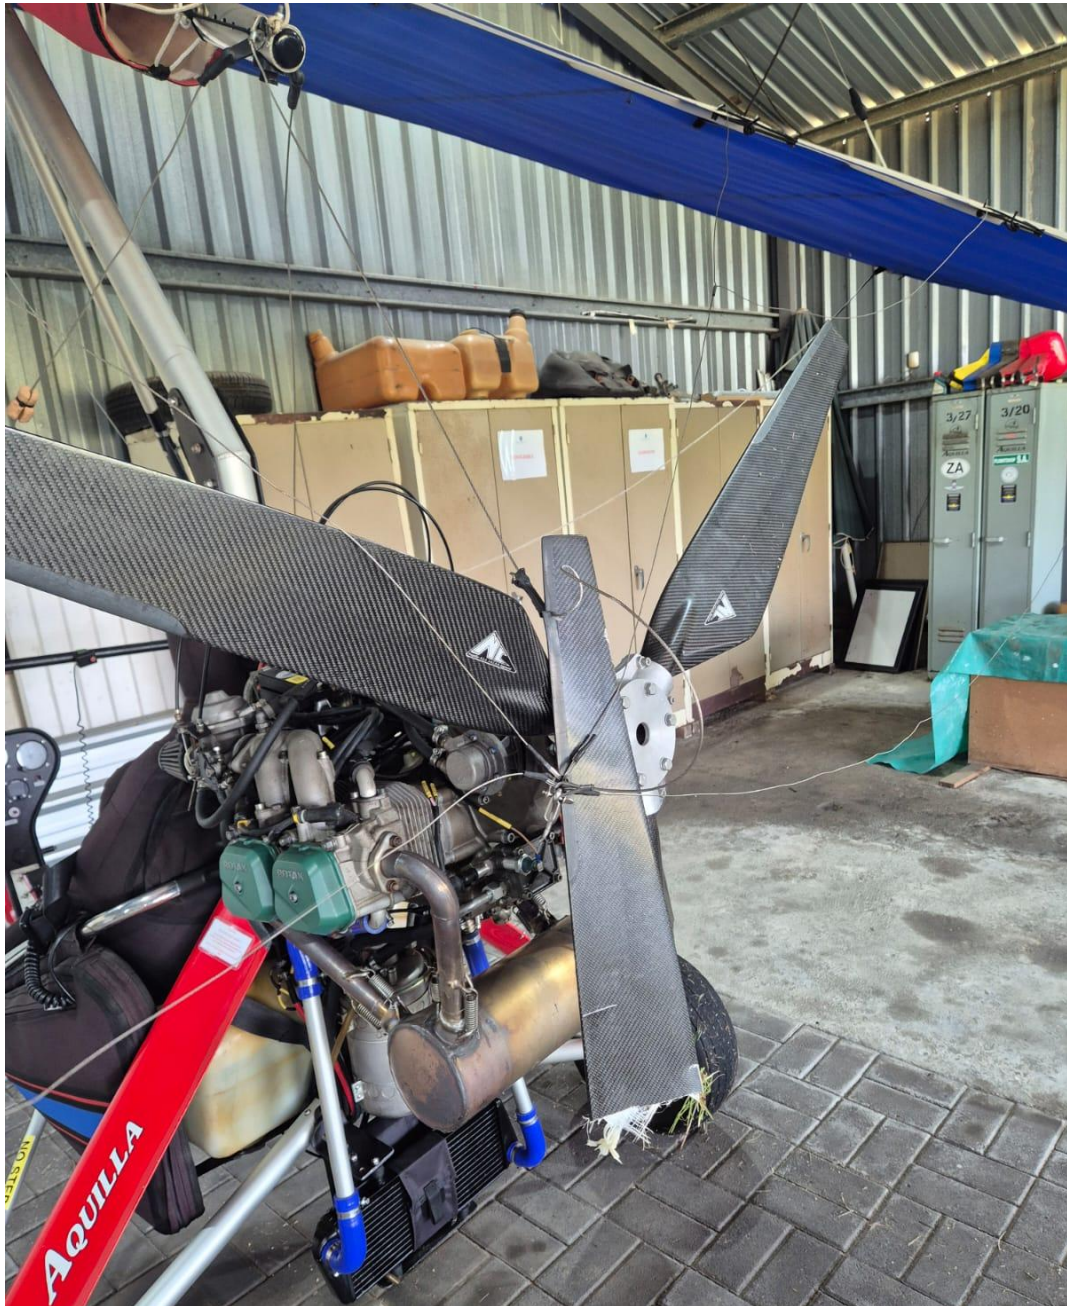
What Happened							
<p>On Sunday, 8 February 2026 at approximately 0505Z, a pilot and a passenger on-board a microlight registered ZU-BBN were about to conduct a scenic flight from Ballito Aerodrome in KwaZulu-Natal province with the intention to land back at the same aerodrome when the serious incident occurred. The flight was intended to be conducted under visual meteorological conditions (VMC) by day and under the provisions of Part 96 of the Civil Aviation Regulations (CAR) 2011, as amended.</p> <p>The pilot stated that he assisted the passenger into the rear seat and gave him a safety briefing in accordance with the standard operating procedures (SOP's) whilst the microlight was still parked. The microlight was fitted with dual flight controls. The passenger did not take heed of the briefing regarding the rear throttle control and had his feet resting on the throttle control lever. Upon starting the engine, the passenger's foot was pressing down on the rear throttle control, and the microlight accelerated. The pilot applied the brakes and tried to switch off the magnetos, but the microlight aircraft was already moving forward, and it impacted another stationary microlight with registration ZU-BUI, which sustained cosmetic damage (see Figure 4).</p> <p>No person was injured during the serious incident sequence. The microlight (ZU-BBN) sustained a singular broken propeller blade, bent keel tube and bent drag link.</p>

Figure 2: A singular broken propeller blade. (Source: Pilot)

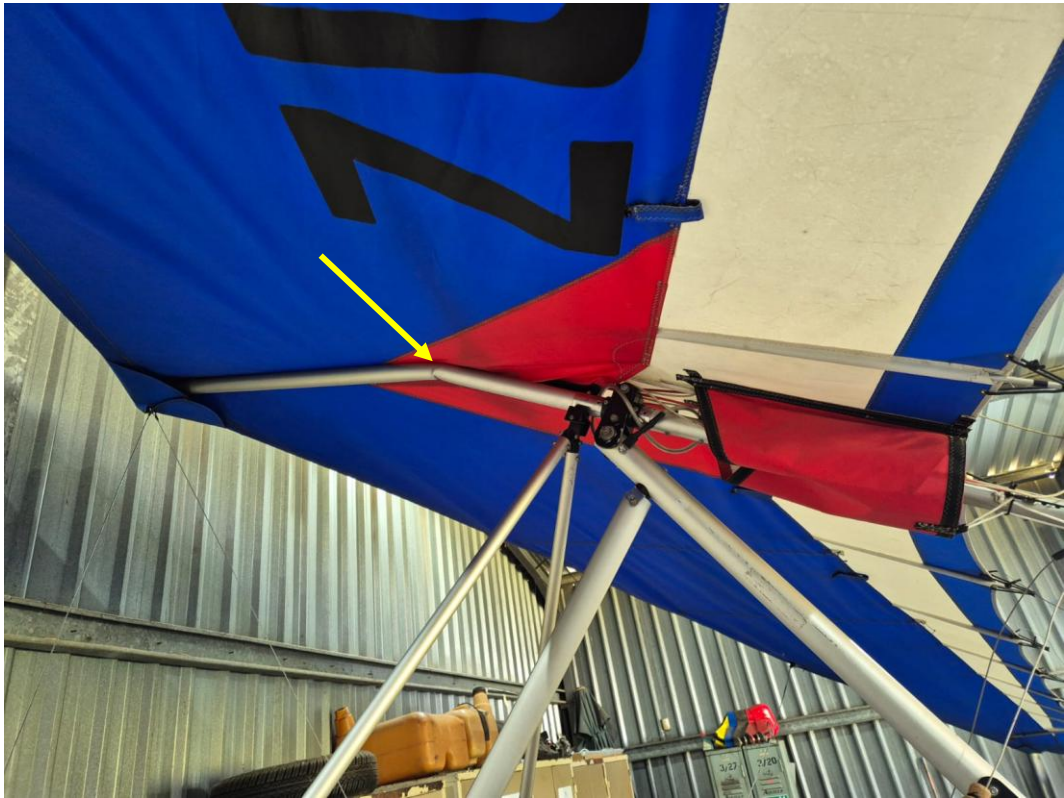
Figure 3: The bent keel tube. (Source: Pilot)

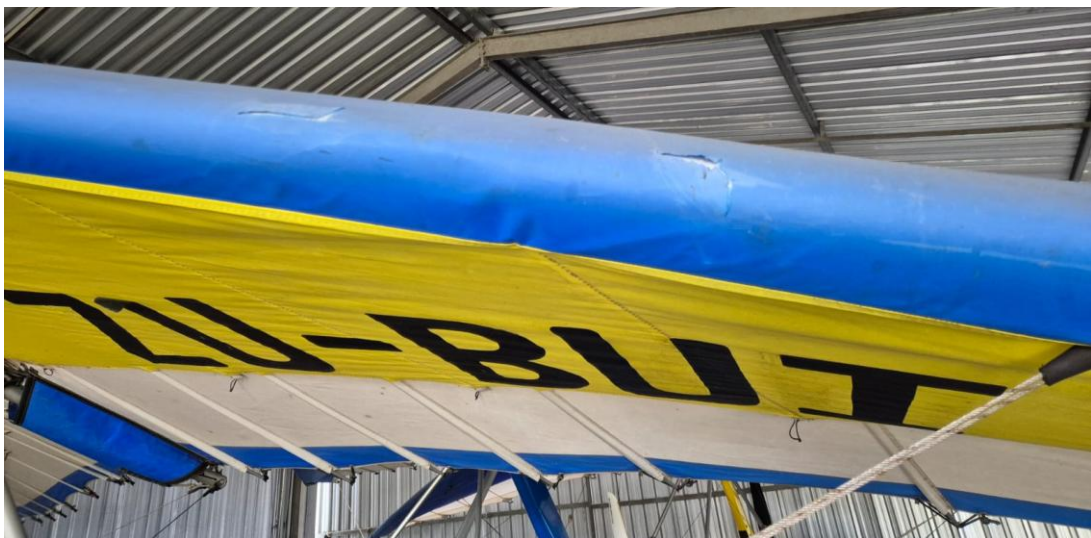
Figure 4: The leading-edge canvas covering of the ZU-BUI showing sustained damage.
(Source: Pilot)

Ground impact occurred when the passenger rested his foot on the aft throttle lever at the time the pilot started the engine. This caused the microlight to accelerate forward and impact another parked, unoccupied microlight.

2.	It is recommended that the operator ensures proper flight line safety is complied with by parking the microlight away from direct line with other aircraft to mitigate the risk of a ground impact as well as ensure that aircraft safety is not compromised.
About this Report	
<p><i>The decision to conduct a limited investigation is based on factors including whether the cause is known and the evidence supporting the cause is clear, the level of safety benefit likely to be obtained from an investigation, and that will determine the scope of an investigation. For this occurrence, a limited investigation has been conducted, and the Accident and Incident Investigations Division (AIID) has relied on the information submitted by the affected person/s and organisation/s to compile this limited report. The report has been compiled using information supplied in the initial notification, as well as from follow-up desk top enquiries to bring awareness of potential safety issues to the industry in respect of this occurrence, as well as possible safety action/s that the industry might want to consider in preventing a recurrence of a similar occurrence.</i></p> <p><i>All times given in this report are Co-ordinated Universal Time (UTC) and will be denoted by (Z). South African Standard Time is UTC plus 2 hours.</i></p>

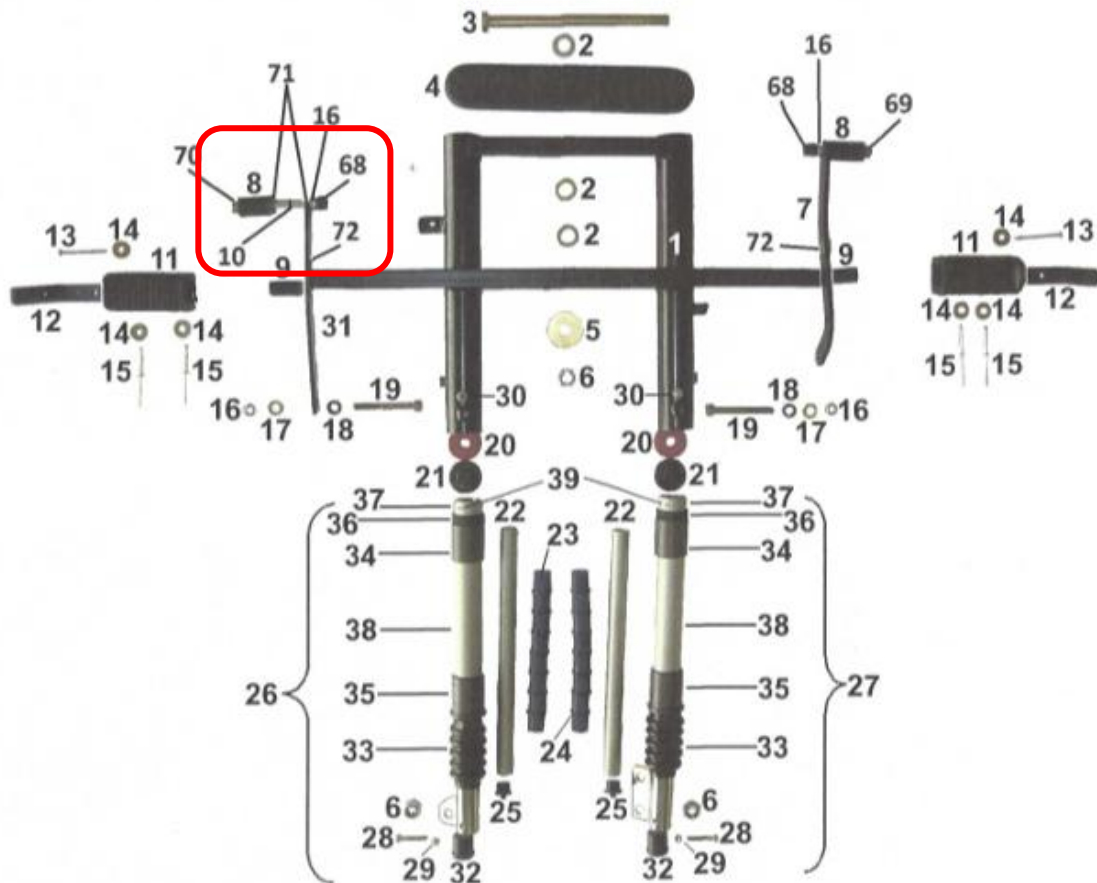
Diagram 2: The front-end fork assembly, indicating the pilot's foot throttle lever, item 10.

2.	The microlight was equipped with dual flight controls which should be regarded as a significant contributing factor to this serious incident.
3.	The passenger interfered with the duties of the pilot by resting his foot on the aft throttle lever, even though he received a safety briefing before the flight.
Safety Action(s)	
None.	
Safety Message and/or Safety Recommendations

1.	It is recommended to the operator that if they continue to conduct commercial flights with microlight fitted with dual controls, the pilot should conduct a physical check before starting the engine to ensure that the passengers' feet are clear of the aft throttle lever. The pilot should continue to observe the position of the passengers' feet during the flight; in addition, this should be repeated before touchdown.
