LIMITED OCCURRENCE INVESTIGATION REPORT – FINAL

Reference Number	CA18/3/2/1538						
Classification	Serious Incident		Date	27 February 2026		Time	1256Z
Type of Operation	Private (Part 91)						
Location							
Place of Departure	Bram Fischer International Airport (FABL), Free State Province		Place of Intended Landing		Rand Airport (FAGM), Gauteng Province		
Place of Occurrence	Runway 29 at Rand Airport (FAGM), Gauteng Province						
GPS Co-ordinates	Latitude	26°14' 18.35" S	Longitude	28° 08' 50.90" E	Elevation	5 474 ft	
Aircraft Information							
Registration	ZS-CJG						
Make; Model; S/N	Piper; PA-28-180 Cherokee (Serial Number: 28-2761)						
Damage to Aircraft	Substantial			Total Aircraft Hours	8 660.4		
Pilot-in-command							
Licence Type	Private Pilot Licence (PPL)		Gender	Male		Age	29
Licence Valid	Yes	Total Hours	120.6		Total Hours on Type	120.6	
Total Hours 30 Days	7.7		Total Flying on Type Past 90 Days		36.3		
People On-board	1+1	Injuries	0	Fatalities	0	Other (on ground)	0

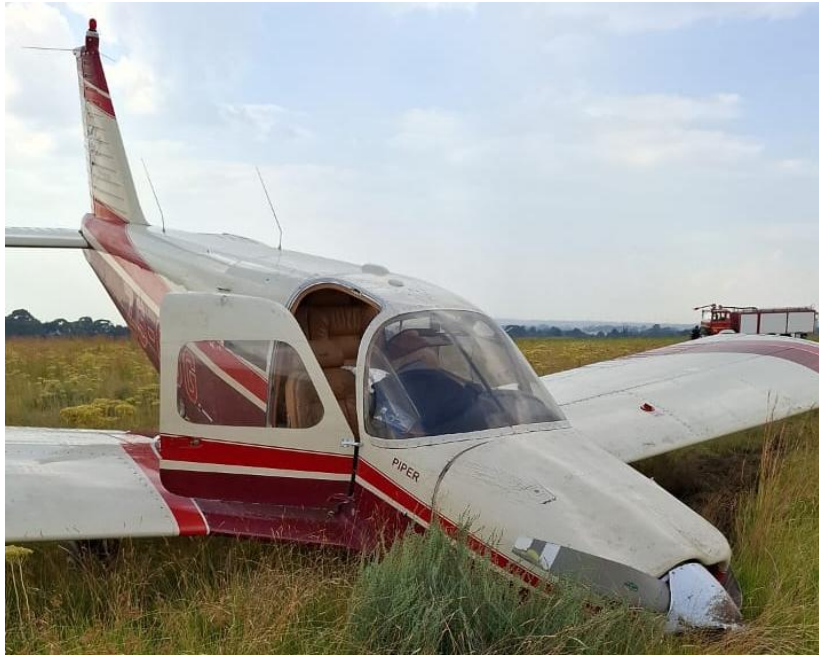
The aircraft came to rest on the grass on the left side of the runway. The aircraft was substantially damaged. Both occupants were not injured.

Figure 1: The resting position of the aircraft after the serious incident. (Source: Recovery team)

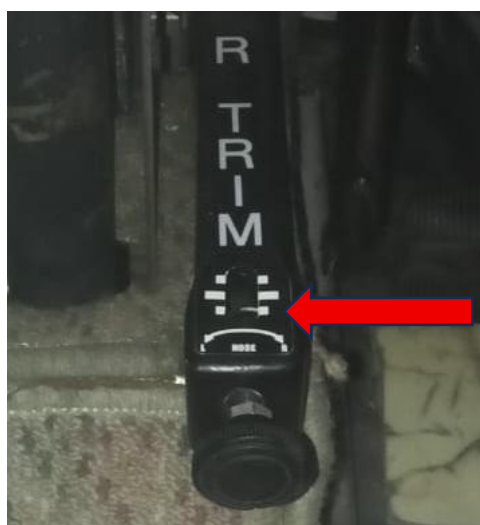
After the serious incident, the aircraft was recovered to the aircraft maintenance organisation (AMO) facility at FAGM. Upon inspection of the aircraft by the investigating team, it was found that the rudder was trimmed nose right. They were also able to verify that the trim control was working and that there was continuity in the control cables. *It should be noted that because of the damage sustained to the nose gear, the investigating team could not accurately assess the rigging of the rudder control or if the rudder trim was affected.*

Figure 2: Rudder trim indication in the aircraft after the serious incident.

2.6 The right nose trim condition identified by the investigating team likely caused the aircraft to yaw and roll to the right in-flight. The nose trim condition also likely impacted the aircraft's directional stability during the landing roll. This indicated that the aircraft was probably unstable on approach and did not touch down in the area initially stated by the pilot.

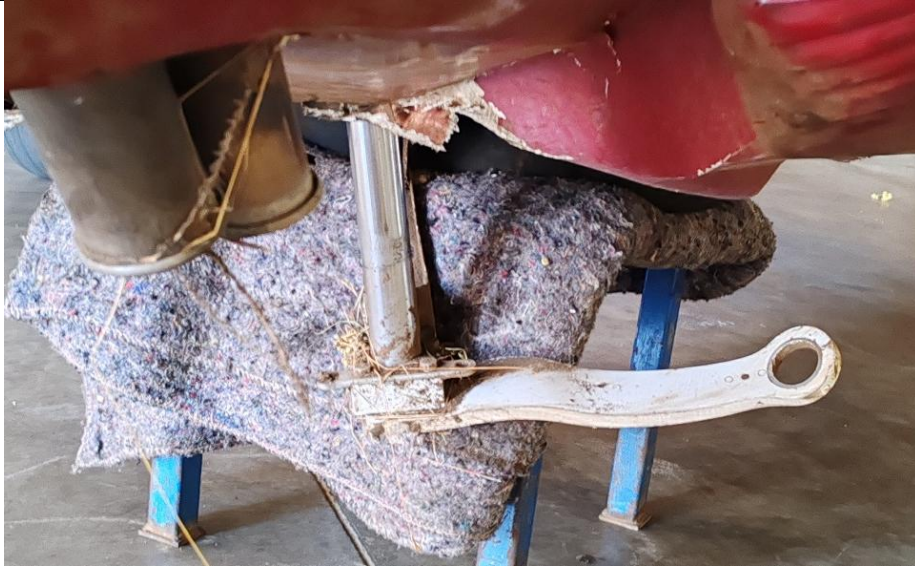
What Happened							
<p>On Friday, 27 February 2026, a pilot and a passenger on-board a Piper PA-28-180 Cherokee aircraft registered ZS-CJG took off on a private flight from Bram Fischer International Airport (FABL) in Free State province to Rand Airport (FAGM) in Gauteng province. The flight was conducted under visual meteorological conditions (VMC) by day and under the provisions of Part 91 of the Civil Aviation Regulations (CAR) 2011, as amended.</p> <p>The pilot stated that a pre-flight inspection of the aircraft was conducted with no anomalies noted. The aircraft took off and routed to FAGM; the flight was uneventful. The wind was calm with a light fall of rain during approach for landing on Runway 29 at FAGM, and the approach speed was approximately 80 miles per hour (mph). After touchdown and during the landing roll, the pilot stated that the aircraft started to veer off to the right of the centreline. He then applied the left rudder to recover; however, the aircraft was unsteady (oscillated). He, therefore, lost directional control of the aircraft which exited to the left (opposite side) during which the nose gear strut collapsed.</p>

Figure 3: The damaged nose gear strut.

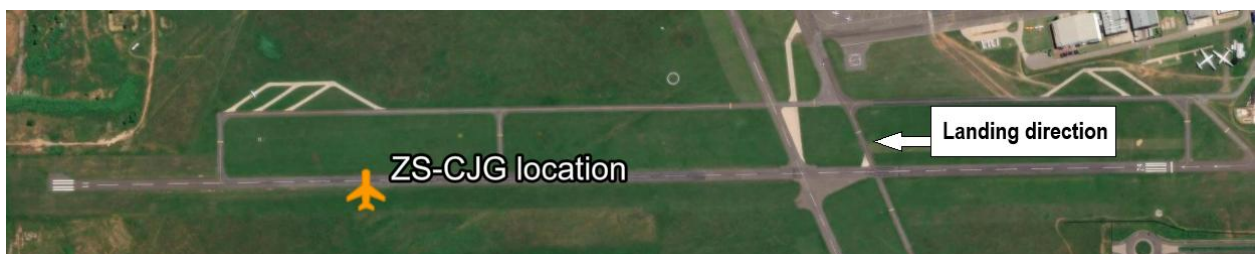
During the interview of the pilot by the investigation team, he stated that the aircraft exhibited a tendency to yaw and roll to the right during flight, and that he did not check or adjust the rudder trim. He further stated that during the approach to land on Runway 29 at FAGM, he had selected 25° flaps with an approach speed of approximately 80 mph. He stated that he aimed for the threshold numbers and touched down just beyond them. After touchdown, the aircraft veered to the right and he applied left rudder input to regain control; however, the aircraft oscillated as if about to overturn and it, subsequently, exited to the left side of the runway.

Figure 4: Location of ZS-CJG after the serious incident.
