**AIRCRAFT SERIOUS INCIDENT REPORT AND EXECUTIVE SUMMARY**

| | | | | <b>Reference:</b> | | CA18/3/2/1539 | |
| <b>Aircraft Registration</b> | ZU-IXR | <b>Date of Incident</b> | 28 February 2026 | | <b>Time of Incident</b> | 1130Z | |
| <b>Type of Aircraft</b> | Jabiru J430 | | <b>Type of Operation</b> | | Private (Part 94) | | |

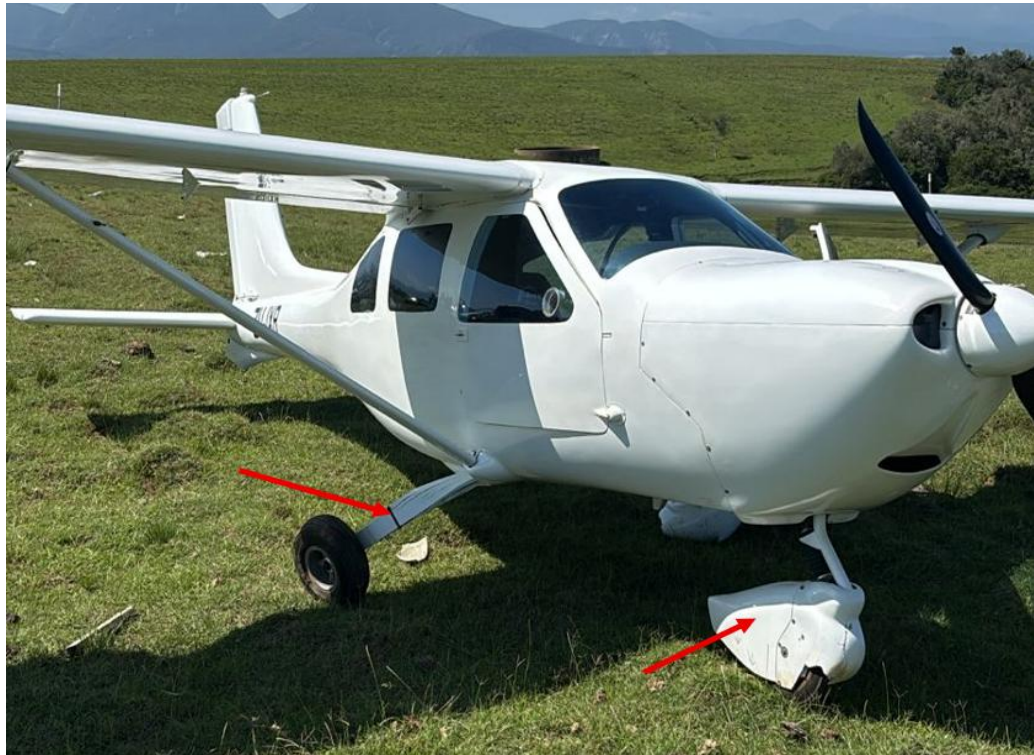
- 1.3.1. The aircraft was forced-landed on a field. It sustained damage to the spring-loaded main landing gear and three-wheel spats.

**Figure 1:** The damaged landing gear (red arrows). (Source: Pilot)

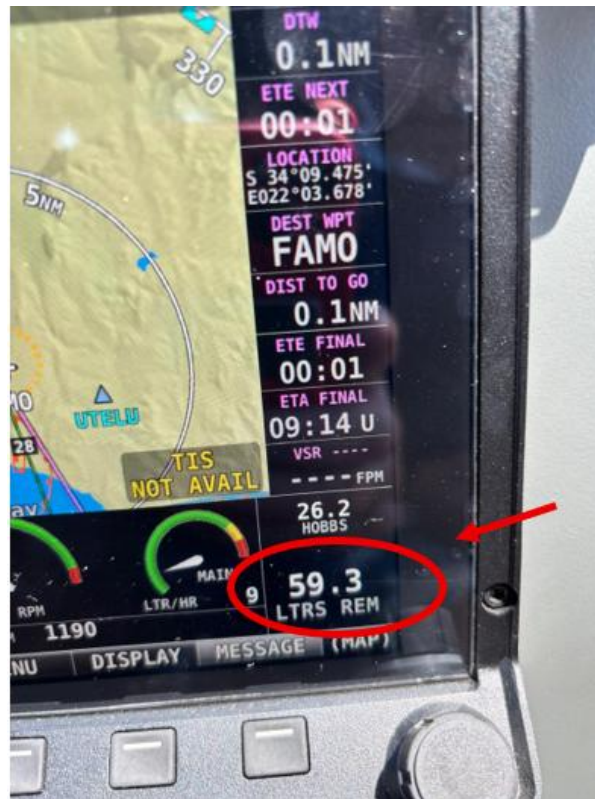
- 1.6.7. The EFIS indicated that the aircraft had 59.3 litres of Mogas, which should have provided approximately 3 hours' endurance. According to the pilot, the first leg from FAPG to FAMO lasted about 1 hour during which the aircraft covered 64 nautical miles (nm). On the return leg, approximately 25 minutes into the flight, the engine stopped in-flight after the aircraft had flown 23nm.
- 1.6.8. In total, the aircraft had covered 87nm. Based on the expected consumption rate of 21 litres per hour at 108 knots (kts), this duration would normally account for a consumption of about 21.2 litres. The aircraft ran out of fuel before the calculated 3-hour endurance, suggesting a reading error in the EFIS.

**Figure 2:** Fuel on-board before take-off from FAPG to FAMO. (Source: Pilot)

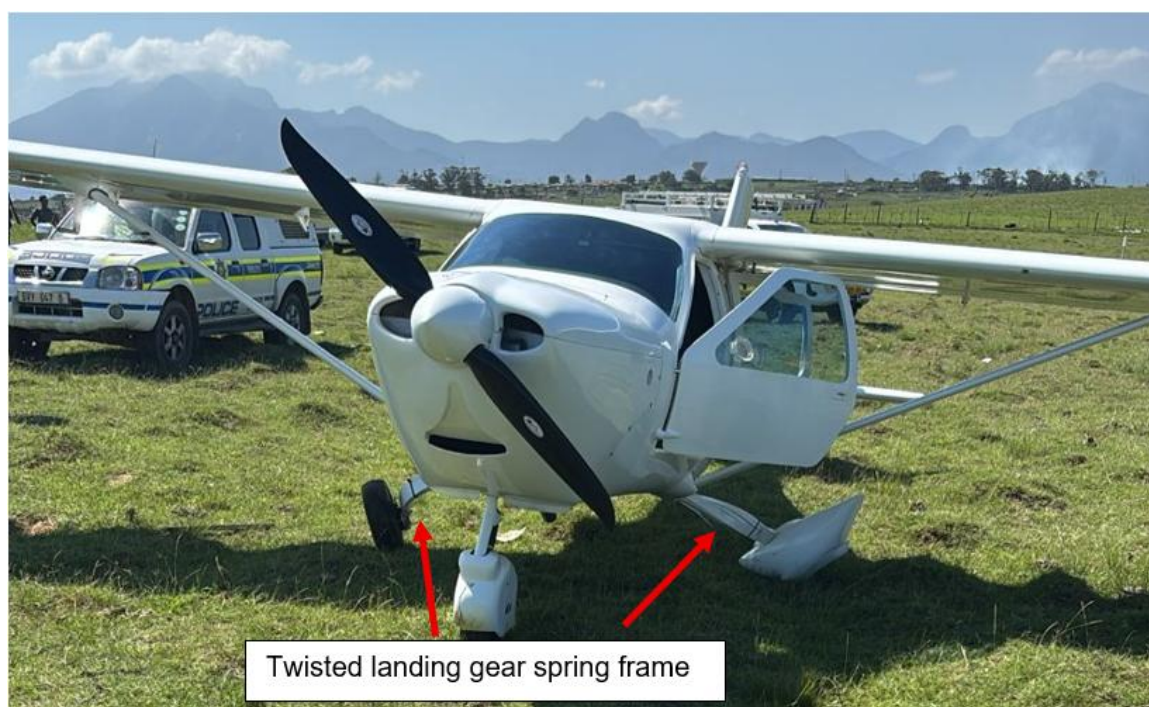
1.12.1. The pilot conducted a forced landing after the engine stopped in-flight. It landed on an uneven grass-covered field. During the forced landing, the spring-loaded main landing gear and three-wheel spats were damaged.

**Figure 3:** A view of the landing gear from the front. (Source: Pilot)

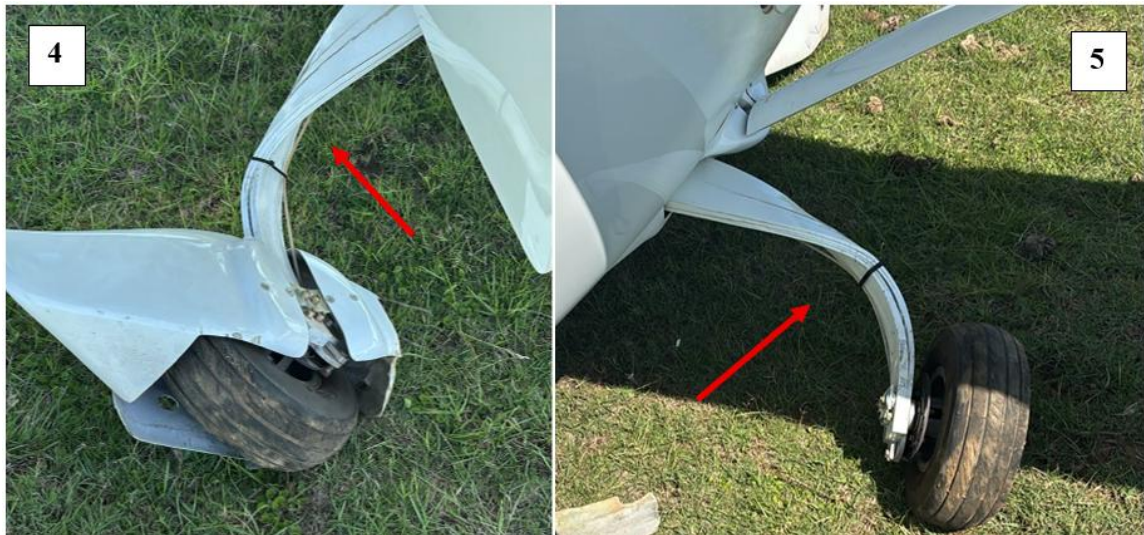
**Figures 4 and 5:** The damaged left and right landing gear (the red arrows point to the damage).  
(Source: Pilot)

| FLIGHT FOLIO AND DEFECT REPORT<br>VLUGFOLIANT EN VERSLAG VAN DEFEKTE | | | | (IN TERMS of<br>AAC 60.9) | | NON-PRESSURISED SINGLE & TWIN PISTON ENGINE AIRCRAFT<br>NIE-DRUKKEELING ENKEL & MULTISUIERENJINVLIEGTUIG | | | | 04 | | | |
|---|---|---|---|---|---|---|---|---|---|---|---|---|---|
| 23-2 | | Aircraft Accident - | | 3-3-26 | Replaced with gear legs<br>Aircraft safe for flight | | [Signature] | | | | | | |

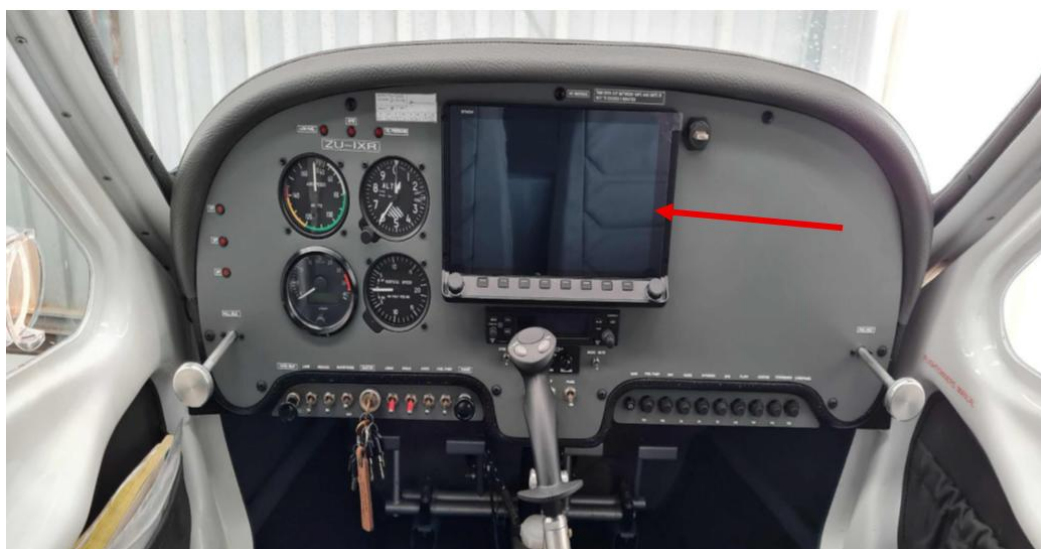
**Figure 6:** ZU- IXR instrument panel showing Dynon HDX Skyview EFIS (red arrow).  
(Source: Technical report)

The aircraft was fitted with a Dynon Skyview HDX 10" EFIS/EMS which provided all flight instruments and engine monitoring data. Fuel is monitored via the Dynon Fuel Flow Transducer (Figure 8) but requires the operator to upload the volume of fuel after each upliftment.

- 1.16.3. According to the technical report that was made available to the investigator, no external damage was visible on the engine assembly or the fuel tanks. The aircraft was thoroughly inspected, and all fuel lines showed no sign of damage or leakage. After fuel was uplifted, the engine ran normally. The EFIS system was re-set, and the correct fuel volume was uploaded.

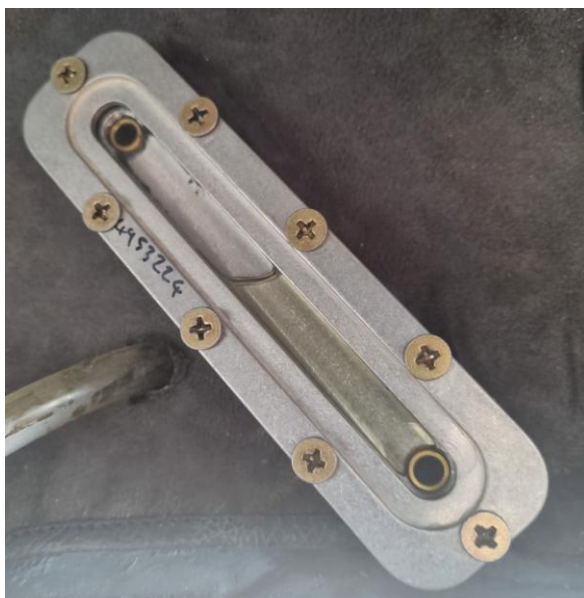
- 1.16.5. The Jabiru fuel is gravity fed and runs from the left and right wings into a central sump tank. The aircraft has a set of sight glasses in the cabin to indicate fuel flow from the wing tanks into the central sump fuel tank, and there is also a low fuel light on the instrument panel that illuminates when the fuel is no longer running into the sump tank. After the light comes on, the pilot has about 10 minutes to land before the fuel runs out.

**Figure 7:** The wing fuel sight glass. (Source: Technical Report)

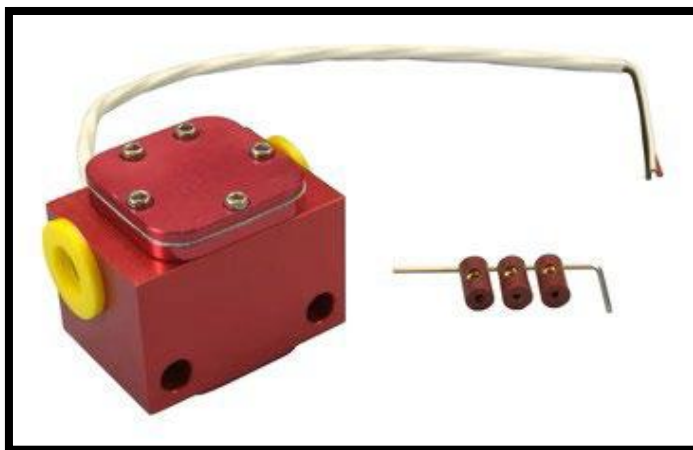
**Figure 8:** Fuel transducer fitted to the fuel line, which is part of the Dynon EFIS. (Source: Technical Report)
