## LIMITED OCCURRENCE INVESTIGATION REPORT – FINAL

| <b>Reference Number</b> | CA18/3/2/1542 | | | | | | |
| Registration | ZS-SNR | | | | | | |
| Make; Model; S/N | Piper Seneca; PA-34-200T (Serial Number:34-7970428) | | | | | | |

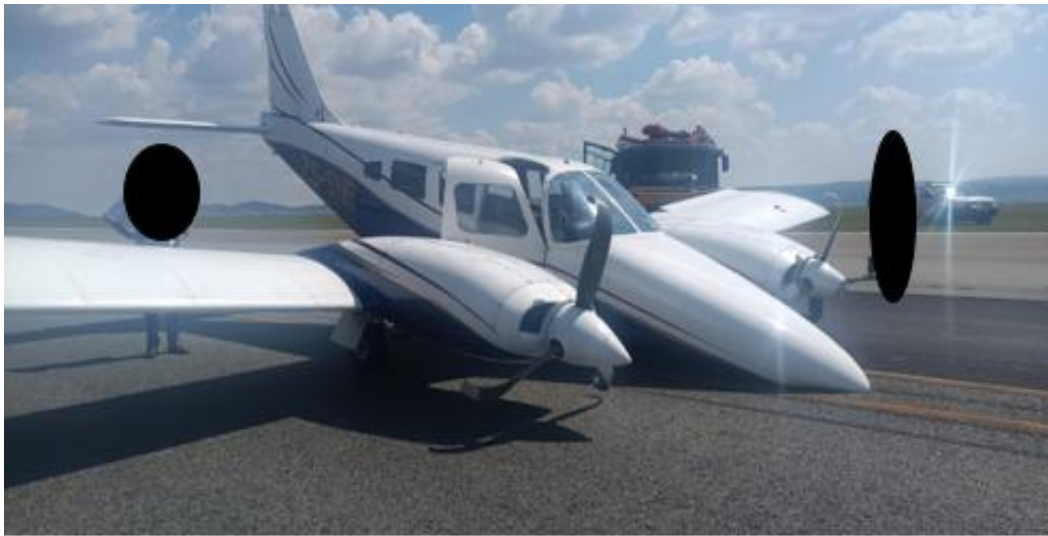
the ground. The aircraft sustained substantial damage to the nose cone and propeller blades. The pilots were not injured.

**Figure 1:** The aircraft on Runway 25 after the accident.

During an interview, one of the pilots described the nose landing gear's collapse as slow and gradual after the second touch-and-go landing.

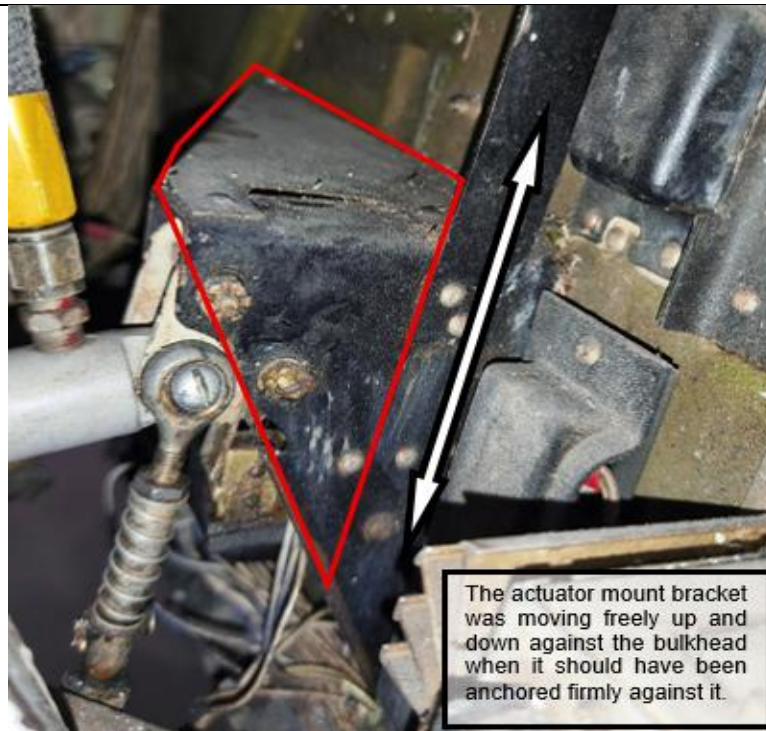
After the (current) serious incident, the aircraft was recovered to the owner's hangar and was examined by the investigating team on 24 April 2026. The examination revealed that all the rivets connecting the actuator mount assembly bracket and the lower drag link mount to the bulkhead at station 49.50 (see Figure 3) were sheared. Consequently, the brackets moved freely up and down against the bulkhead whenever the landing gear was extended.

**Figure 2:** The loose actuator mount bracket on ZS-SNR.

4.1. The previous nose gear collapse likely damaged the actuator mount bracket rivets at fuselage station 49.50. The damage was not detected during the subsequent 100-hour inspection, leaving a latent defect.

4.2. During the maintenance test flight, the weakened rivets likely failed during the second touch-and-go landing, leaving the bracket unsecured and preventing the nose landing gear drag braces from achieving the over-centre locked position during the subsequent gear extension.

| Nose landing gear collapsed during the landing roll likely due to failure of the previously damaged actuator mount bracket rivets, resulting in loss of structural integrity, improper gear locking, and a false “down and locked” indication. With no effective mechanical lock or hydraulic support, the landing gear collapsed under load. |

| Operators and aircraft maintenance organisations are reminded that when an aircraft experiences a structural event not explicitly covered in the maintenance manual, the manufacturer of the aircraft should be contacted for technical advice on the maintenance action required to return the aircraft to service. |

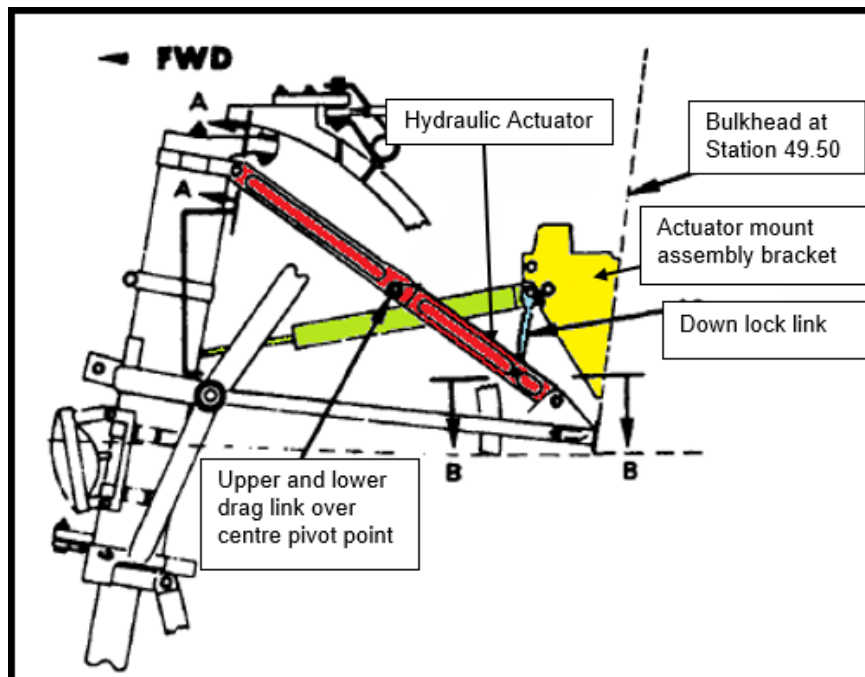
**Diagram 1:** A side-view illustration of an installed nose gear. (Source: Piper-Seneca II Service Manual)
