Section/division **Accident and Incident Investigations Division**

## LIMITED OCCURRENCE INVESTIGATION REPORT – FINAL

| <b>Reference Number</b> | CA18/3/2/1549 | | | | | | |
| Registration | ZU-IFT | | | | | | |

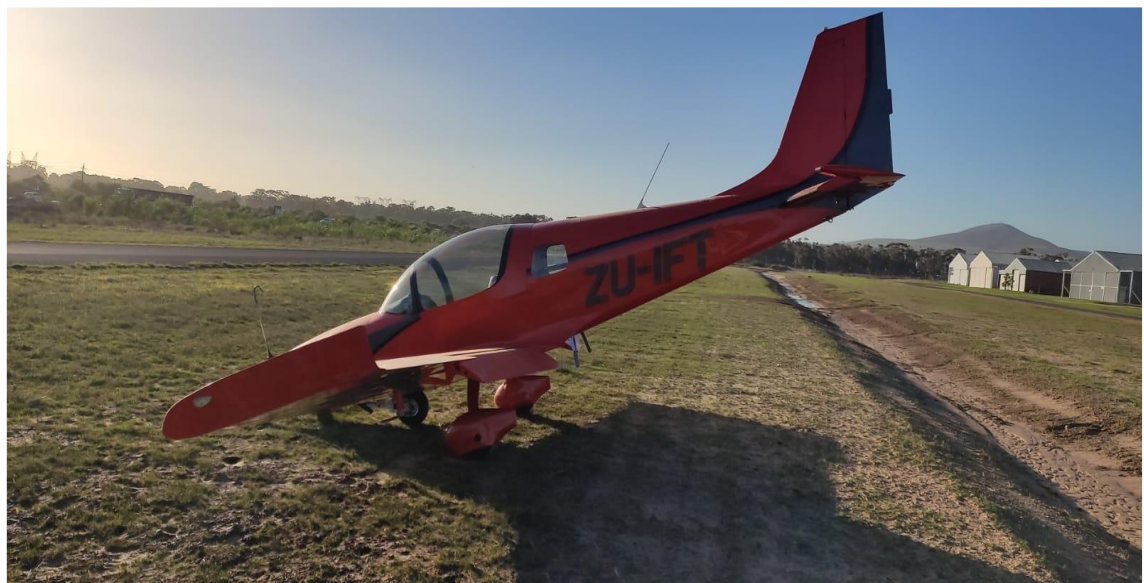
**Figure 2:** The aircraft after it stopped. (Source: Operator)

12. During landing, the aircraft touched down with the nose landing gear first. This resulted in an excessive impact load on the nose landing gear, exceeding its design limitations and leading to the collapse of the nose landing gear.
13. After the landing gear collapse, the propeller struck the asphalt runway surface and sustained substantial damage.
14. The aircraft veered off to the left side of the runway and came to a full stop on the grass alongside it.

The aircraft touched down hard with the nose gear first, creating an impact load that was beyond its design limits which caused the gear to collapse. Subsequently, the propeller struck the runway surface and the aircraft veered off to the left of the runway before it stopped.
