Section/division **Accident and Incident Investigations Division**

## LIMITED OCCURRENCE INVESTIGATION REPORT – FINAL

| <b>Reference Number</b> | CA18/3/2/1551 | | | | | | |
| <b>Make; Model; S/N</b> | Ayres S2R-T34 (Serial Number: 6013) | | | | | | |

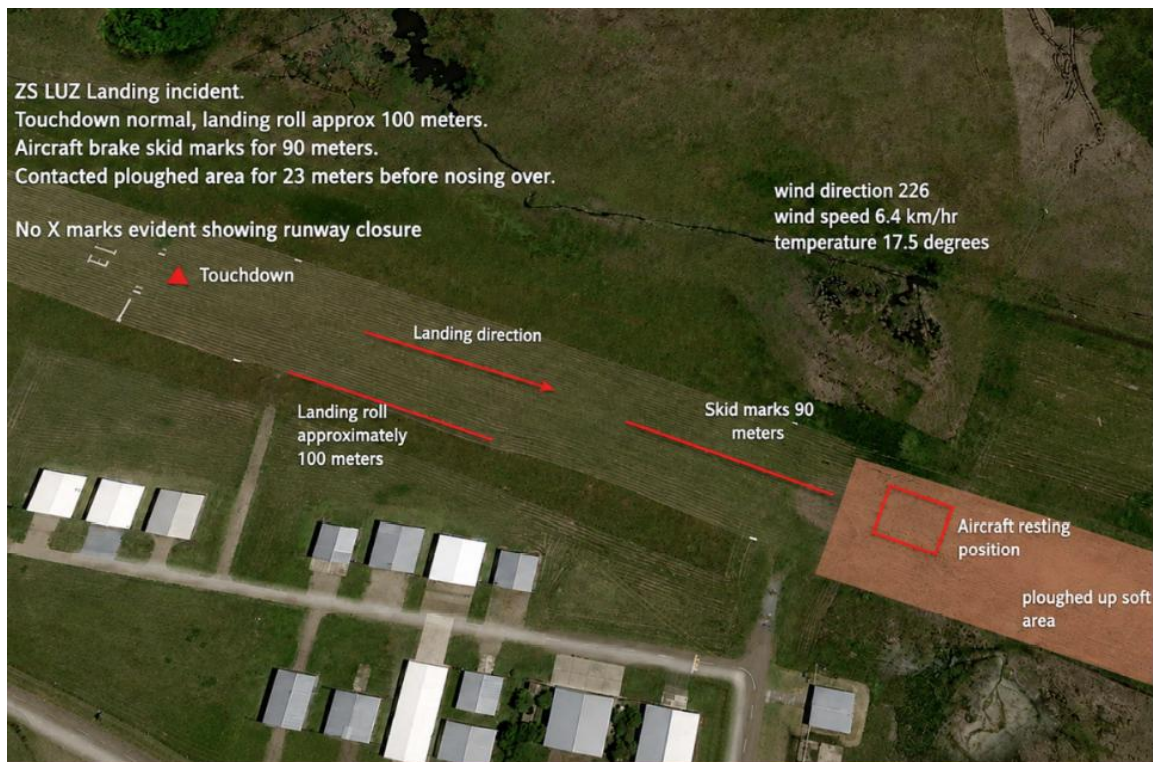
At approximately 1200Z, the pilot commenced with the approach for landing at FABM; he elected to land on the grass Runway (RWY) 13; this runway was temporarily closed due to maintenance works. On final approach, the aircraft was travelling at approximately 80 kts; it touched down on RWY 13 and rolled about 100 metres (m), during which the pilot applied the thrust reverser and, later, toe-brakes. This input caused the landing gear wheels to skid another 90m from the grass-covered runway to the soft ground beyond the runway. As a result, the main landing gear sank into the soft ground, and the aircraft decelerated. The nose pitched down, and the propeller struck the soft ground; subsequently, the aircraft nosed over. The aircraft sustained minor damage; the pilot disembarked from the aircraft uninjured. He later stated that he had forgotten that RWY 13/31 was closed despite having received the relevant Notice to Airmen (NOTAM).

**Figure 1:** An illustration of the sequence of events during the serious incident. (Source: Pilot)

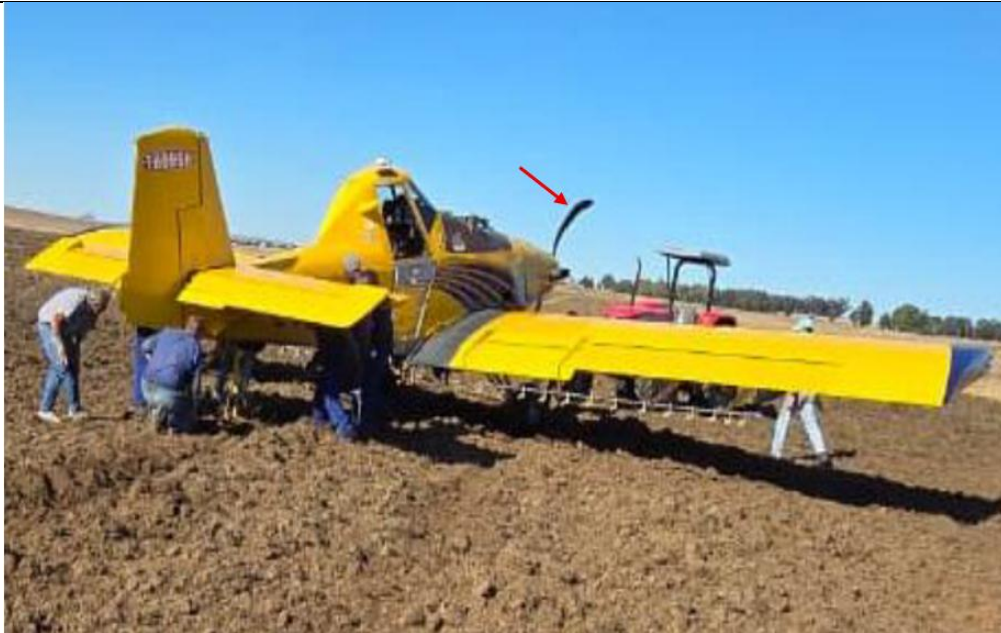
**Figure 2:** The aircraft in its final position at the serious incident site. The red arrow points to the damaged blades. (Source: Pilot)

The aircraft landed on the runway that was closed for maintenance works despite having received and acknowledged the applicable NOTAM; this resulted in the aircraft entering soft ground which caused the main landing gear to sink and, subsequently, nose over.

1. Pilots are reminded to review and comply with all applicable NOTAM during pre-flight planning and before landing.
2. The airfield operator must review procedures to ensure that closed runways are clearly marked to comply with the existing Regulatory requirements as specified in the SA-CATS 139.02.23, Subpart 12.

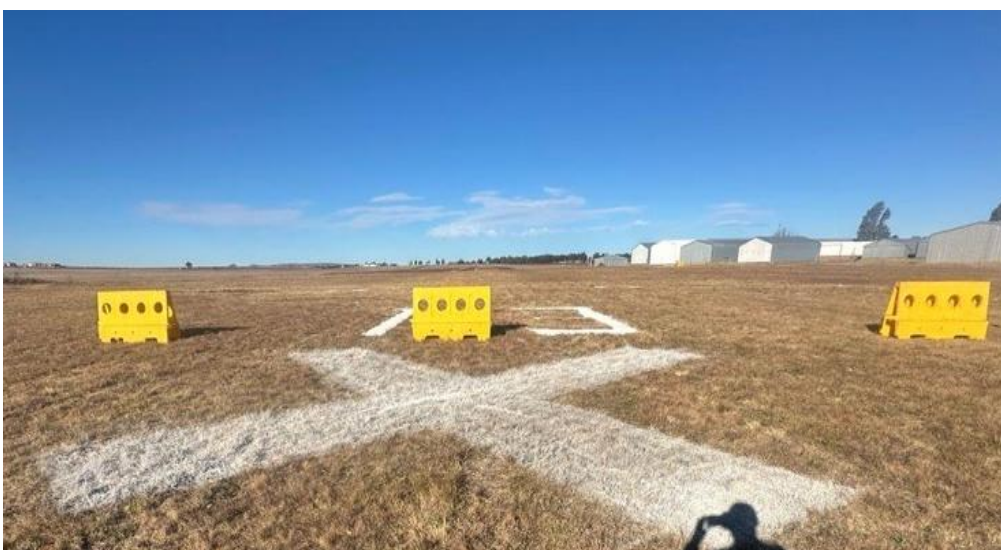
**Figure 3:** Temporary closure markings on RWY 13 after the serious incident. (Source: Aerodrome manager)

The investigation found that the NOTAM was issued (active) prior to the serious incident and no physical runway closure markers were displayed due to the initially planned short duration of the maintenance works and the nature of the repairs. RWY 11/29 remained operational. After the serious incident, temporary runway closure markers were placed on RWY 13/31 on 19 May 2026 (Figure 3).

The airfield (FABM) was not compliant with the requirements of the SA-CATS 139.02.23, Subpart 12. Although the NOTAM was issued which advised of the temporary closure of RWY 13/31, no physical runway closure marking or signage was displayed on the runway at the time of the serious incident. The required marking or signage was only installed (displayed) after the serious incident.

4.1 Bethlehem Airfield (FABM) contravened SA-CATS 139.02.23, Subpart 12 as no visible warning sign about RWY 13/31 closure was displayed during the time of the serious incident.

1. Non-display of runway closure signage or markings.
