## LIMITED OCCURRENCE INVESTIGATION REPORT – FINAL

| <b>Reference Number</b> | | CA18/3/2/1555 | | | | | |
| <b>Registration</b> | | ZU-DHB | | | | | |
| <b>Make; Model; S/N</b> | | TL Ultralite 2000 Sting RG (Serial Number: 03 ST 54) | | | | | |

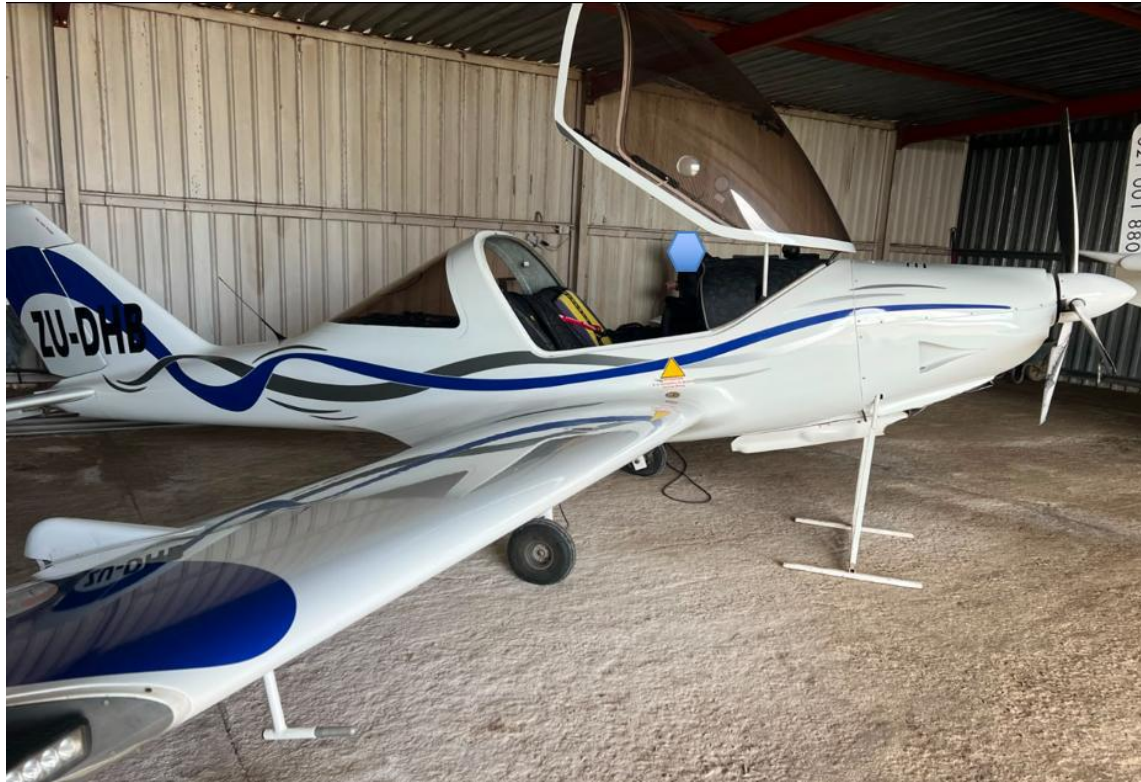
The pilot continued with the approach and the aircraft touched down with the main landing gear wheels first after which the bottom cowling contacted the asphalt runway surface. As a result, the propeller struck the runway surface and the aircraft skidded for several metres (m) before coming to a stop. The aircraft was later recovered to the hangar. The pilot and the passenger disembarked from the aircraft; they were not injured. Post-landing inspection revealed minor damage to the nose landing gear, propeller blades and the bottom engine cowling structure.

**Figure 2:** The aircraft in the hangar after it was recovered. (Source: Pilot)

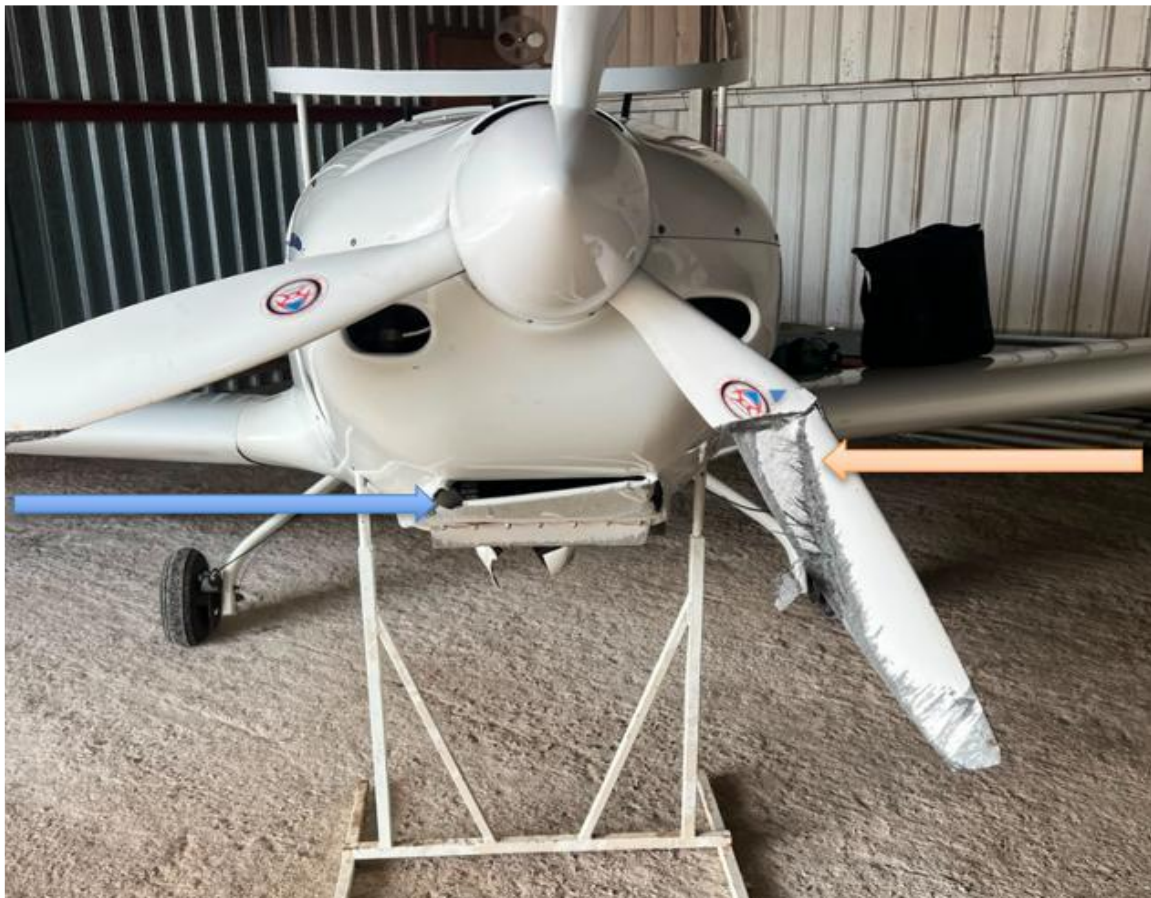
**Figure 3:** The amber arrow indicates the damaged propeller blade, and the blue arrow indicates the damaged cowling area. (Source: Pilot)

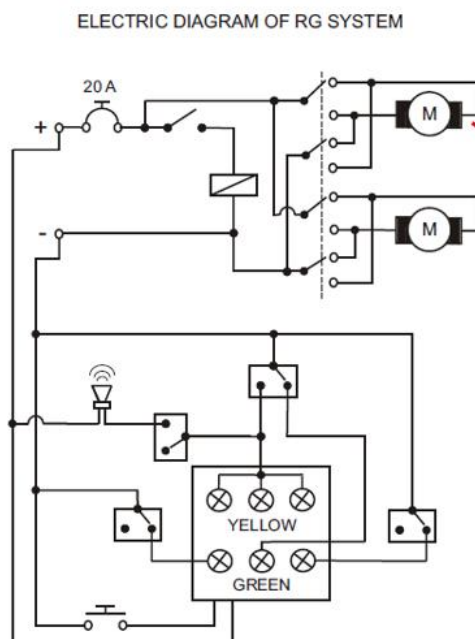
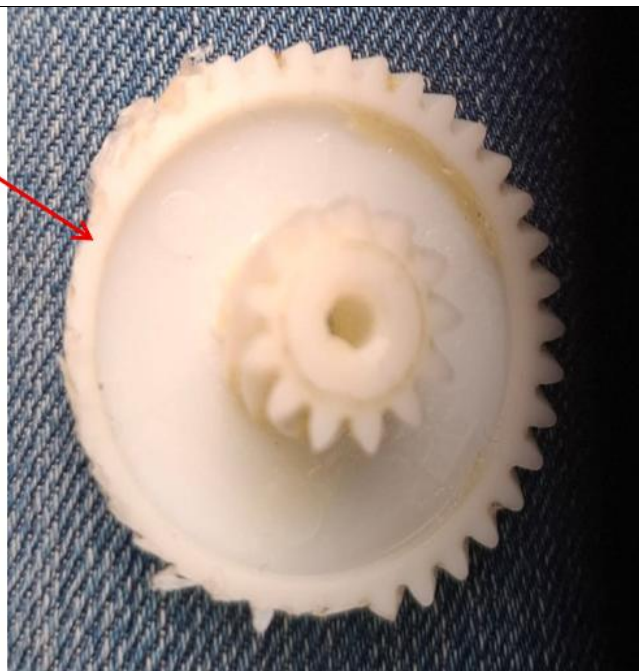
The investigation revealed that the nose landing gear electric servo motor pinion had failed, thus, preventing the nose gear from extending.

**Diagram 1:** The landing gear electrical diagram. The red arrow indicates the nose gear servo motor at the top, and the image on the right shows the failed pinion inside the servo motor.

| A failed electric servo motor pinion prevented the nose landing gear from extending during landing, which resulted in damage to the nose gear, propeller blades and cowling structure. |
