## LIMITED OCCURRENCE INVESTIGATION REPORT – FINAL

| <b>Reference Number</b> | | CA18/3/2/1563 | | | | | |
| <b>Registration</b> | | ZS-PDA | | | | | |
| <b>Make; Model; S/N</b> | | Cirrus SR22 (Serial Number: 2319) | | | | | |

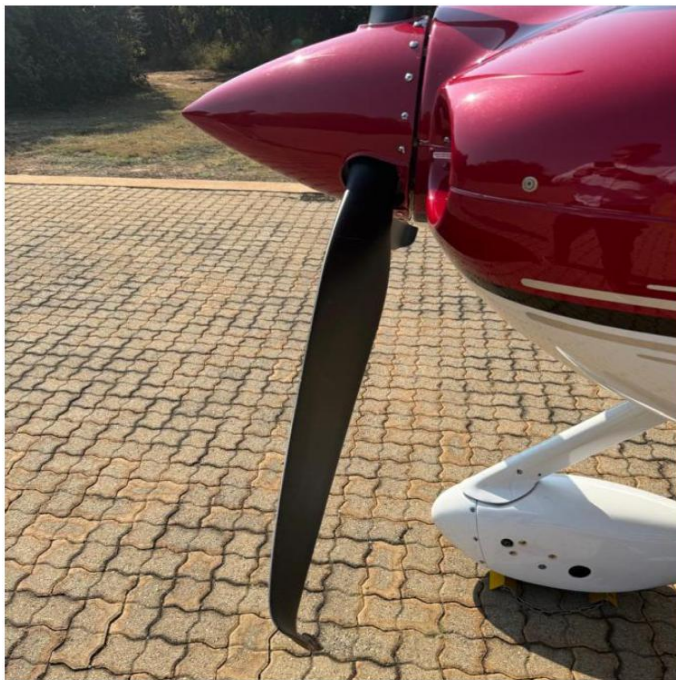
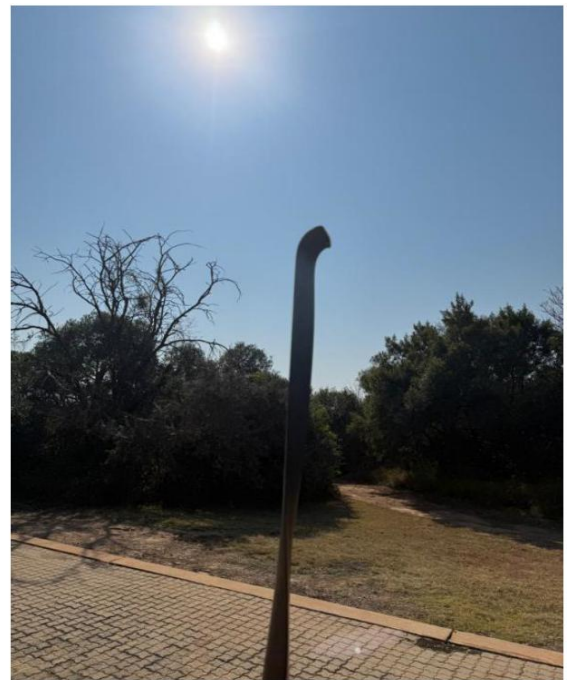
**Figures 2 and 3:** The damaged propeller. (Source: Operator)

| The aircraft landed hard and at an excessive energy which led to a bounce and propeller strike on the runway. |
| Incorrect landing configuration (technique). |
