AIRCRAFT ACCIDENT REPORT AND EXECUTIVE SUMMARY

Reference:	CA18/2/3/9888	
Aircraft Registration	ZT-RHC	Date of Accident	17 June 2020		Time of Accident	1457Z
Type of Aircraft	Bell 206B		Type of Operation		Private (Part 91)	
Pilot-in-command Licence Type	PPL (Helicopter)		Age	54	Licence Valid	Yes
Pilot-in-command Flying Experience	Total Flying Hours		447.6		Hours on Type	209.4
Last Point of Departure	Kitty Hawk Airfield (FAKT), Gauteng Province					
Next Point of Intended Landing	Grand Central Airport (FAGC), Gauteng Province					
Location of the accident site with reference to easily defined geographical points (GPS readings if possible)						
New Road adjacent FAGC, Gauteng province (GPS position: 25°59'16.81" South, 028°8'19.37" East, elevation 5302 ft)						
Damage to Helicopter	Destroyed					
Meteorological Information	Wind: 120° 17kts gusting 24kts, Temperature: 6°C, Dew Point: 4°C, Visibility: 9999m, QNH: 1034 hPa					
Number of People On-board	1+1	No. of People Injured	0	No. of People Killed	2

Synopsis	<p>On 17 June 2020, a Bell 206B helicopter with registration ZT-RHC took off on a private flight from Kitty Hawk Airfield (FAKT) in Gauteng province to the Grand Central Airpo

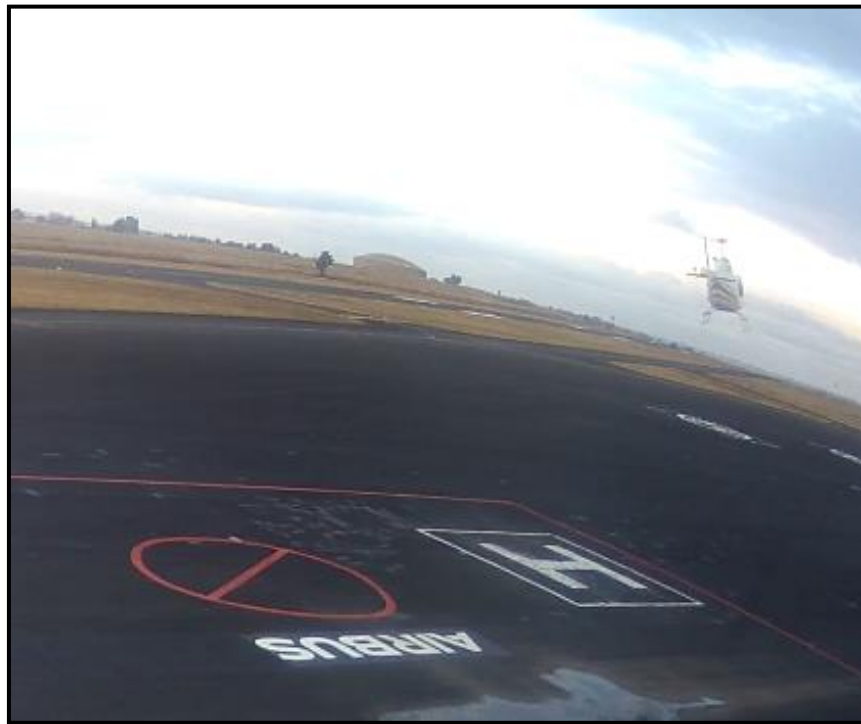
- 1.1.3.1 The first video footage showed the helicopter approaching the helipads. The helicopter was then seen making a descent with forward movement (a normal approach for landing on a helipad). As the helicopter passed the airbus helipads, it slowly started to yaw left with its nose facing east. The helicopter pilot then flew past both the first and the second sets of helipads, ending up in the area between the helipads and the parked aircraft on the apron, facing east.

Figure 1: A video footage of the helicopter when is started to yaw to the left. (Source: Airbus Helicopters)

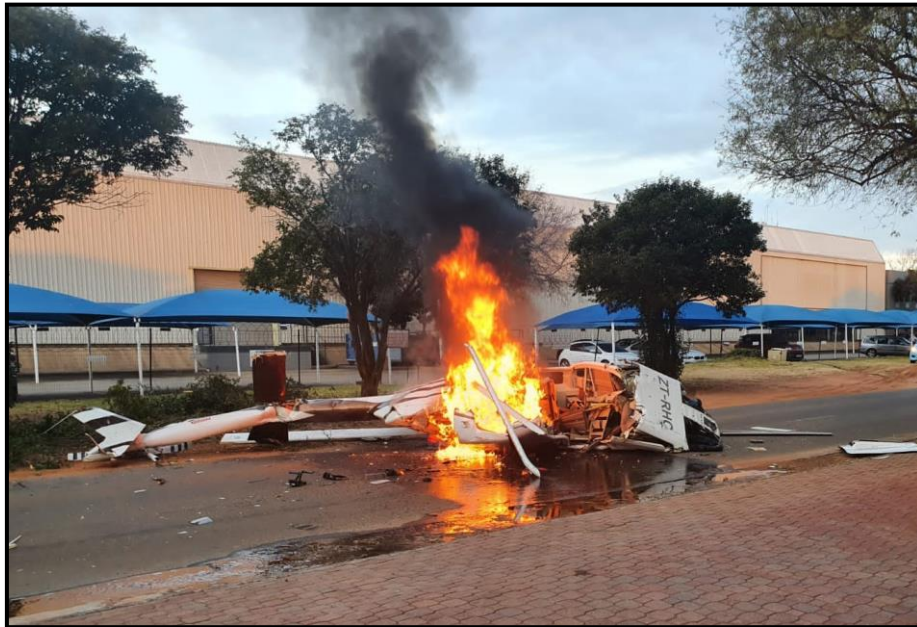
- 1.1.3.4 The fourth video footage, also facing New Road, showed the helicopter with its nose-low and the tail-high attitude, and in a high-rate of descent before impacting the ground. The helicopter impacted the ground hard with both front ends of the skid gears before turning sharply in a south-westerly direction and rolling onto its left side. White smoke was immediately seen coming from the helicopter and, 10 seconds later, a post-impact fire with black smoke ensued from the engine side, engulfing the middle section of the helicopter. The fire-fighters responded to the scene shortly thereafter and extinguished the fire. It was also noted that ample fuel had leaked from the helicopter and was ignited by the hot section of the engine.

Figure 2: The helicopter engulfed in flames. (Source: Eyewitness)

1.3.1 The helicopter was destroyed during the accident sequence and by a post-impact fire (see Figure 2).

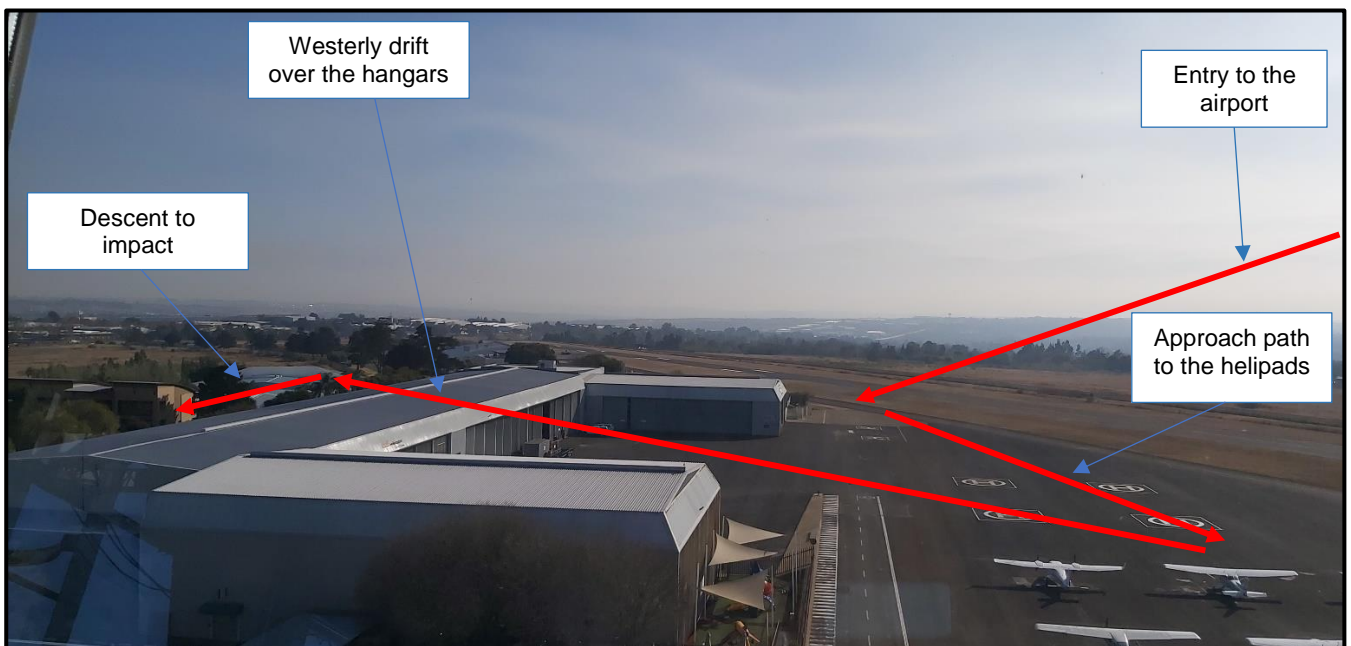
- 1.1.4 The helicopter was destroyed by impact forces and a post-impact fire, and both occupants were fatally injured.
- 1.1.5 The accident occurred during daylight on New Road adjacent to FAGC in Gauteng province at Global Positioning System (GPS) co-ordinates determined to be: 25°59'16.81" South, 028°8'19.37" East at an elevation of 5302ft.
- 1.1.6 Figure 3 shows the path the helicopter followed as it crossed the runway from the east and turning south to approach the helipads before losing control and drifting towards the west, and subsequently crashing on New Road, which is located adjacent to FAGC.

Figure 3: The red line depicts the flight path of the helicopter. (Source: Google Earth)

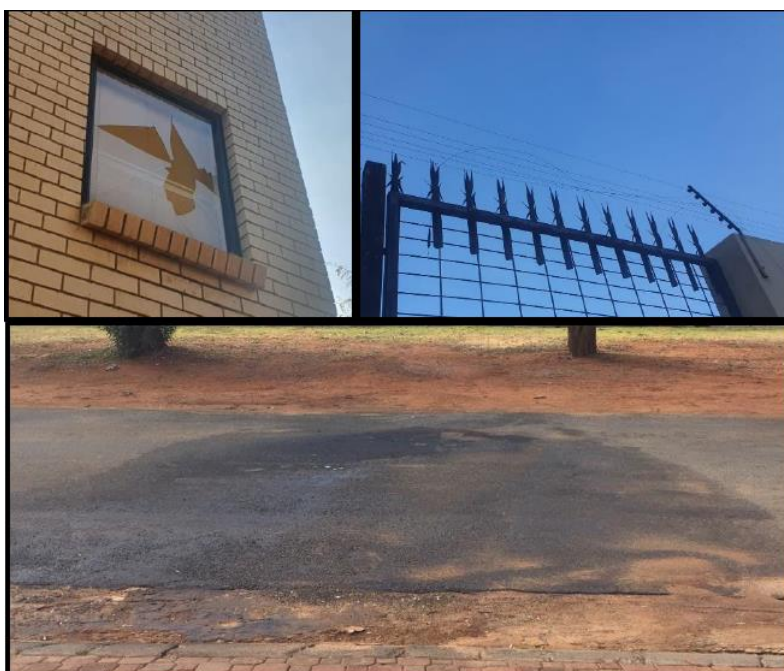
1.4.1 During the impact sequence, the main rotor severed some tree branches which broke a window and cut off an electric fence of a building adjacent to the accident site. The main rotor impacted the road and left a mark on it, while the post-impact fire caused some damage on the tarred road.

Figure 4: A broken window, severed electric fence and the burnt tarred road surface caused during the accident sequence.

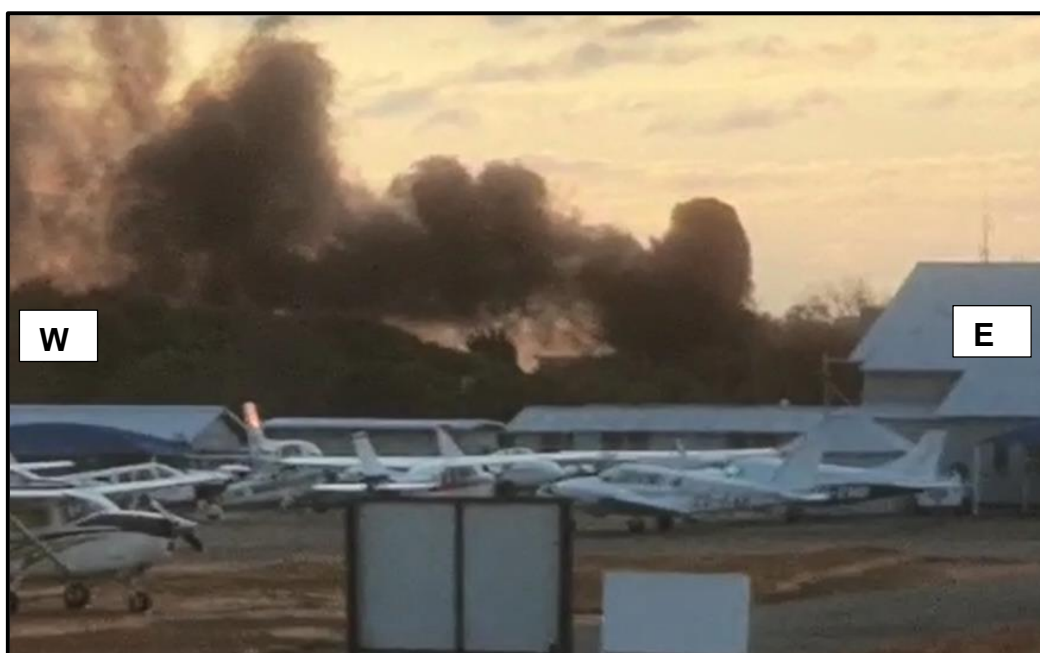
1.7.2 The wind condition at the accident site was confirmed by a video footage provided by an eyewitness showing smoke from the burning wreckage which was moving from the east to the west moments after impact (see Figure 5).

Figure 5: Video footage showing movement of smoke at the accident site. (Source: Eyewitness)

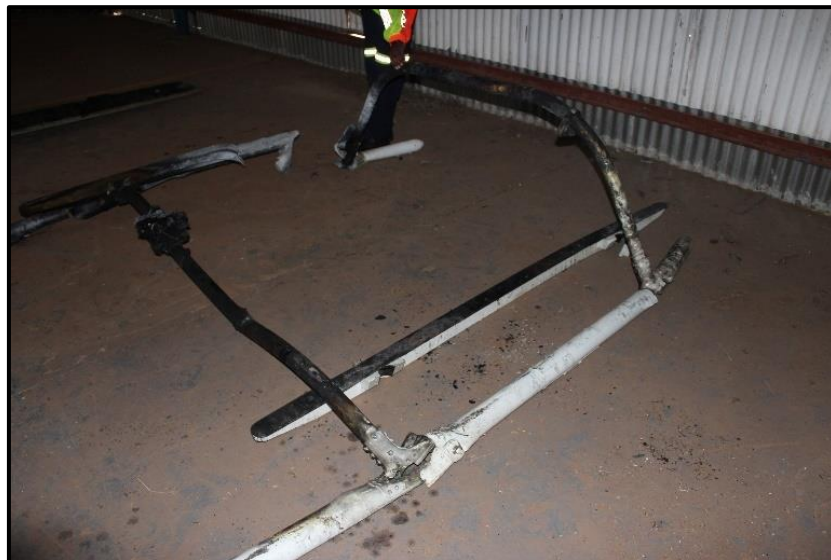
1.12.2 The bottom centre section of the cockpit floor was burnt; it had separated from the rest of the helicopter during recovery. The skid gear had broken off at different points. The front cross tube was bent downwards; it had separated as a result of high-vertical impact force, indicating a nose-down attitude on impact. The rear cross tube was still intact although it had separated from the attachment mounts.

Figure 6: The skid gear assembly after the accident.

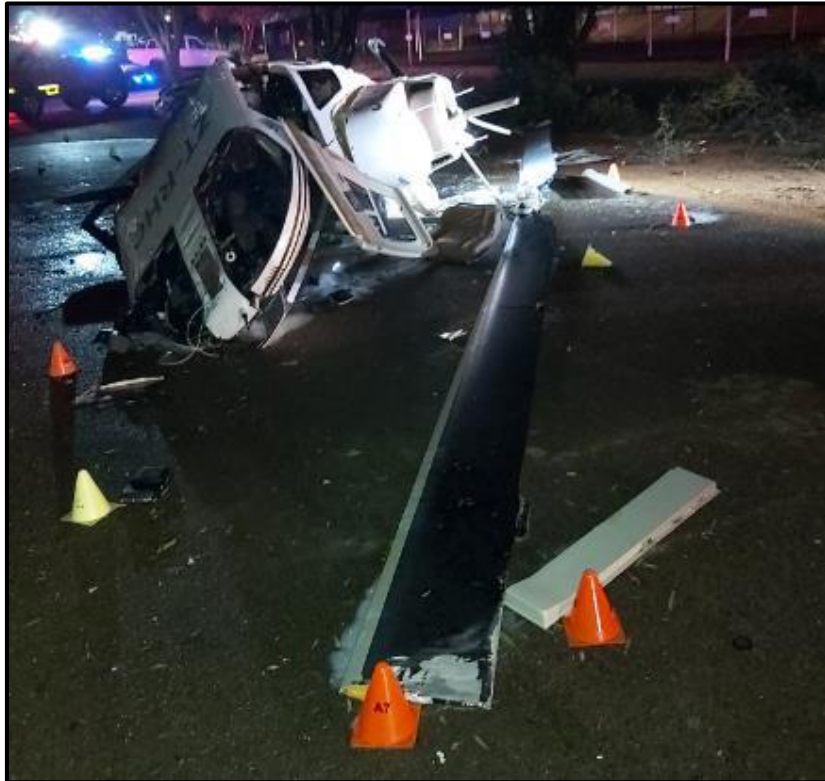
1.12.3 The main rotor blades were still attached to the hub, but the mast had failed as a result of overload fracture. One of the main rotor blades showed impact damage at the tip, whereas the other rotor blade had dents, creases and scratches on the surface, indicating impact damage.

Figure 7: The main rotor blade assembly after the accident.

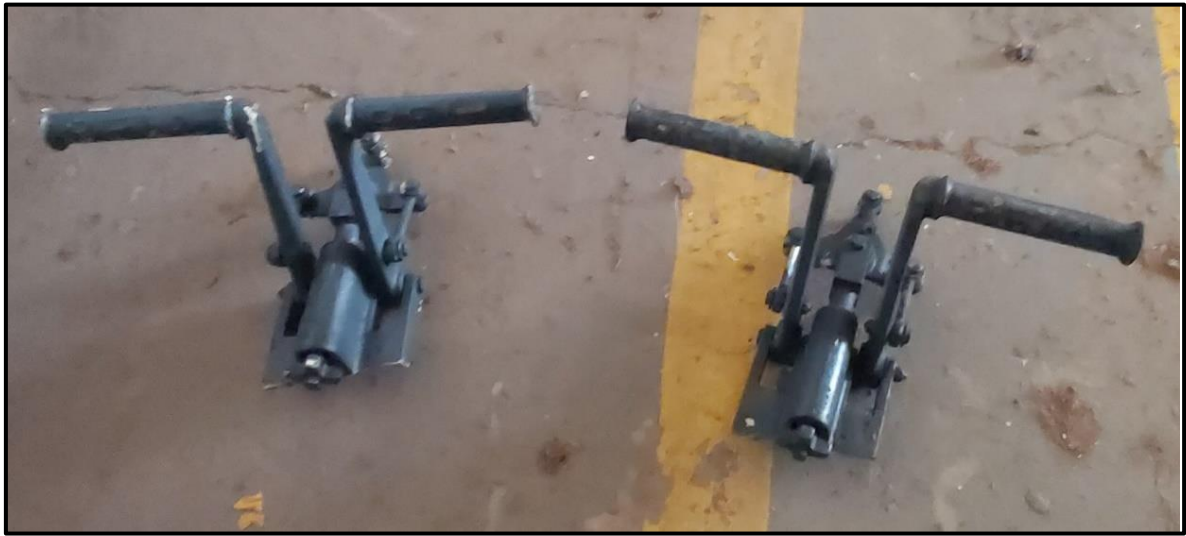
1.12.4 The tail boom mid-section exhibited compression load stress at the bottom, indicating a high-energy impact; it was also burnt where it attaches to the fuselage. The tail drive shaft assembly was still attached on the hangar assemblies. The lower section of the vertical fin was found crushed with the stinger detached. The tail rotor blades were still attached to the tail rotor output shaft. One of the blades exhibited damage on the tip, indicating impact with the ground (see Figure 9). The tail gearbox fairing had fracture damage near the output shaft. It was noted that both pedals were severed from the helicopter due to impact. The right pedals were found outside the helicopter while the left pedals were found inside.

Figure 8: Both tail rotor pedals were found severed.

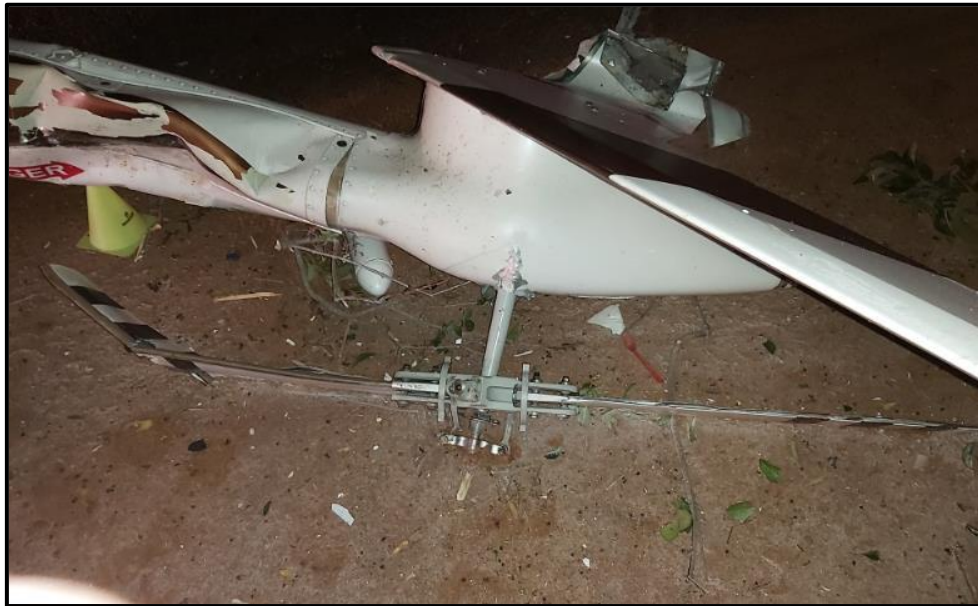
Figure 9: The tail rotor section after the accident.

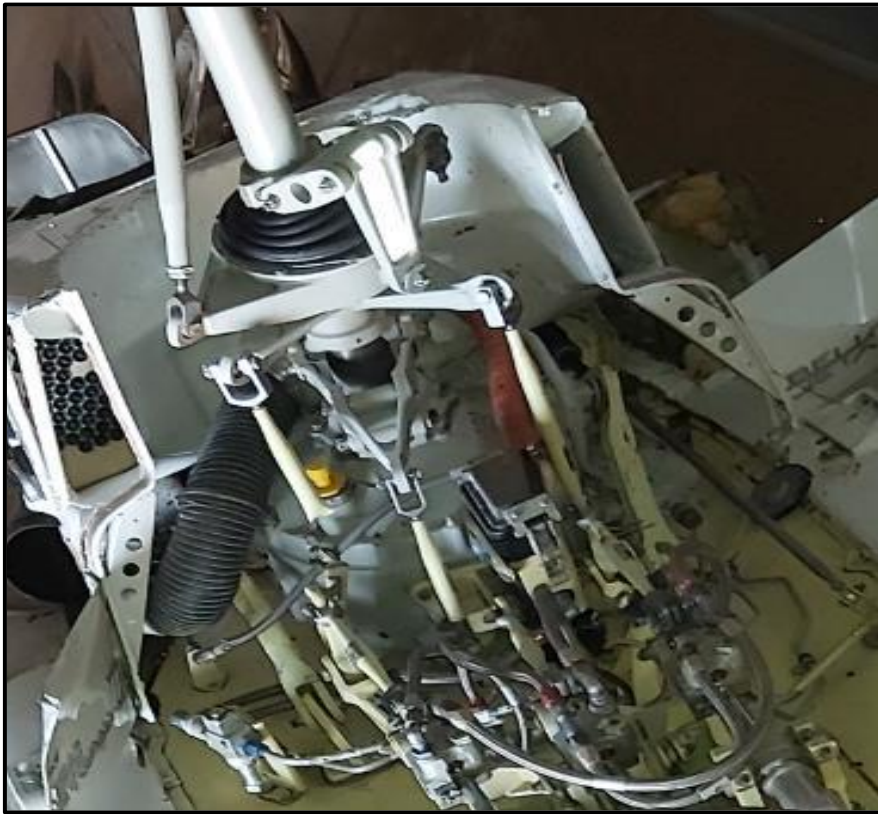
1.12.5 The main gearbox was still intact; however, the mounting strut was slightly bent. The outside condition of the gearbox was good and there were no oil leaks visible around the casing. The mast had fractured near the main rotor hub. The drive shaft was severely damaged and had separated from the gearbox. The swash plate rotating and non-rotating star were still intact (see Figure 10).

Figure 10: The swash plate assembly.

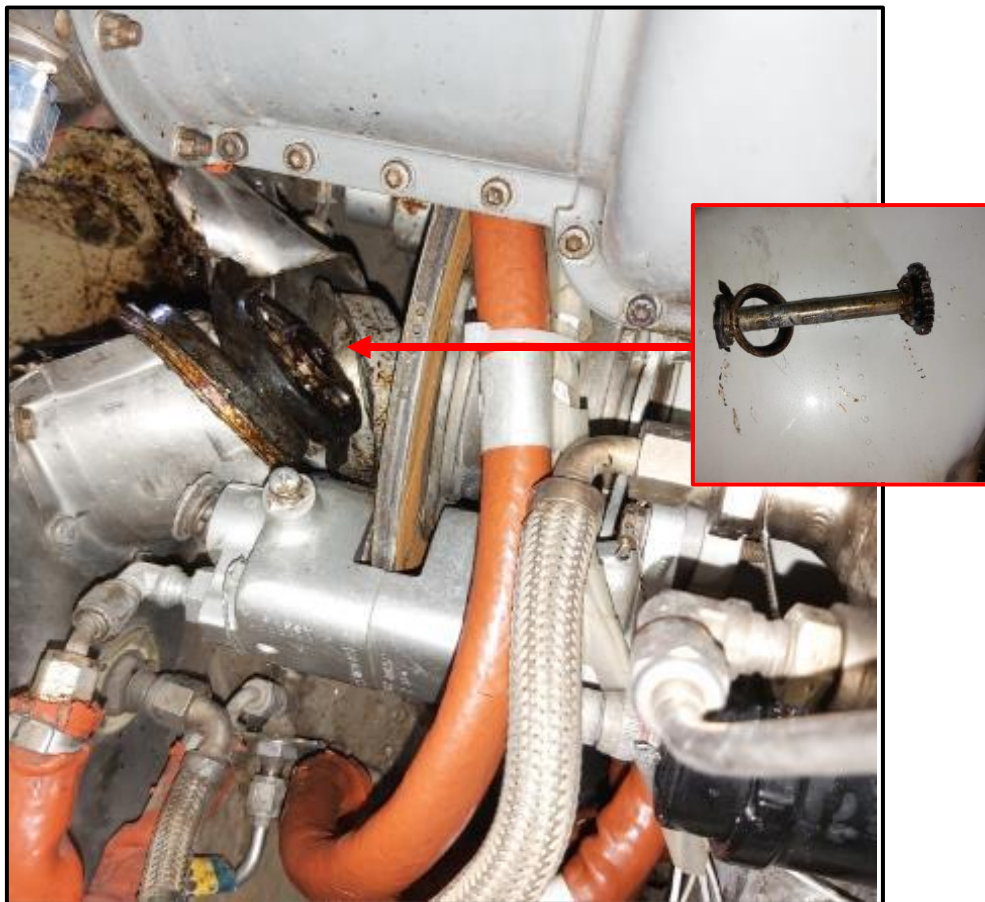
Figure 11: The damaged output drive shaft.

result of impact. The output shaft was severely damaged and had separated from the engine and gearbox as a result of a sudden stoppage (see Figure 11). The oil and fuel pipes were still intact and there were no visible ruptures or punctures.

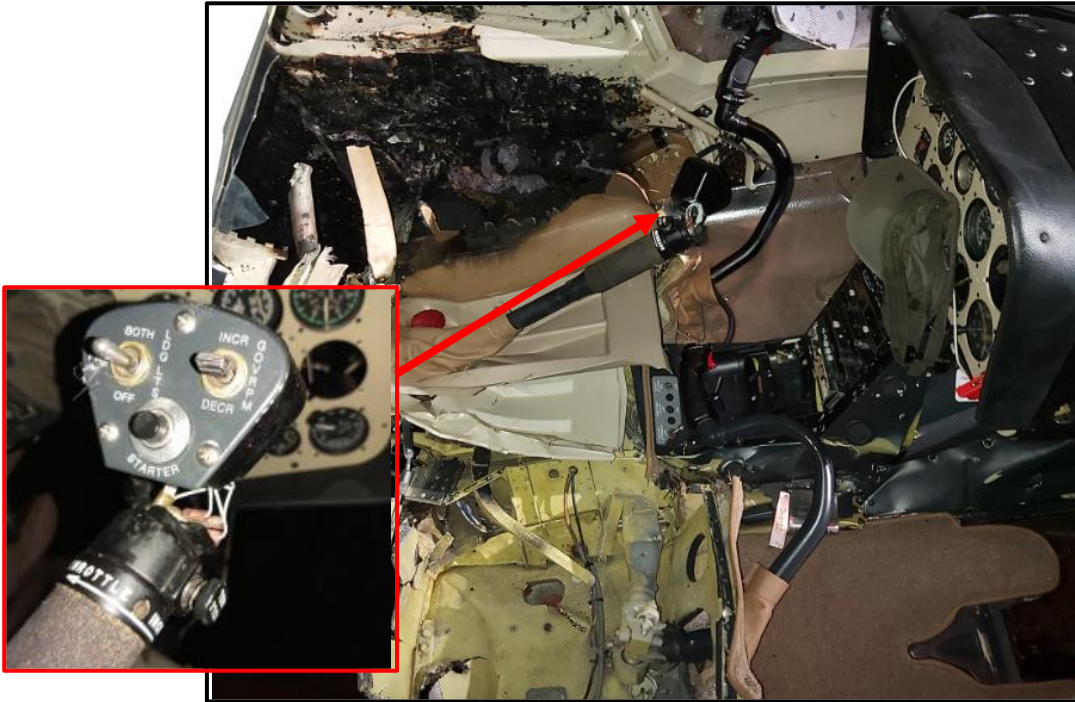
1.12.6 The left pitch change control tube was severely damaged and had separated from the hub assembly. The flight control actuators were still intact; there were no visible leaks on the upper deck. The continuity check was done on the control tubes by moving the tubes

individually by hand. All control tubes movement corresponded with the bell-cranks movement above the transmission deck, except for those that were damaged by impact force. The helicopter was fitted with dual controls. The pilot-in-command collective handle had broken off and was found hanging by its electrical wires. The twist grip throttle was moved by hand; the movement caused a change on the interlinking control tube indicating continuity. The friction adjustment knob was found stuck as a result of a jam in the unit. The pilot cyclic stick was still attached; however, the connecting rods were found broken due to impact. The left cyclic had broken off from its mounting point.

Figure 12: The damaged flight controls.

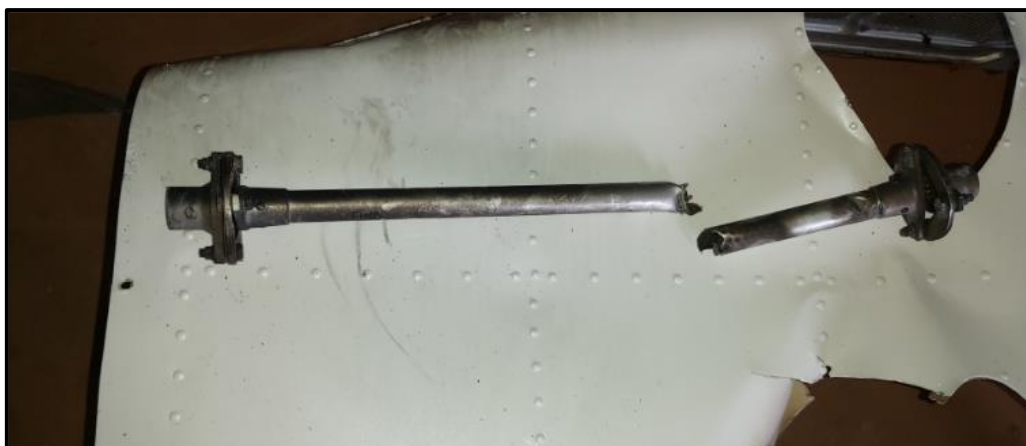
1.12.7 The main drive shaft assemblies were still attached to the main bearings. The input drive shaft had a twisted fracture as a result of a sudden stoppage, indicating an engine that was producing power when it suddenly stopped. The input shaft came off from the splines and was found lying underneath the engine compartment.

Figure 13: The damaged input shaft.
