LIMITED ACCIDENT INVESTIGATION REPORT

Reference Number	CA18/2/3/9940						
Classification	Accident	Date	10 January 2021	Time	0810Z		
Type of Operation	Private (Part 91)						
Location							
Place of Departure	Brits Aerodrome (FABS)		Place of Intended Landing	Brits Aerodrome (FABS)			
Place of Accident	In the Crocodile River 3.5nm Southwest of FABS, Northwest Province						
GPS Co-ordinates	Latitude	25°35'37.5" S	Longitude	027°45'28.5"E	Elevation	3555 ft	
Aircraft Information							
Registration	ZU-RAJ						
Make/Model	Aerospatiale SE 3130-Alouette II (Serial Number. 1414)						
Damage to Aircraft	Destroyed		Total Aircraft Hours	8517			
Pilot-in-command							
Licence Valid	Yes	Gender	Male	Age	58		
Licence Type	Private Pilot Licence (PPL)						
Total Hours on Type	429.9		Total Flying Hours	936.4			
People On-board	1+2	Injuries	2	Fatalities	1	Other (On ground)	0
What Happened							
<p>On Sunday morning 10 January 2021, the pilot accompanied by two passengers on-board an Alouette II helicopter with registration ZU-RAJ, took off from Brits Aerodrome (FABS), in the Northwest province on a private (scenic) flight to Roodekoppies Dam, which was approximately 12.5 nautical miles (nm) fr

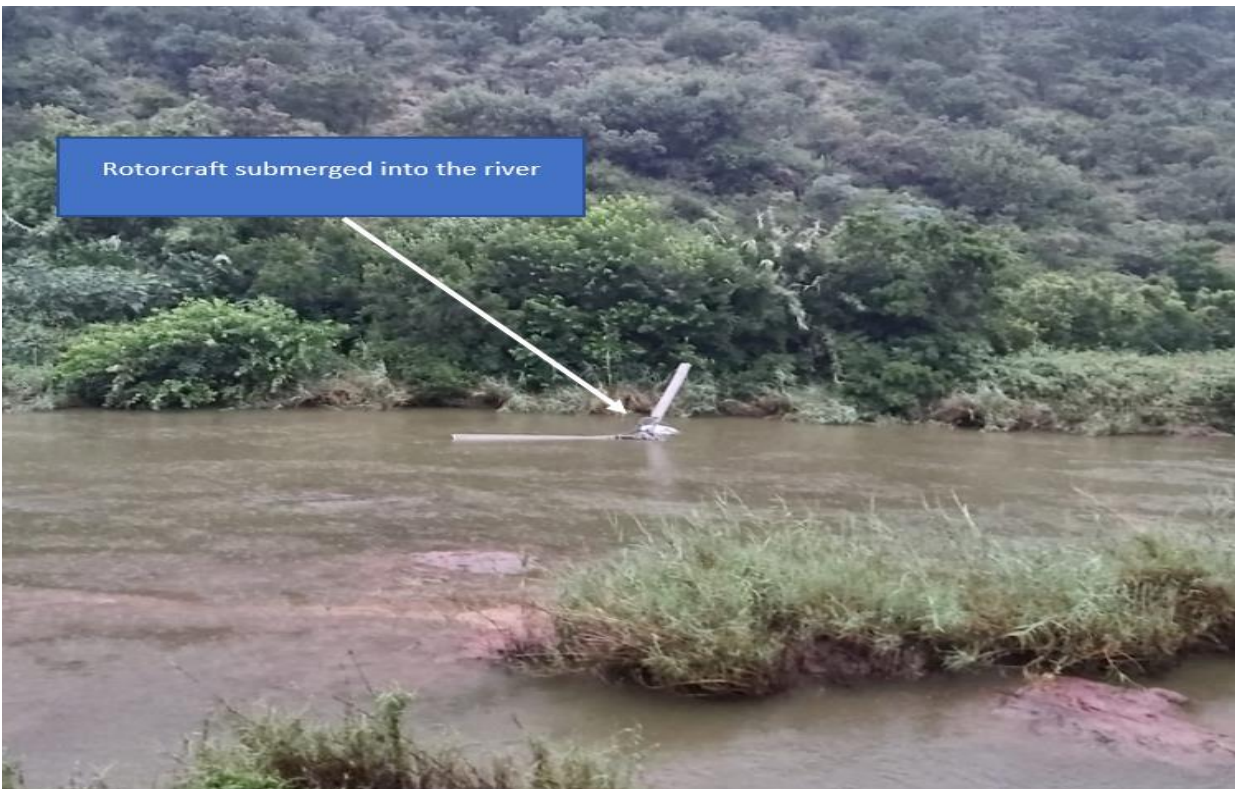
After impact with the water the pilot managed to free himself and once surfaced, he swam to shore. He then walked for approximately 2 kilometres (km) looking for help. The Helicopter Emergency Medical Services (H.E.M.S) and South African Police Services (SAPS) were called to the scene. A witness who is a resident where the accident happened reported that on the morning of 10 January 2021 at approximately 11 o' clock while sitting on the porch of his house, he suddenly heard the sound of a helicopter engine that was approaching his house from the north: upstream. All of a sudden, the engine went quiet, and he heard a faint clicking sound. The witness further reported that what he found strange was the sound of seven pistols shots, followed by what sounded like a burst of automatic gun fire. He suspected that these sounds were that of shooting taking place at the Rashoop shooting range which is close to their area. Following the confirmation of the accident he also considered the possibility that the cracking sounds could have been caused by the rotors of a helicopter as it hit the water.

Figure 3: Showing rotorcraft underwater.

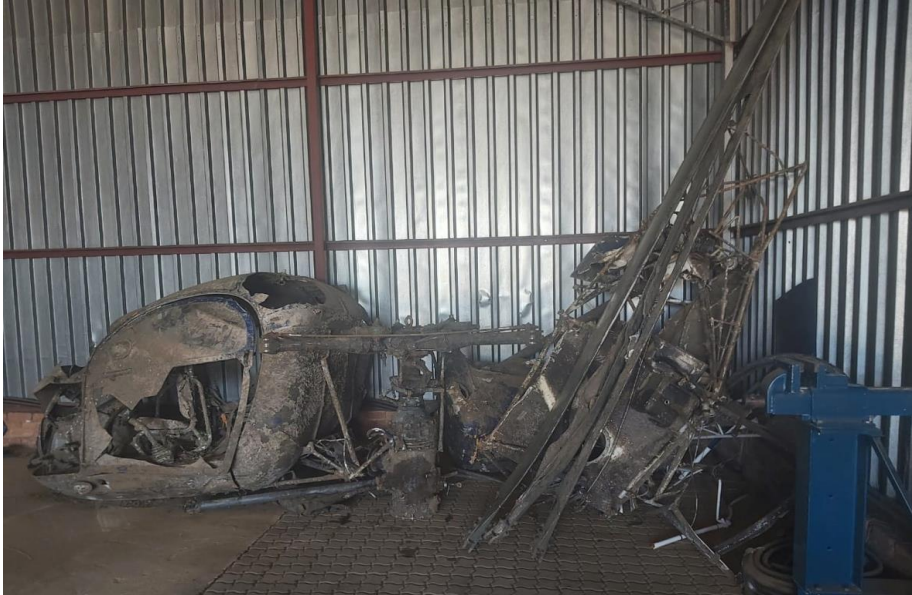
- During onsite visit at the pilot's hangar on 18 November 2021 the investigators found the wreckage of the helicopter with some of the parts missing, among other parts that were missing were the engine, some of the instruments panels and the rotor blades were found at nearby shacks, the pilot stated that the missing parts were stolen whilst the helicopter was in the river before it can be recovered on August .(See figure 3 & 4 as it was found at pilot's hangar)

Figure 3: Picture of the helicopter after recovery

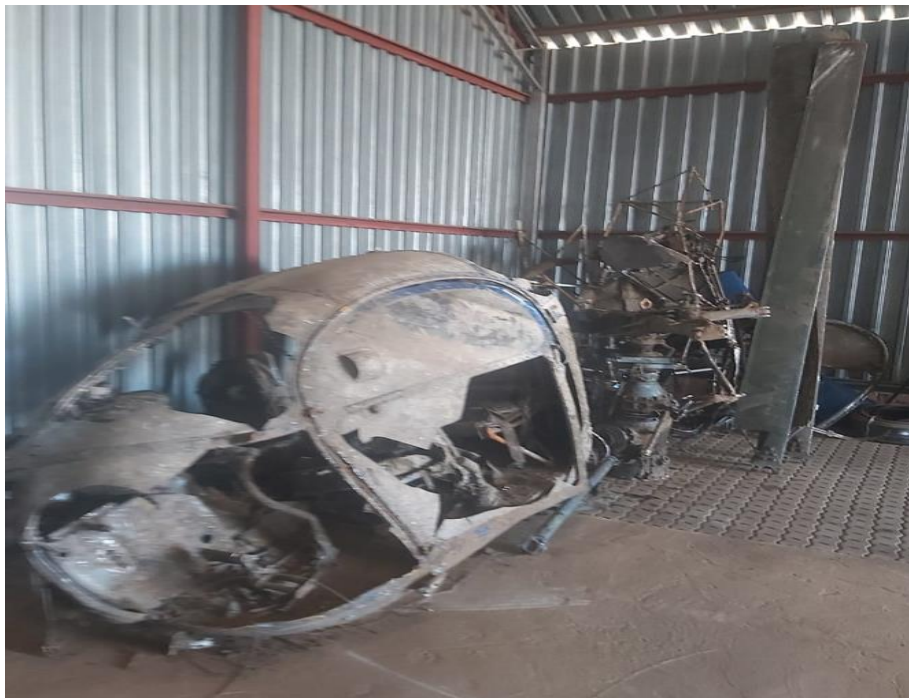
Figure 4: Picture of the helicopter after recovery

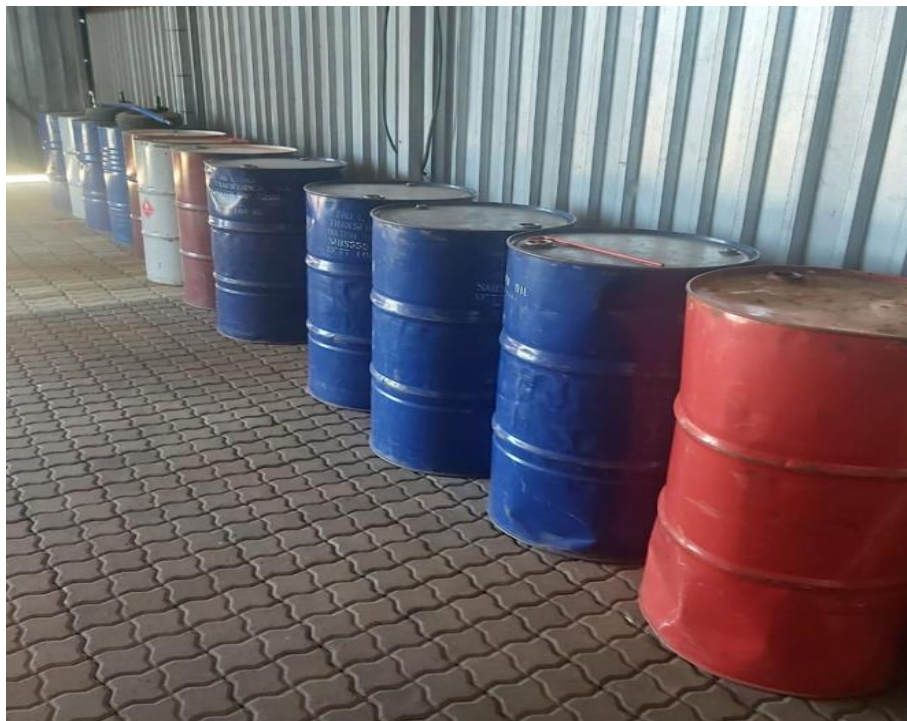
- There were eleven drums of approximately 200 litres each full of Jet A-1 and they were all sealed with torques seal. The pilot further reported that he used Jet A-1 fuel on the helicopter engine and he also provided fuel receipts. The fuel was kept in the drums which were used to keep avgas 100LL fuel as they are very strong and durable. (See figure 5 & 6)

Figure 5: Drums were the fuel was kept.
