AIRCRAFT ACCIDENT REPORT AND EXECUTIVE SUMMARY

Reference:		CA18/2/3/9970	
Aircraft Registration	ZU-CPJ	Date of Accident	17 March 2021		Time of Accident	0650Z	
Type of Aircraft	Windlass Aquilla Trike			Type of Operation	Training (Part 141)		
Pilot-in-command Licence Type	National Pilot Licence (NPL)		Age	58	Licence Valid	Yes	
Pilot-in-command Flying Experience	Total Flying Hours			21 826	Hours on Type	105.8	
Last Point of Departure	Ballito Airfield, KwaZulu-Natal Province						
Next Point of Intended Landing	Ballito Airfield, KwaZulu-Natal Province						
Damage to Aircraft	Destroyed						
Location of the accident site with reference to easily defined geographical points (GPS readings if possible)							
Skyland sugarcane farm, north-east of Ballito Airfield at Global Positioning System (GPS) co-ordinates determined to be 29°29'11.14" South 31°10'53.93" East at an elevation of 230 feet (ft)							
Meteorological Information	Wind direction: 100°; Wind speed: 4kts; Temperature: 22°C; Cloud Cover: Few; Cloud Base: 3 800ft; Visibility: 9 999m; QNH: 1013hPa

Reference Number : CA18/2/3/9970
Occurrence Category : Category 1
Type of Operation : Training (Part 141)
Name of Operator : Ballit

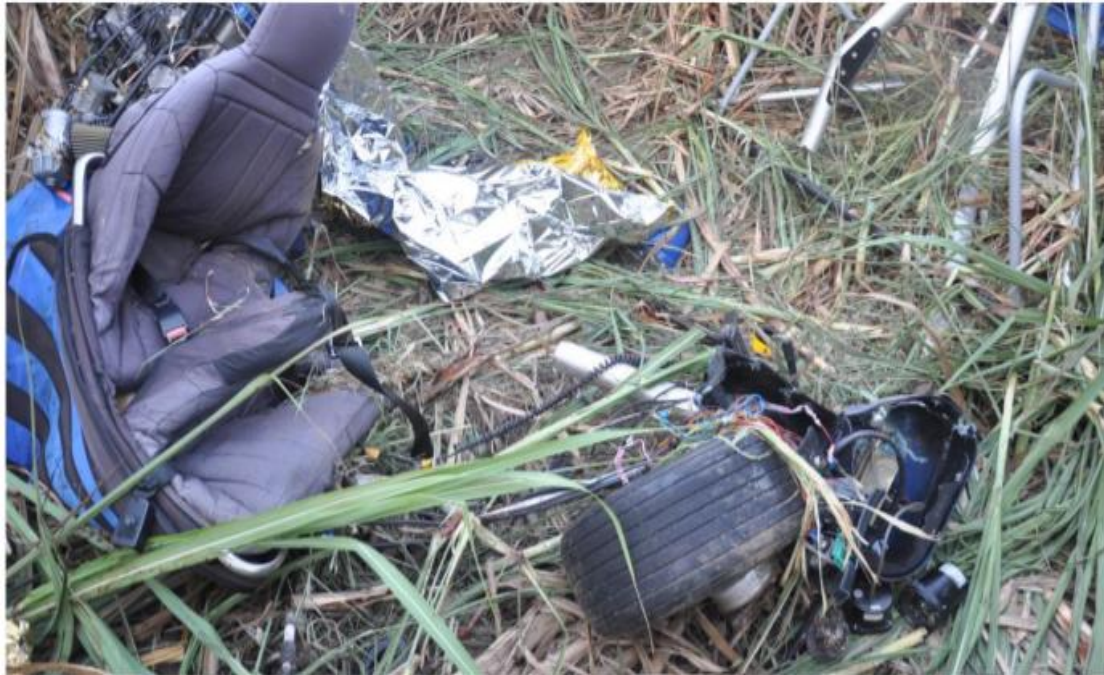
1.3.1. The aircraft was destroyed during the accident sequence.

Figure 2: The final resting position of the microlight at the site.

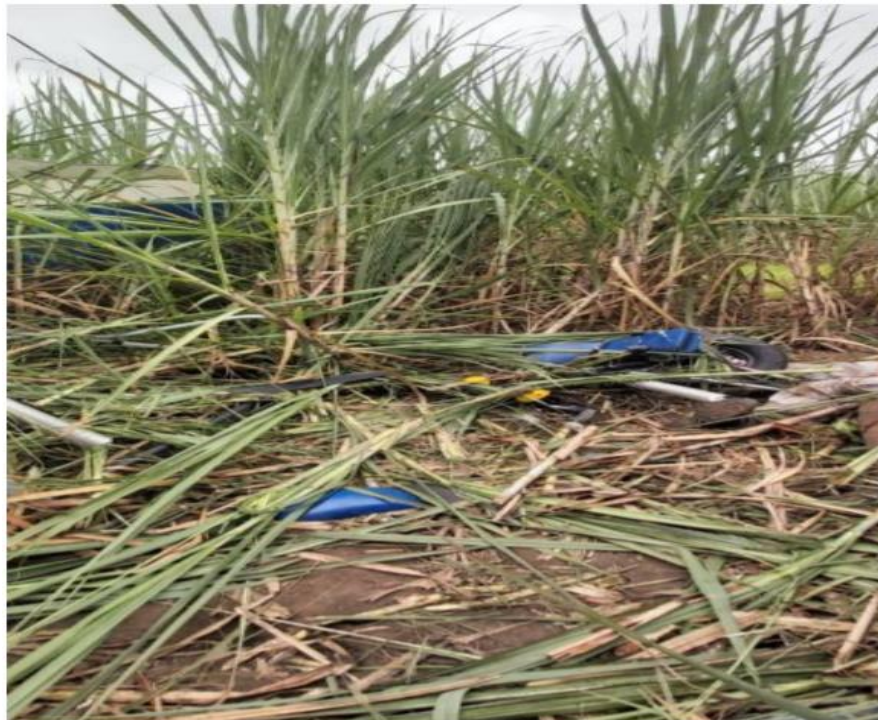
1.4.1. Some sugarcane crops were damaged during the accident.

Figure 3: Damaged sugarcane crops.

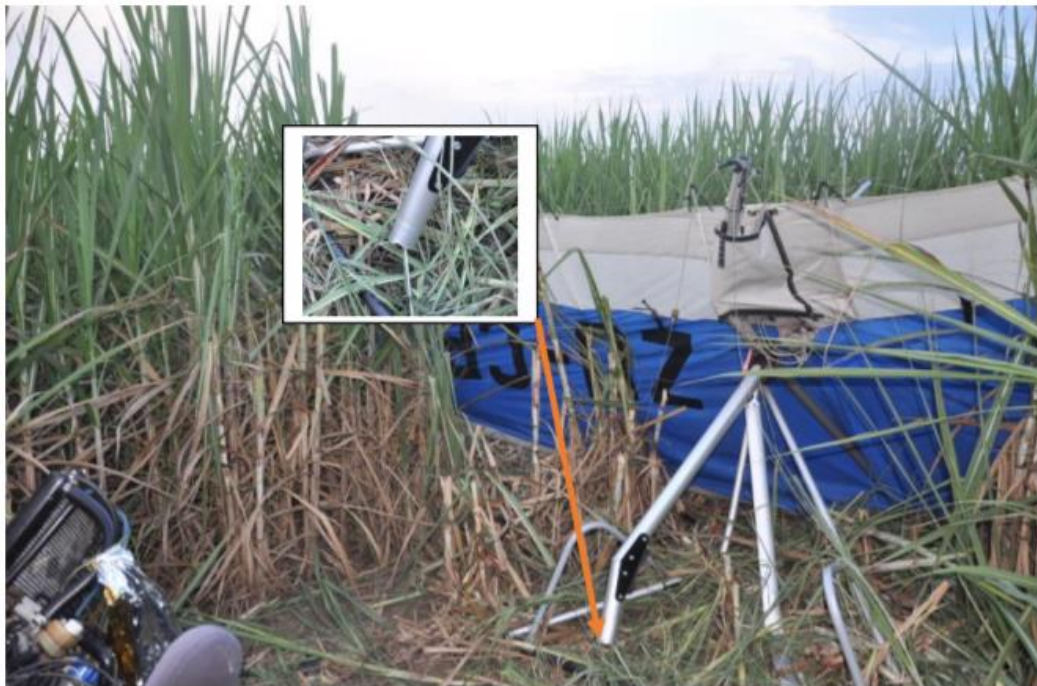
1.12.1 The microlight struck the ground in a steep nose-down attitude approximately 624m north-east of the extended centreline of Runway 08. The wing separated from the structure/mainframe and was found next to the mainframe. The wing's leading edge was intact and the cables that attach and keep the wing structure together were not frayed or broken. The trapeze down tubes, corner fittings, attachment points, bracket bolts and nuts were in place. The fixed washout tubes on the wing tips were still intact. The general condition of the main support tube was good; however, a shear lip fracture was visible where it attaches to the mainframe, indicative of instantaneous failure due to impact sequence. The wing fabric was not torn. The cable that prevents wing separation from the main support tube appeared to have a cut which is consistent with the shear lip fracture of the main support tube. The hang point assembly was still intact, and it was configured with training bars to facilitate operation from the tandem seat. The pylon pivot point was still intact and no sign of damage was visible. The flying cables were also still intact.

Figure 4: Wing section and hand glide fitted with training bars extend tubes.
The inset shows extended training bars.

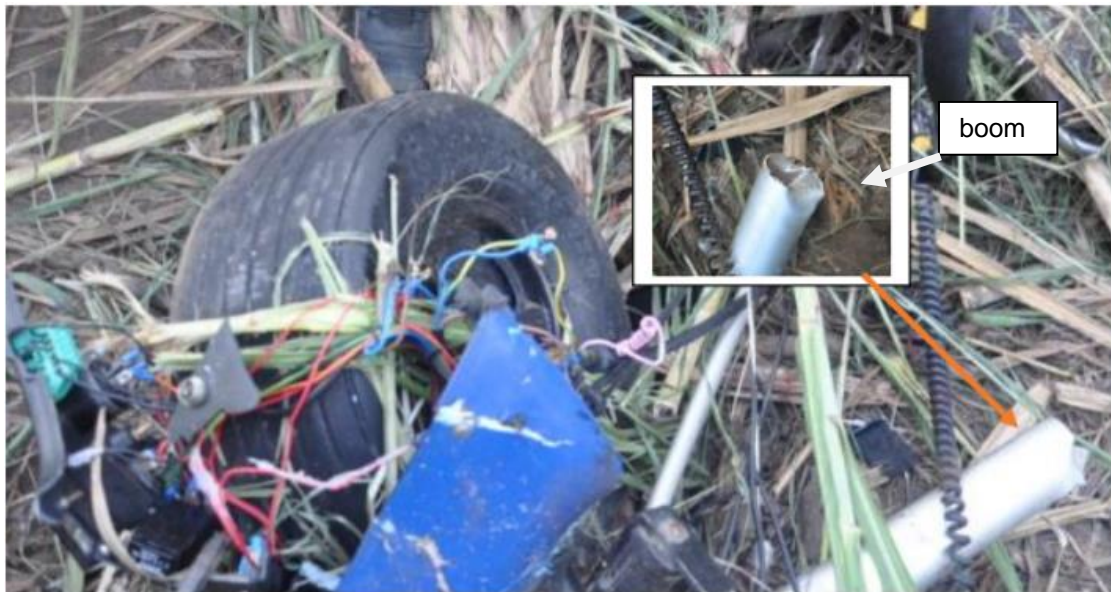
Figure 5: The boom that fractured and separated from the nose gear.

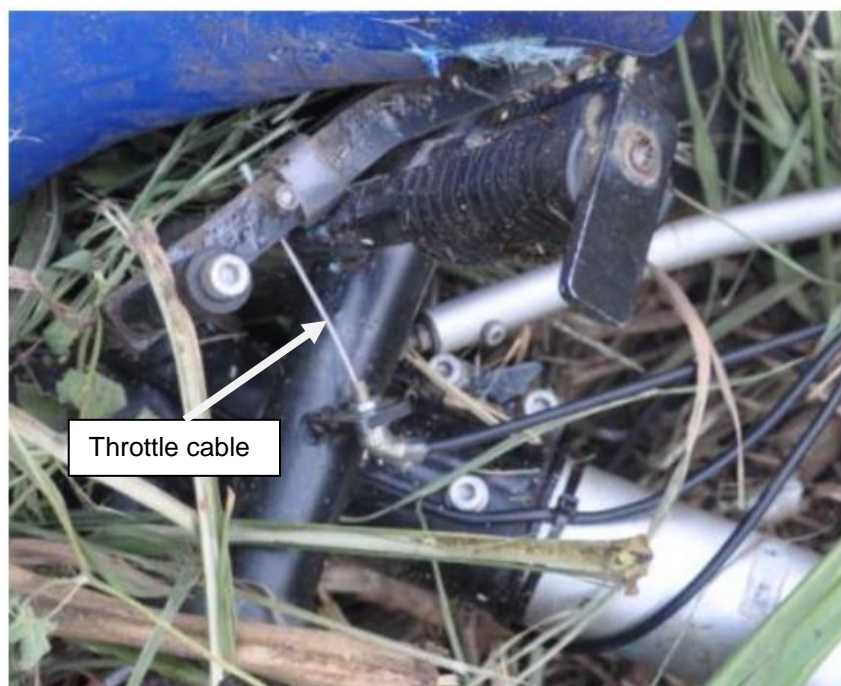
1.12.2 The shock aerofoil on the left-side was damaged, whilst the right-side was still attached. The main wheel was still attached to its respective axle. The nosewheel had separated from the tube, which seemed to have been from the impact fracture. The hub was fractured in different places with smaller pieces found in the vicinity of the tyre assembly; the tyre came off of the hub. The foot throttle and brake assembly cables and linkages were still in place, the cables were not frayed or broken. Continuity was verified and found to be satisfactory. Both seats appeared to have been heavily disturbed. The fuel tank, which is housed underneath the seat, was not ruptured and had approximately 35 litres of fuel.

Figure 6: The arrow points to throttle cable with linkages still attached.

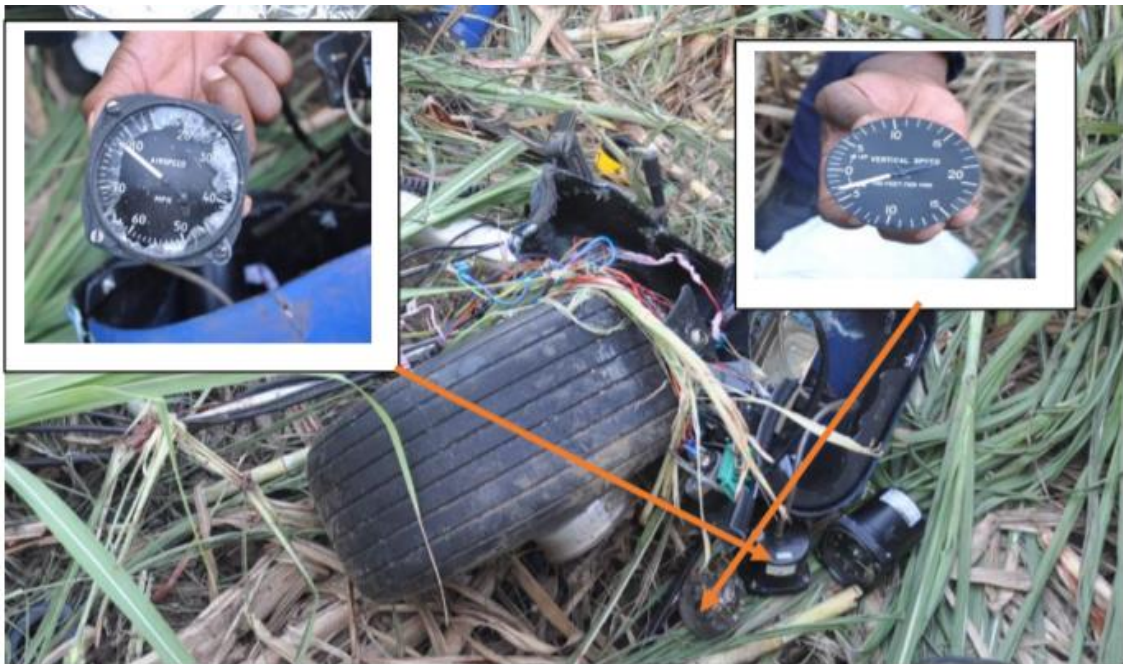
1.12.3 The instrument panel detached when the nosewheel separated from the tube. The instruments were severely damaged as a result of impact forces, and had separated from the instrument panel. The airspeed indicator glass was shattered as a result of impact, and the needle pointed at 78 miles per hour (mph). The vertical speed indicator glass had also broken, and the needle pointed at 300 feet per minute (fpm). The impact force damage to the microlight was such that the nose section of the microlight was significantly disrupted, indicative of a nose-down attitude at impact.

Figure 7: The damaged nose section. The left inset image shows airspeed indicator and the right inset image shows vertical speed indicator of the instrument panel.

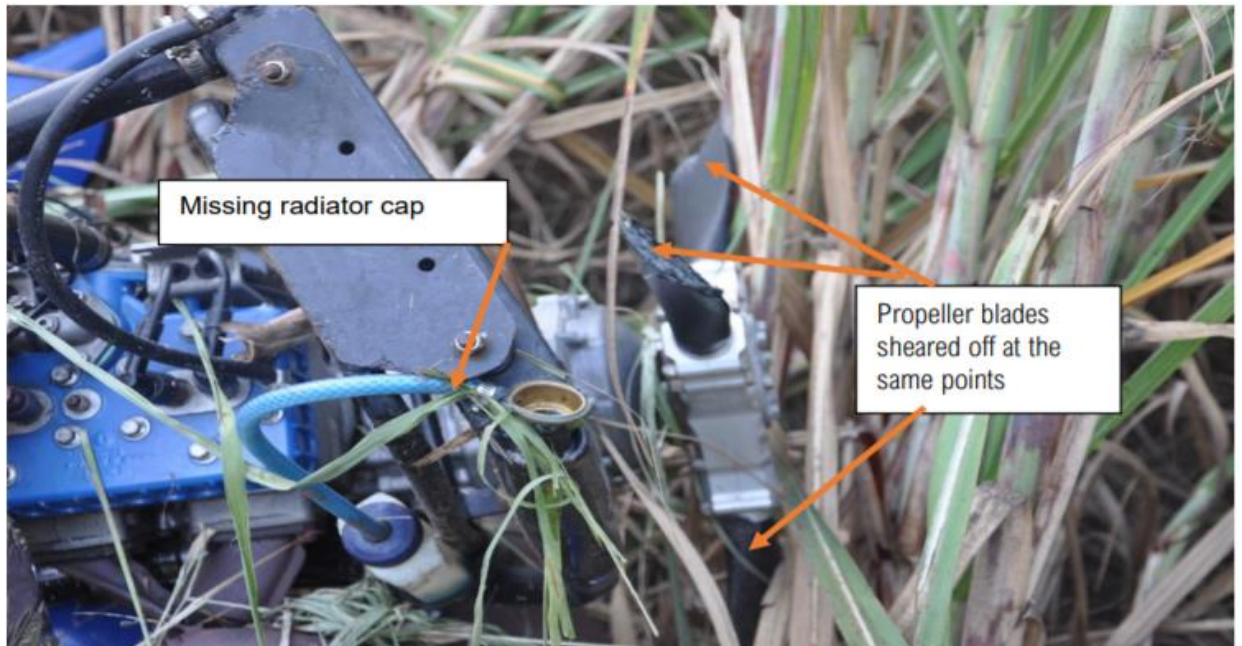
1.12.4 All three propeller blades sustained damage during the impact sequence, indicating that the engine was producing maximum power at the time of the accident. Pieces of the composite blades were found in the vicinity of the accident site. The engine radiator was properly attached to its mountings and the cap was missing, although the coolant inside the radiator was still showing enough quantity. All associated hardware (fuel pipes, electrical wires and exhaust system) of the engine were intact. The propeller flange was rotated by hand, and it rotated freely, indicating free internal components movement. The carburettor float bowls were removed and fuel samples were taken. The fuel sample indicated positive fuel flow before impact. The fuel filter was checked and there was fuel inside; no sediment or contamination was present.

Figure 8: Damaged propeller blades and radiator with a missing cap.

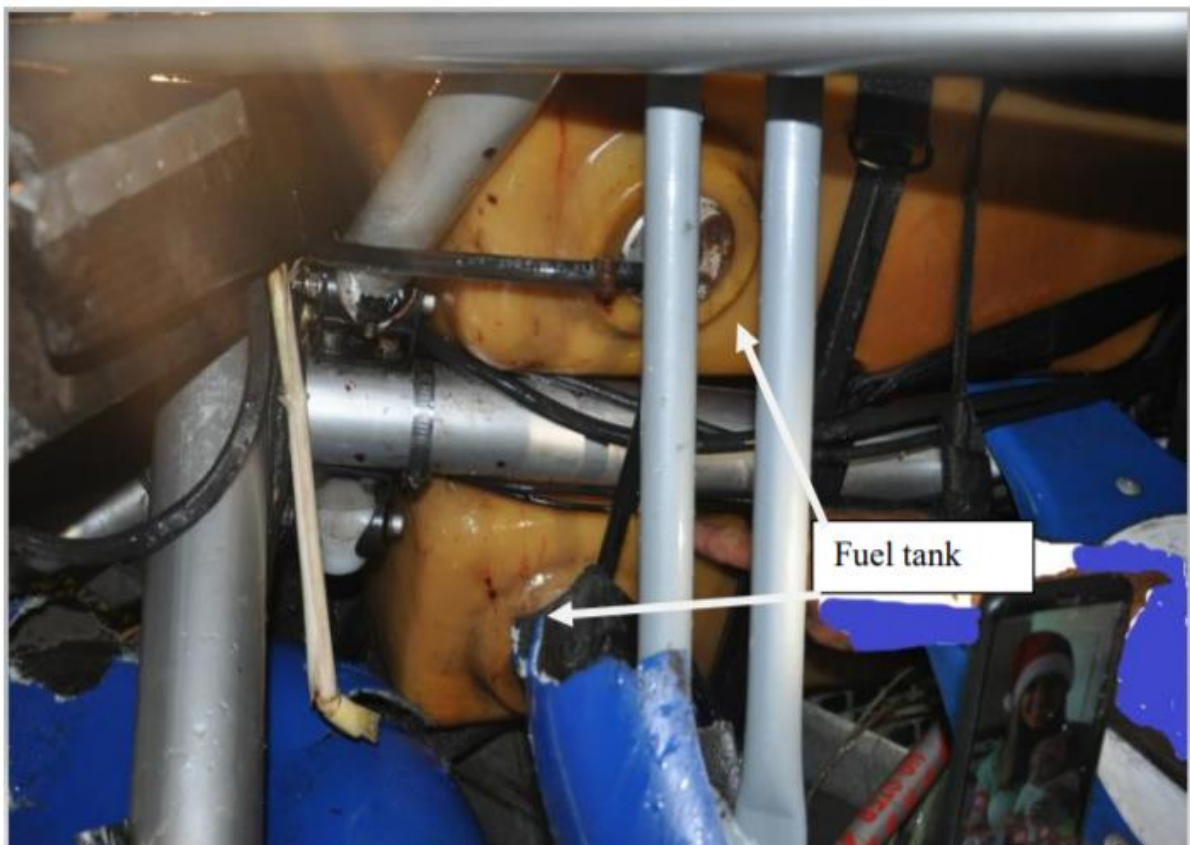
1.12.5 The microlight fuel tank was found intact. It contained approximately 35 litres of fuel.

Figure 9: The fuel tank which was found intact.

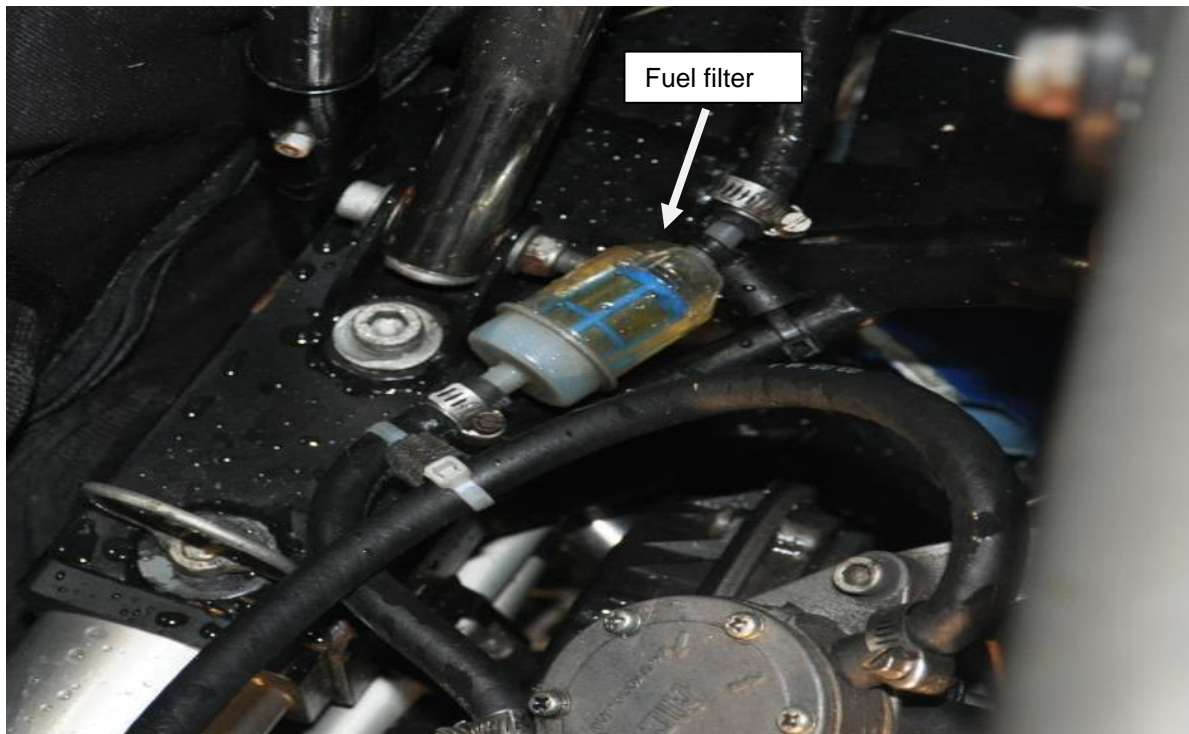
1.12.7 There was fuel contained in the filter, fuel lines and carburettor. The fuel was free from contaminants, and the fuel lines were still intact.

Figure 10: Fuel in the filter.

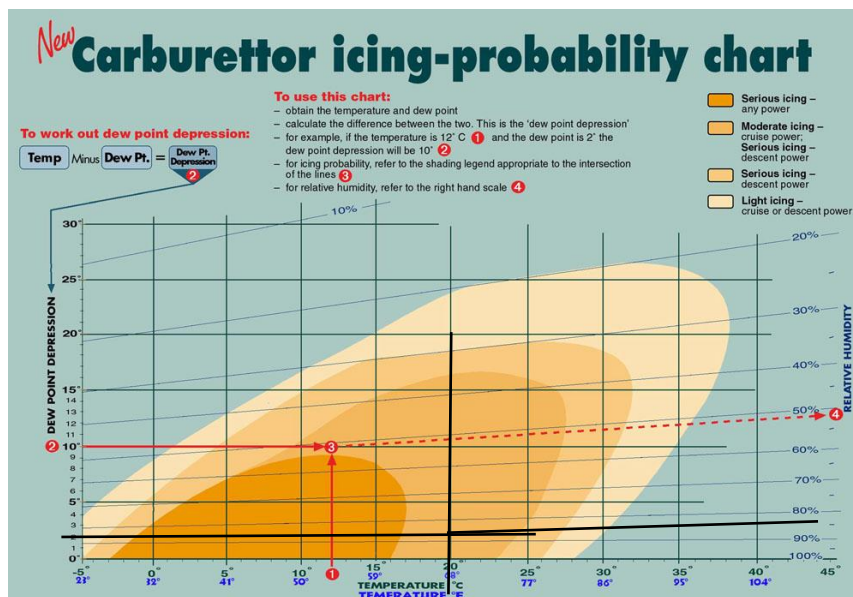
Chart 1: Carburettor icing chart

According to the weather report at FALE, the temperature was 22°C, the dew point was 20°C and the dew point depression was 2°C. When plotted on the carburettor icing chart, it places the marker on moderate icing on cruise power and serious icing on descent power with relative humidity at 85%.

The reported weather condition at the time of the accident was considered to have no bearing to this accident. The probability of carburettor icing was considered during the investigation due to the reported weather and was calculated based on the dew point depression formula by taking into consideration the temperature and dew point, which added to 85% relative humidity. The chart also depicted serious icing during descent and moderate icing during cruise. However, it is not known at which phase of flight did the accident occur. The carburettor icing was ruled out as stated above. The damage sustained by the propeller blades indicated that the engine was turning at full power during impact.
