**AIRCRAFT ACCIDENT REPORT AND EXECUTIVE SUMMARY**

<b>Reference:</b>		CA18/2/3/9993	
<b>Aircraft Registration</b>	ZU-BDY	<b>Date of Accident</b>	3 May 2021		<b>Time of Accident</b>	0817Z
<b>Type of Aircraft</b>	Magni M16 Gyrocopter		<b>Type of Operation</b>	Private (Part 94 NTCA)		
<b>Pilot-in-command Licence Type</b>	National Pilot Licence (NPL)		<b>Age</b>	50	<b>Licence Valid</b>	Yes
<b>Pilot-in-command Flying Experience</b>	<b>Total Flying Hours</b>		190	<b>Hours on Type</b>	190	
<b>Last Point of Departure</b>	Laingsburg Airfield, Western Cape Province					
<b>Next Point of Intended Landing</b>	Morning Star Airfield, Western Cape Province					
<b>Damage to Aircraft</b>	Destroyed					
<b>Location of the accident site with reference to easily defined geographical points (GPS readings if possible)</b>						
Baviaan Weg farm, Laingsburg, at Global Positioning System (GPS) co-ordinates determined to be 33°21'00" South 020°74'00" East, at an elevation of 835 feet (ft)

**Reference Number** : CA18/2/3/9993  
**Occurrence Category** : Category 1  
**Type of Operation** : Private (Part 94 NTCA)  
**Name of Operator** : Roux, Pieter Bredell  
**Aircraft Registration** : ZU-BDY  
**Aircra

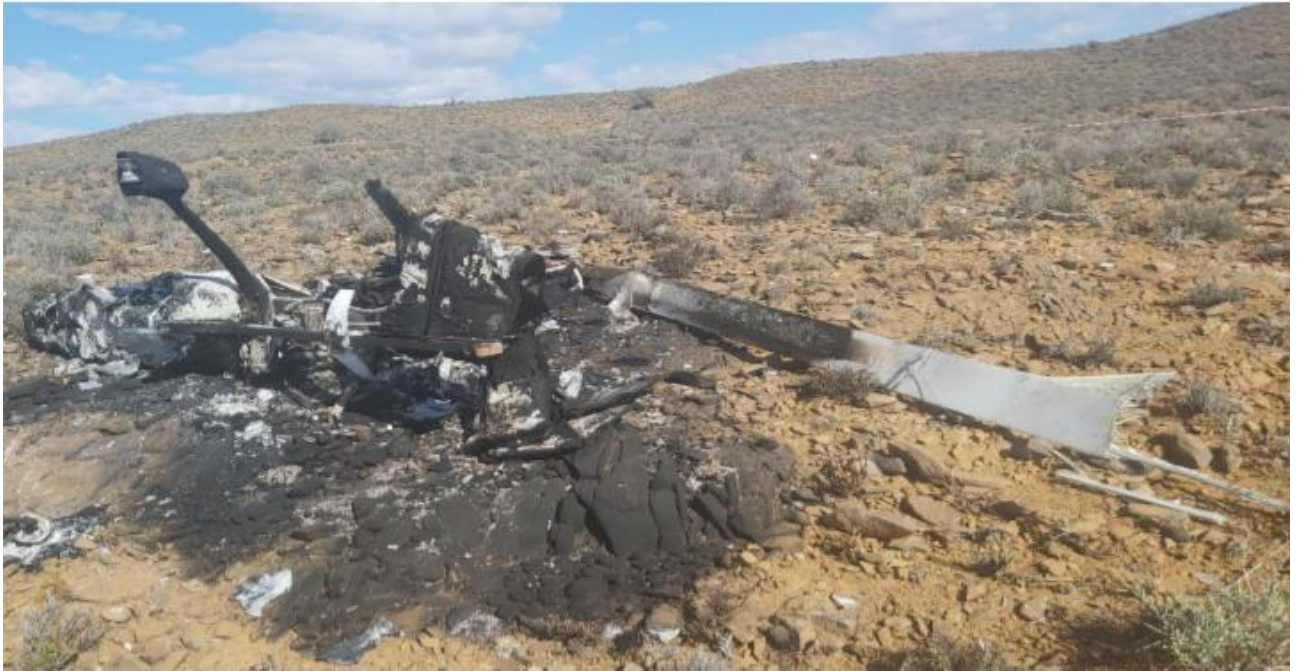
1.3.1. The aircraft was destroyed by impact and post-impact fire.

**Figure 2:** The wreckage of the ZU-BDY gyrocopter post-accident.

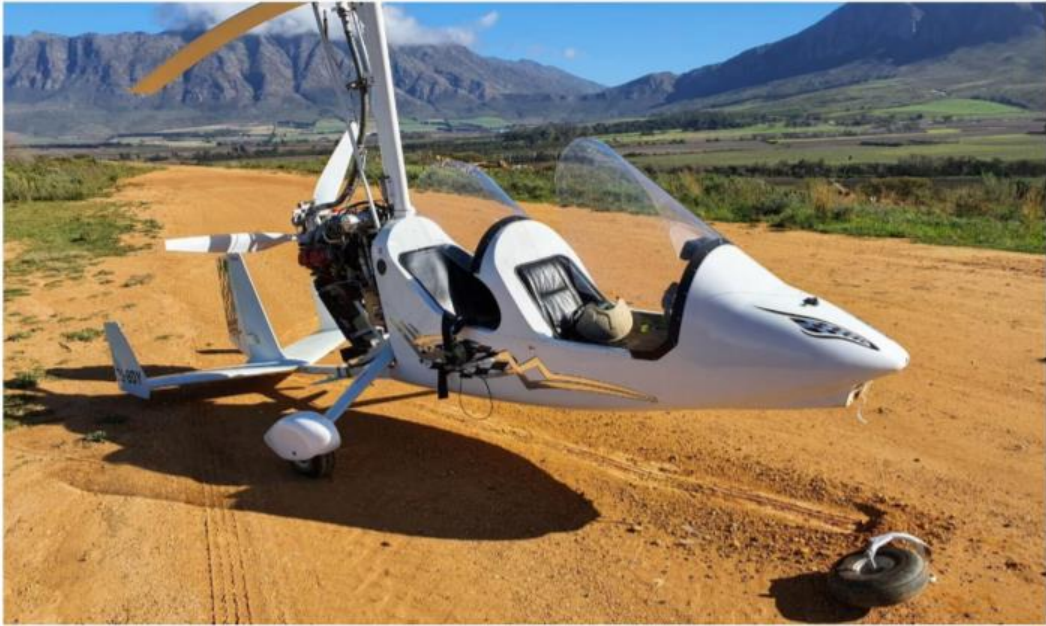
1.6.2. According to available information, the gyrocopter sustained damage to the nose landing gear, which was not reported.

**Figure 3:** The picture of the ZS-BDY damaged nose landing gear sustained in the past accident that was not reported.

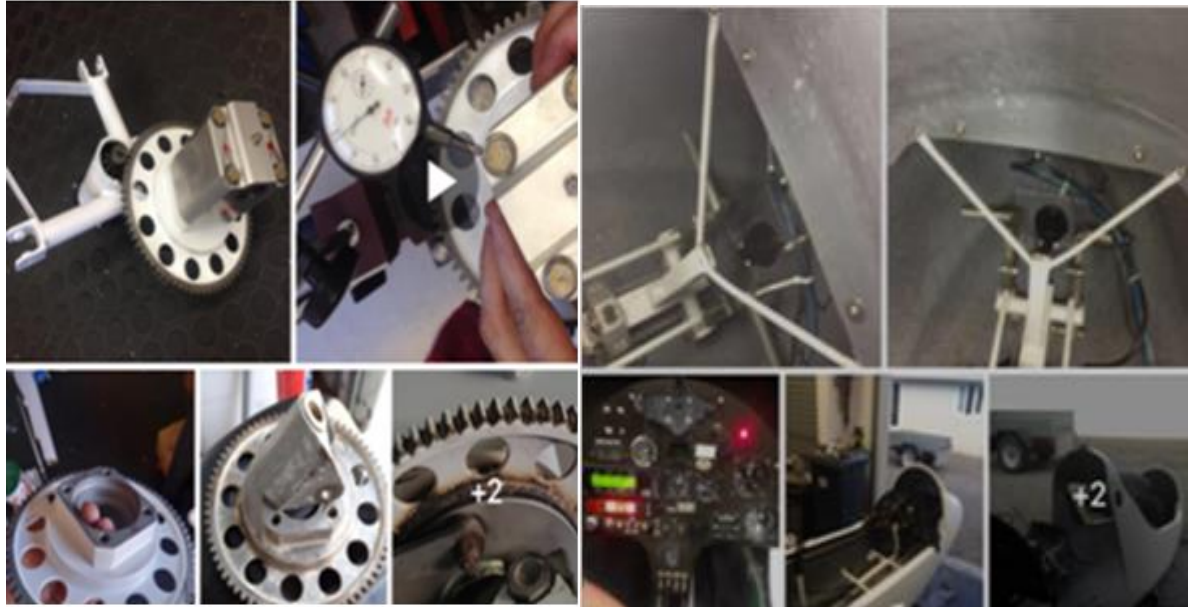
1.6.4 The AP who previously maintained the gyrocopter wrote a letter to the investigation team, stating that an unqualified person had carried out the repairs on the gyrocopter prior to the trip to Gariep Dam and posted them on social media (see Figure 4 and 5). After it was reported that the gyrocopter was involved in an accident, these pictures were removed from social media. Some of the systems that the unqualified person worked on are the rudder, uncovering the body of the gyrocopter, nose landing gear, uncovering the rotor head, and removal of the control rods and the tail section.

**Figures 4 and 5:** The components worked on by the unqualified person. (Source: Former AP)

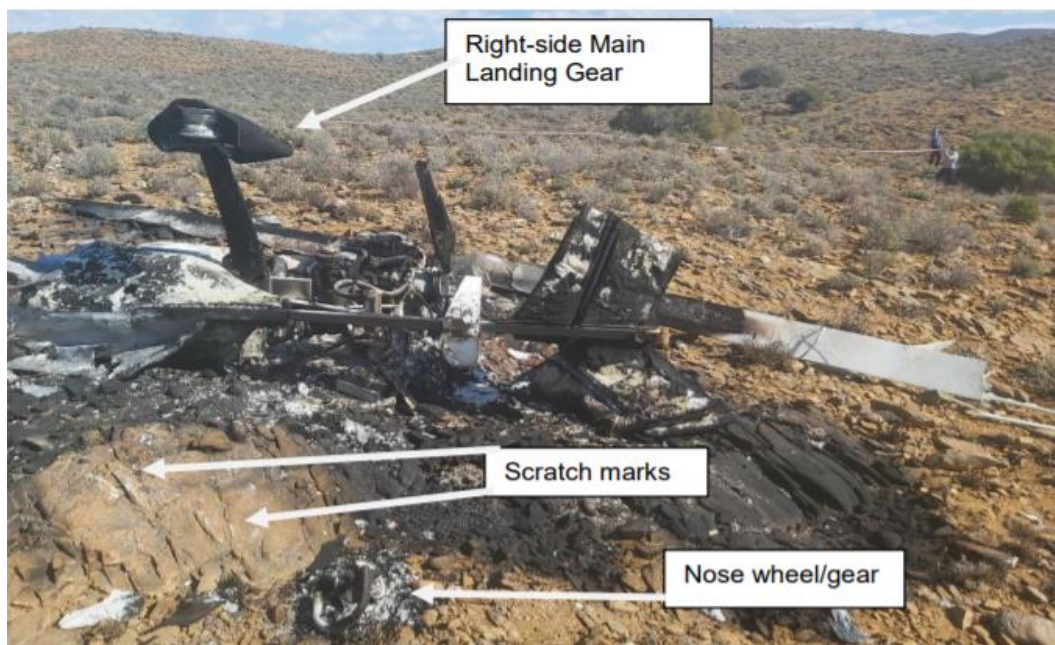
1.12.1. The gyrocopter accident occurred south-west of Laingsburg. The gyrocopter impacted the ground at an open field in a steep nose-down attitude with its right-side first on a heading of approximately 212 degrees magnetic. The aircraft was found resting on its right side. There was evidence of impact and fire damage. The cockpit was destroyed by post-impact fire.

**Figure 6:** The wreckage shows the gyrocopter resting on its right side.

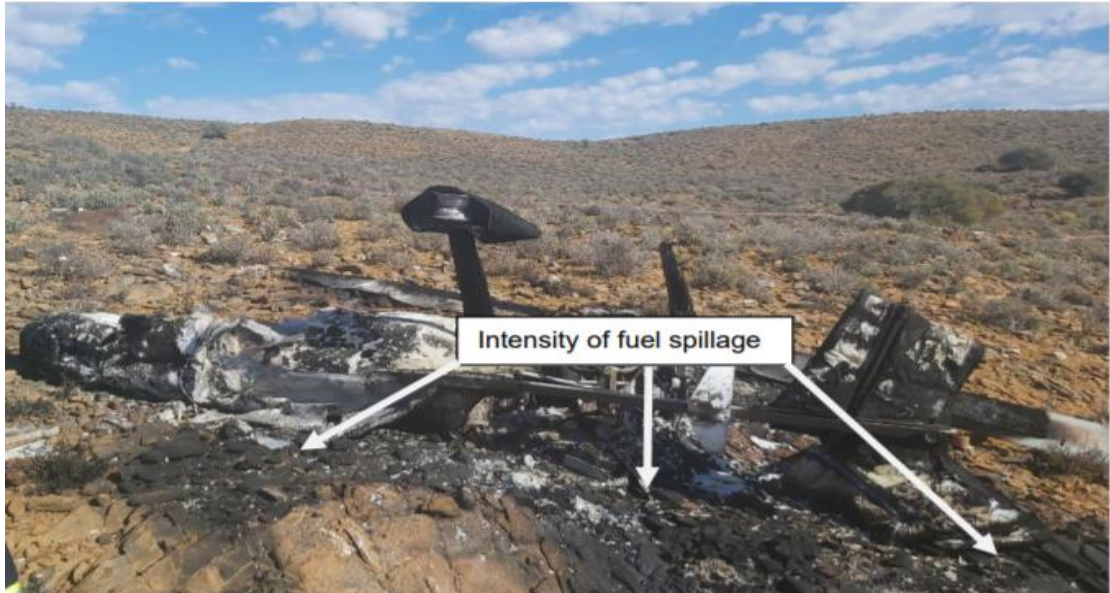
1.12.2 On-site investigation found that the gyrocopter had enough fuel at the time of the accident. The fuel tank was burnt, and some fuel had spilled onto the ground.

**Figure 7:** Spilled fuel on the ground.

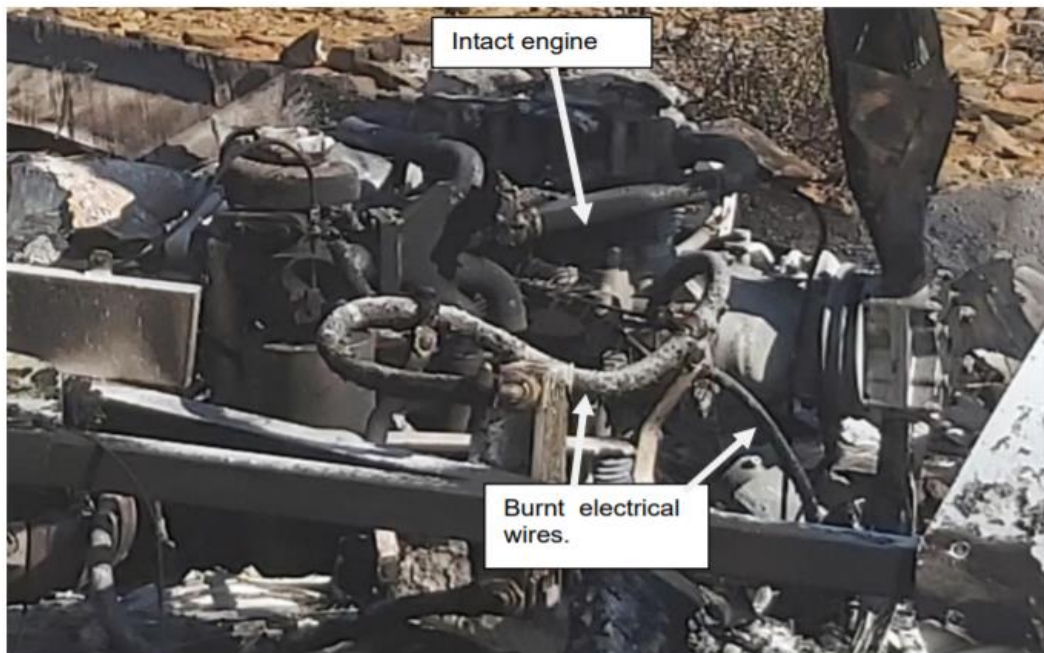
1.12.3 The engine was still intact except for electrical wiring. Rubber pipes and belts that formed part of the engine were damaged by fire. The engine could not be turned 90° by hand due to the damaged propeller hub during impact.

**Figure 8:** The engine was found still intact.

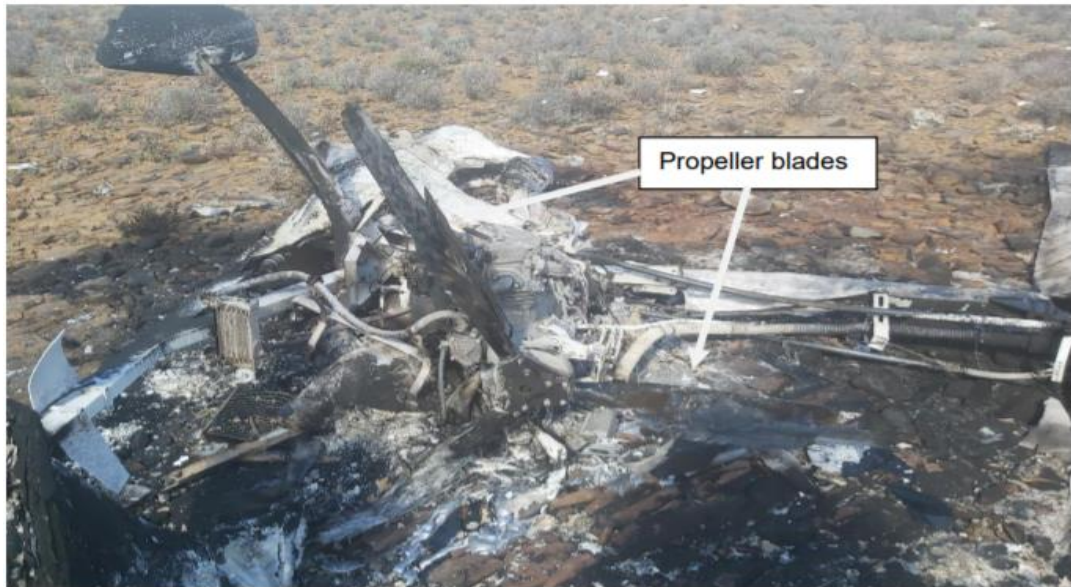
1.12.4 On-site investigation found that the propeller blades were not turning at the time of impact. They were burnt in the fire.

**Figure 9:** The burnt propeller blades.

1.12.6 The main rotor blades and the propeller blades were not at full power, which was consistent with the engine failure. Damage sustained by both the propeller blades and the main rotor blades was a result of the impact with the ground and post-impact fire.

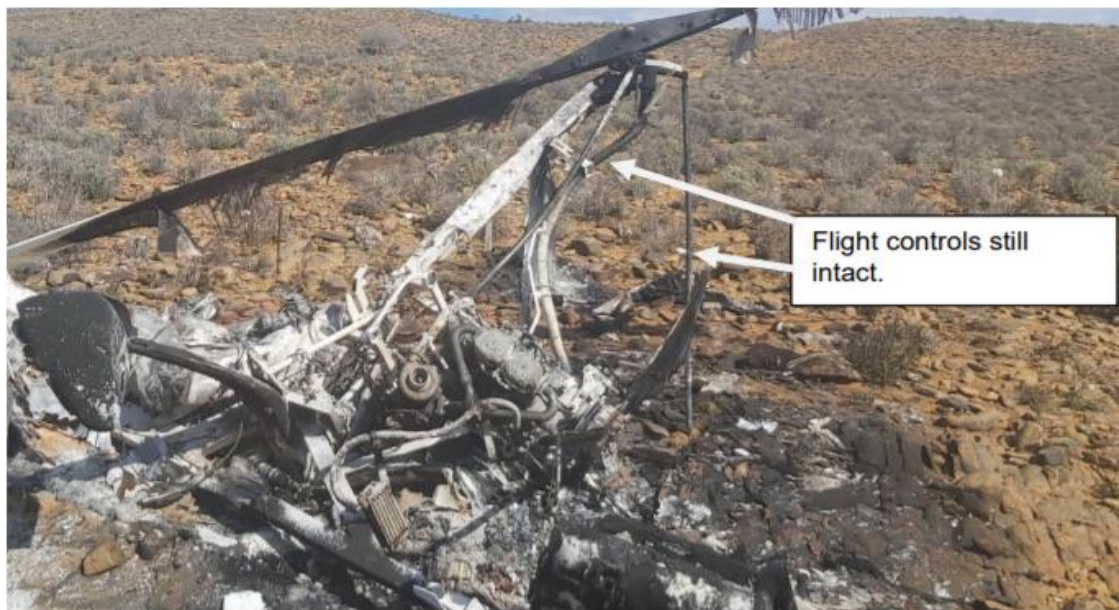
1.12.5 Continuity of flight controls was checked and confirmed to the front with no broken strands on cables.

**Figure 10:** Continuity of flight controls still intact.
