LIMITED ACCIDENT INVESTIGATION

Reference Number		CA18/2/3/9995					
Classification	ACCID	Date	4 May 2021	Time	0825Z		
Type of Operation	Training (Part 141)						
Location							
Place of Departure	Hoedspruit Civil Airfield (FAHT)			Place of Intended Landing	(FAHT)		
Place Accident	Jejene Private Nature Reserve, Hoedspruit, Limpopo Province						
GPS Co-ordinates	Latitude	24°17'27.5" S	Longitude	30°59'38.1" E	Elevation	1610 ft	
Aircraft Information							
Registration	ZU-LEF						
Model/Make	Jabiru 170						
Damage to Aircraft	Substantial		Total Aircraft Hours	154.3			
Pilot-in-command							
Licence Valid	Yes	Gender	Male	Age	30		
Licence Type	National Pilot Licence (Aeroplane)						
Total Hours on Type	±369.8		Total Flying Hours	1818.9			
People On-board	1+1	Injuries	0	Fatalities	0	Other (On Ground) 0	
What Happened							
<p>On Tuesday morning, 4 May 2021, a pilot and a passenger on-board a Jabiru aircraft with registration marking ZU-LEF took off on a familiarisation flight from Runway 15 at Hoedspruit Civil Airfield in Limpopo province. The flight, which was intended to be conducted in the Hoedspruit area. The flight was conducted under Visual Flight Rules (VFR) by day and unde

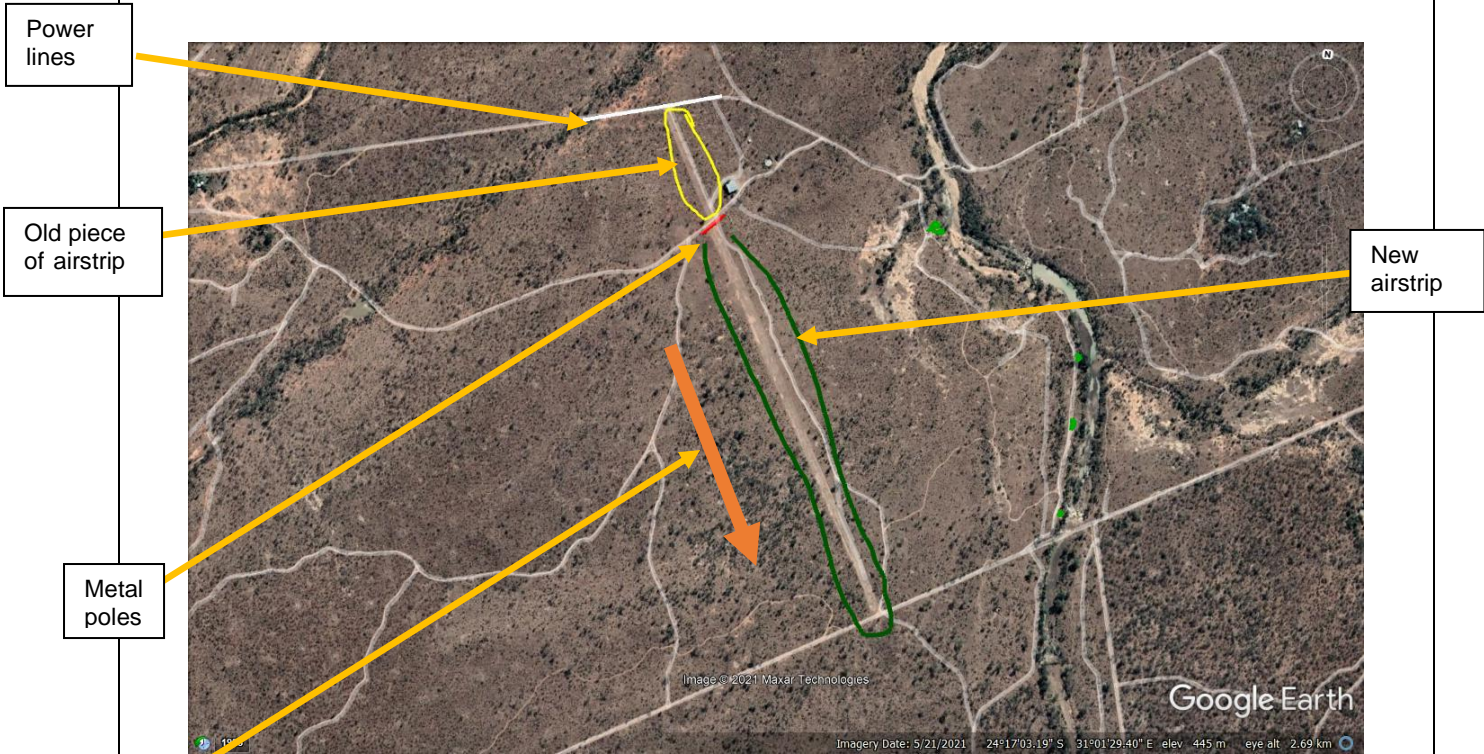
Post-accident interview with the Jejane Lodge manager revealed that there is an old piece of airstrip which is not used. There were also metal poles (see red line on figure 1) to separate the old landing strip (yellow marking) and the new one marked in green). The metal poles were there to prevent cars from driving on the landing strip.

The lodge manager stated that the aircraft approached the Jejane airstrip from the North, heading South, it crash landed on the old piece (marked in yellow) and crashed through the metal barrier poles (Red line) and came to a stop about 50 to 70m on the new airstrip. It was clear that the pilot intended to land on the new airstrip but could not make it. After the accident, Jejane management removed the metal barrier poles and replaced them with a "No Entry" sign for vehicles.

Figure 1: Green colour is the existing airstrip, yellow is an old piece of airstrip, red line is the metal poles and white line is a power line. Orange arrow shows the direction of landing.

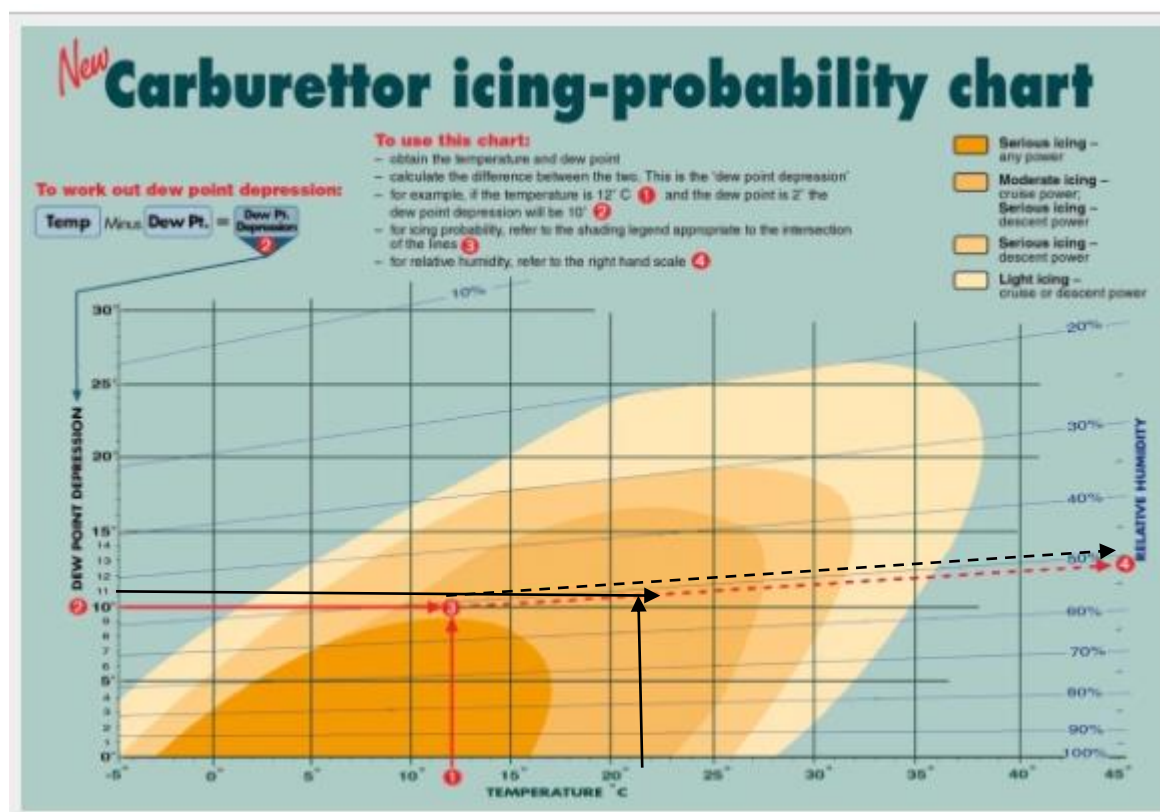
According to the carburettor icing-probability chart below (Figure 1), the relative humidity in the area around FAHS was at approximately 51% with the temperature of 22°C and dew point depreciation of 11°C. When flying in these conditions, the result would be a moderate icing condition at cruise power with serious icing on descent. There would have been a moderate icing probability at cruise power, which is where the aircraft was when the engine lost power.

Figure 1: Carb icing chart.

It is likely that the cause of the engine power loss was due to carburettor icing during cruise power.

Safety message: Pilots are advised to carry out proper flight planning prior to initiating any flight, with emphasis on the weather and calculation of the carburetor icing probability, which could prevent engine power loss or failure, as well as prevent loss of life and damage to property.

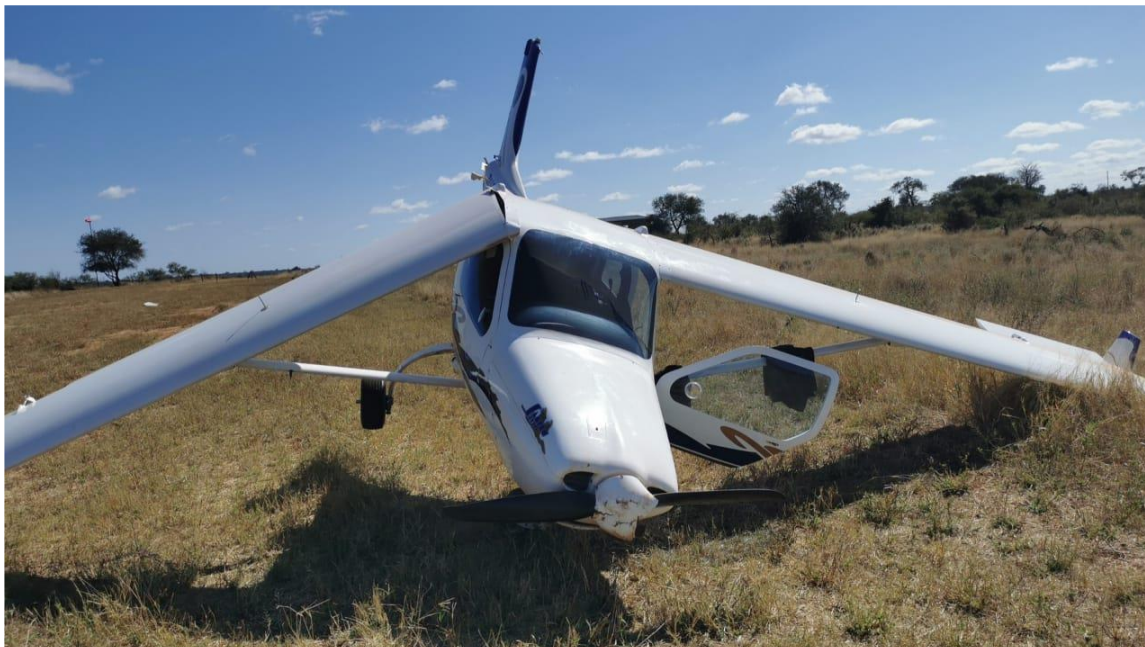
Figure 3: Final resting position of the aircraft.
