INTERIM STATEMENT ACCIDENT

Serious Incident
- Interim Statement -
AIID Ref No: CA18/3/2/1398

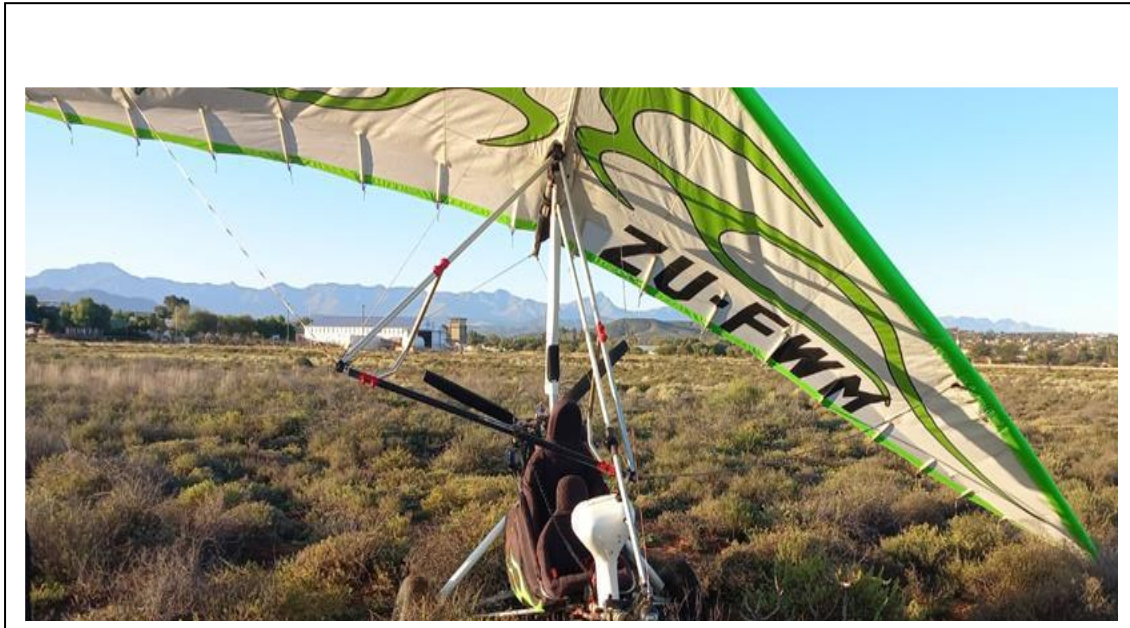
On Monday, 4 July 2022, a flight instructor and a student pilot on-board a Windlass Aquilla 912 Trike with registration ZU-FWM took off on a circuit training flight from Oudtshoorn Aerodrome (FAOH) in the Western Cape province, with the intention to land back at the same aerodrome. According to the flight instructor, they flew one circuit and landed uneventfully on Runway 22. However, while taxiing the trike to the apron on taxiway Alpha, the engine mount that supports the engine and the seat frame broke off which caused the seats to drop down a margin. This led to the throttle cable being pulled down before it got stuck in the open position (80% power); as a result, the trike accelerated sharply. The instructor steered the trike away from possible hazards before he brought it to a stop in a nearby field. The flight instructor and the student pilot disembarked from the trike; they were both not injured. The trike sustained damage to the engine mount (pylon) that failed, the rear axle, the radiator bracket that bent, and the carburetors that fell off during taxi.
