**PRELIMINARY ACCIDENT REPORT**

**Accident and Incident Investigations Division**

Accident  
- Preliminary Report -  
AIID Ref No: CA18/2/3/10609

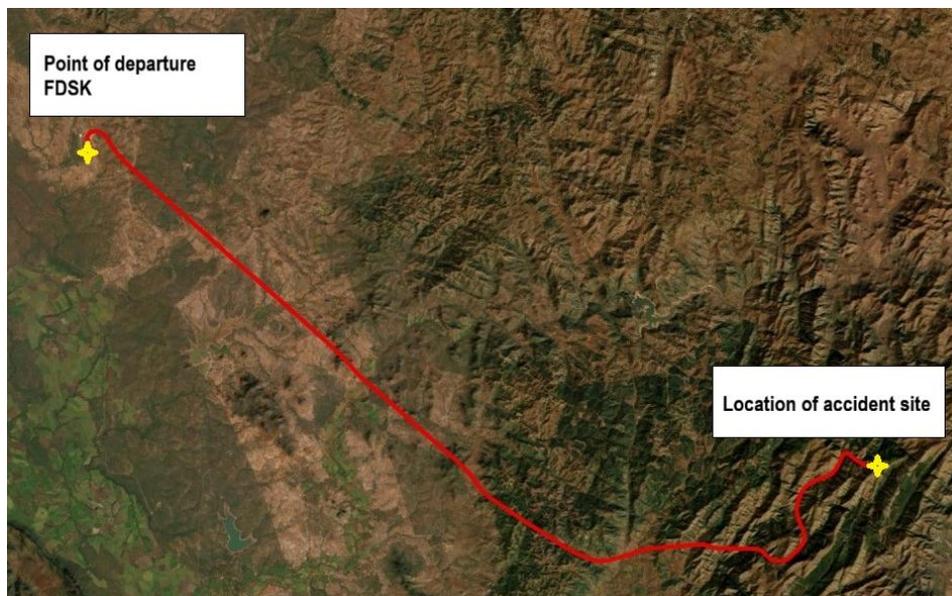
- 1.1.4 The aircraft was destroyed during the accident sequence, and the pilot was fatally injured.
- 1.1.5 The accident occurred during the day at Global Positioning System (GPS) co-ordinates determined to be South 25°52'8.313" East 31°5'23.5212", at approximately 4740 feet (ft) above mean sea level (AMSL).
- 1.1.6 According to the GPS data recovered from the aircraft's navigation system, the aircraft was flown at an indicated airspeed of 87.9 knots (kts) at an altitude of 4994 ft AMSL and climbed at a rate of 1189 ft per minute. The recording stopped 31 minutes into the flight. Data also indicated that the aircraft stayed between 3500 ft AMSL and 4994 ft AMSL in the last 3 minutes of the flight. It did not exceed 4994 ft AMSL for the duration of the recorded flight (see Figures 4 and 5).

**Figure 3:** The flight route tracked by the on-board GPS.

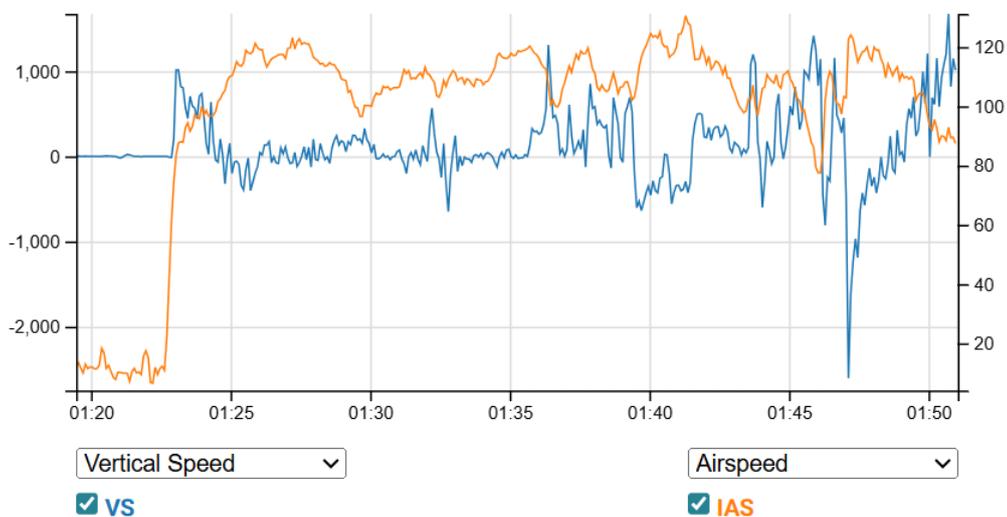
**Figure 4:** The GPS data shows the aircraft's vertical speed and airspeed before the recording stopped.

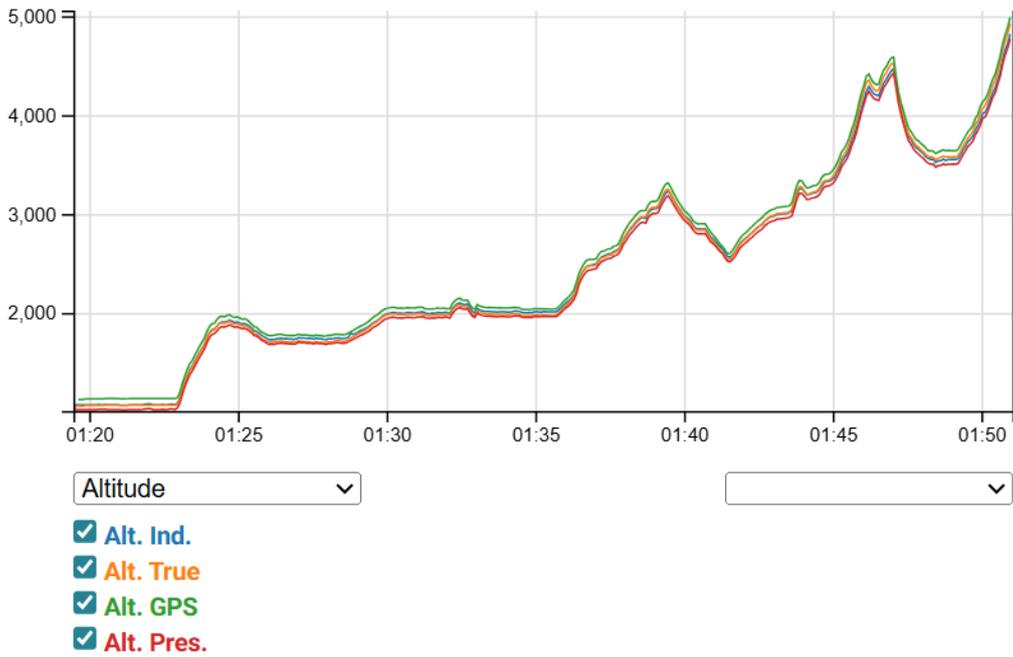
**Figure 5:** The GPS download shows the aircraft's altitude before the recording stopped.

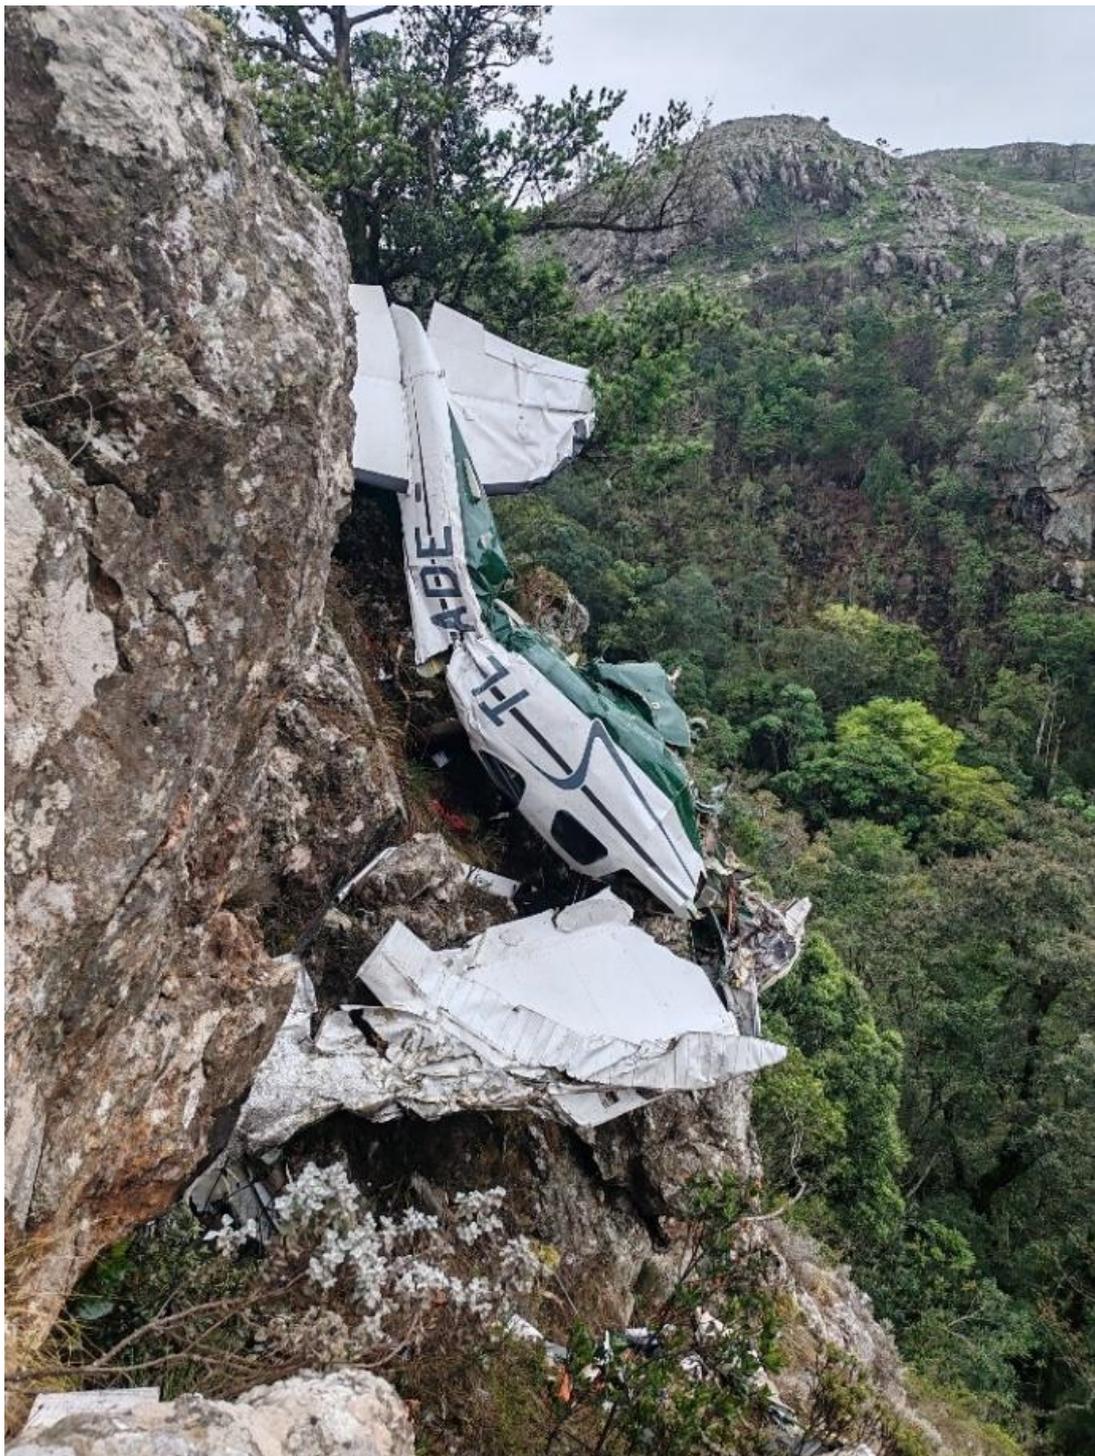
**Figure 6:** The wreckage at the scene of the accident.

1.3.1 The aircraft was destroyed during the accident sequence.

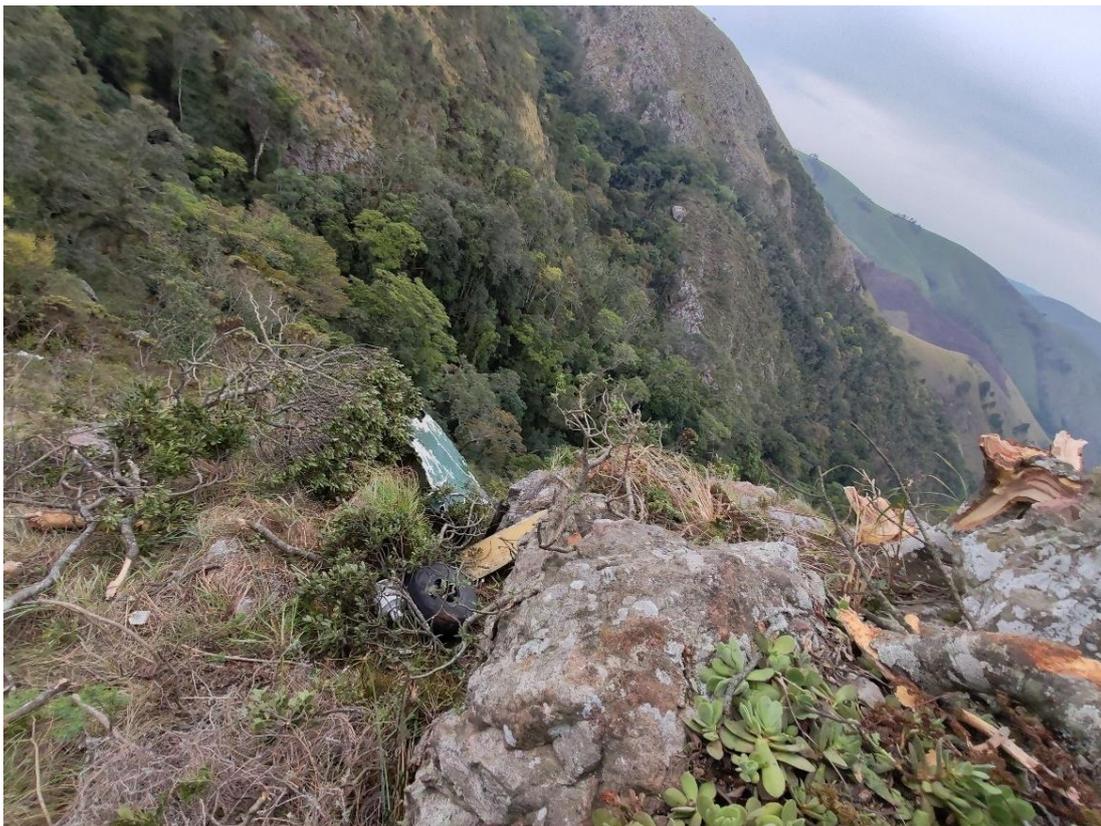
**Figure 7:** Some vegetation on the side of the mountain was destroyed.

1.4.1 Examination of the accident site revealed that vegetation on the mountainside was uprooted along the aircraft's impact path.

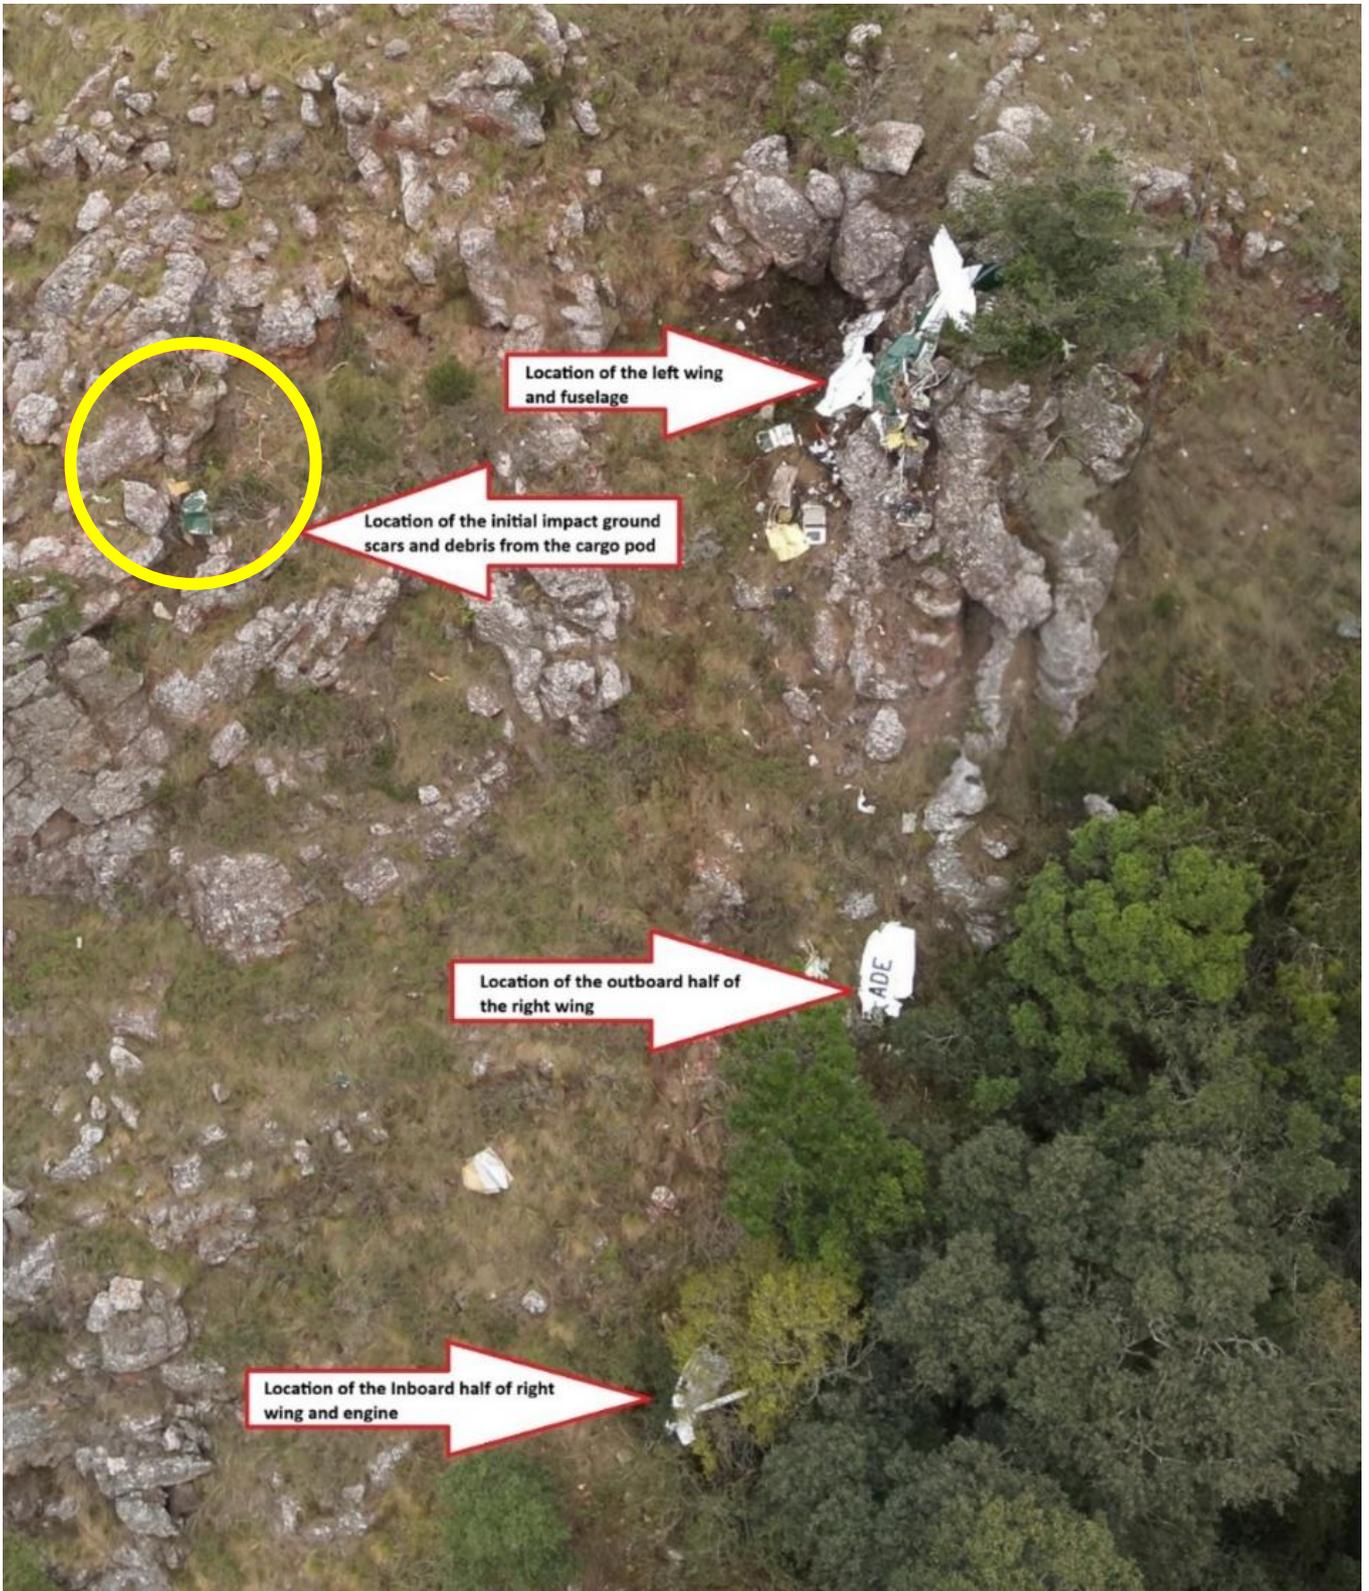
1.12.2 The left wing and fuselage remained on the cliff face, suspended by the empennage that was wedged between the vegetation. The right wing and engine separated from the fuselage; the outboard half of the right wing was found 20m from the main wreckage down the mountain side. The inboard half of the right wing and engine were found at the bottom of the valley approximately 50m from the main wreckage (see Figure 8).

**Figure 8:** The wreckage distribution.

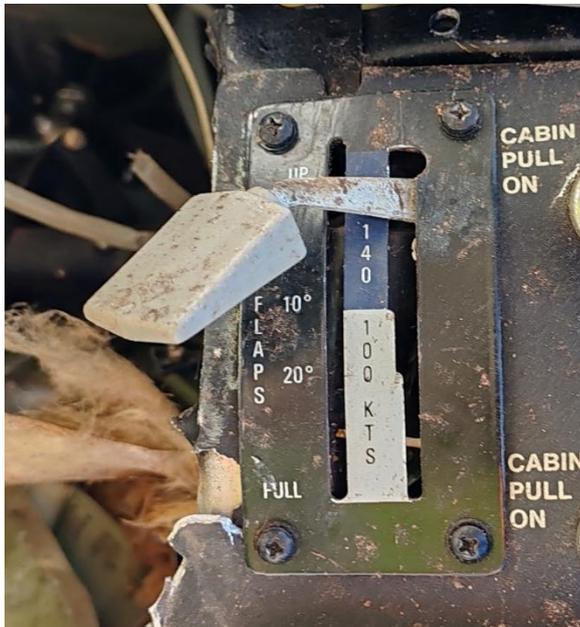
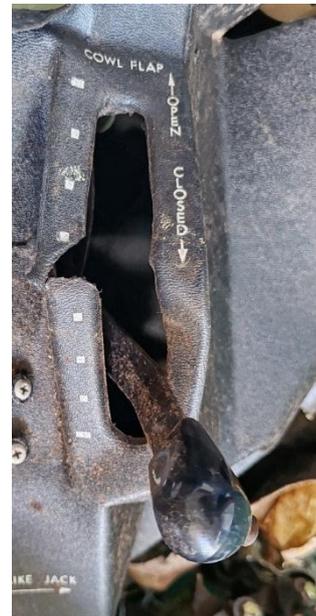
- The flap selector and control surfaces were in the retracted position (see Figure 9).
- The cowl flaps and cowl flap selector were in the closed position (see Figure 10).
- There was continuity in the flight control cables linking the flight control surfaces to the control column (see Figures 11 and 12).
- The engine throttle was depressed in "open" position (see Figure 13).
- The mixture control was extended to "lean mixture" position (see Figure 13).
- The propeller RPM lever was depressed to "increase RPM" position (see Figure 13).
- The magneto switch was selected to "both" position (see Figure 14).
- The engine manifold pressure indicator indicated 20in Hg pressure (see Figure 15).
- The fuel flow indicator indicated a fuel flow of 20 gal/hour (see Figure 15).

**Figures 9 and 10:** Flap and cowl flap selectors.

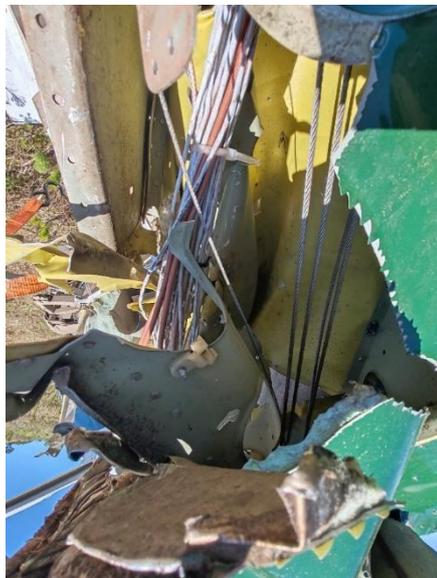
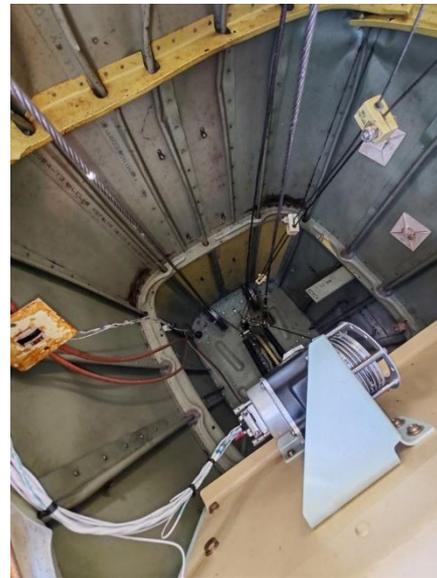
**Figures 11 and 12:** Flight control continuity through the fuselage.

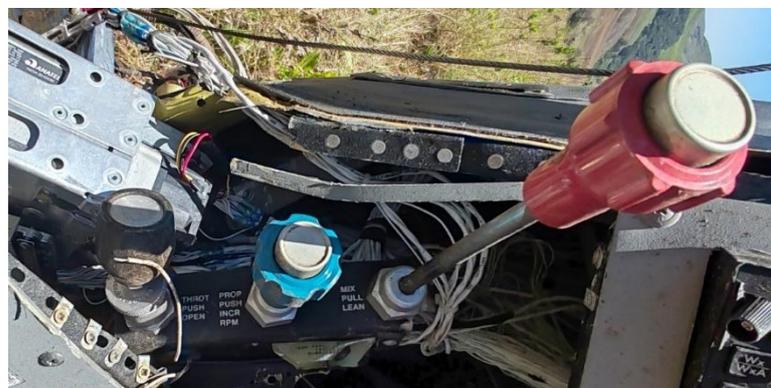
**Figure 13:** The throttle lever, propeller RPM lever, and fuel mixture lever positions.

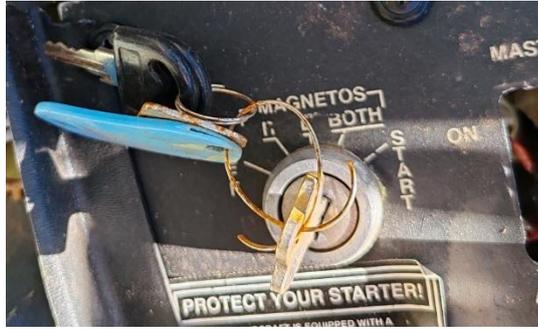
**Figure 14:** Magneto switch position.

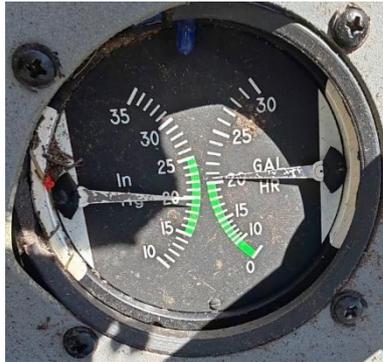
**Figure 15:** Manifold pressure and fuel flow dual indicator.

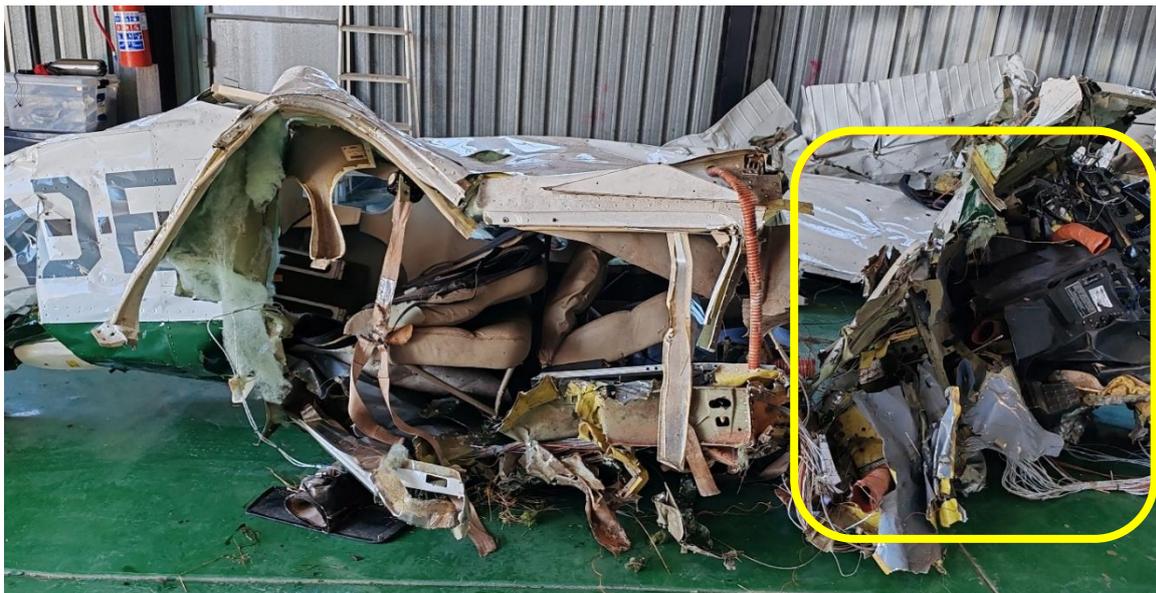
**Figure 16:** The cockpit was completely crushed during the accident sequence (yellow highlight).

1.15.1 The accident was not considered survivable due to the extent of the damage sustained by the aircraft during the high-energy impact.
